Section 8. Inventory of Historic Resources: Sites 21–40

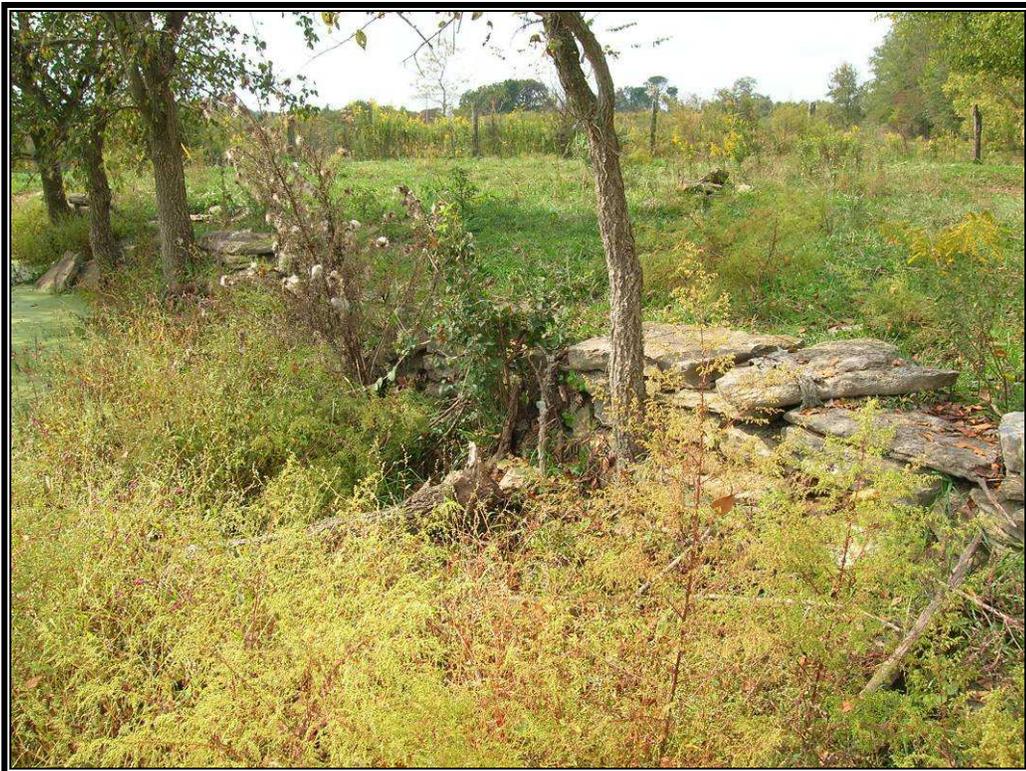
Figure 8.11. Site 21, Rock wall, located on edge of pond.

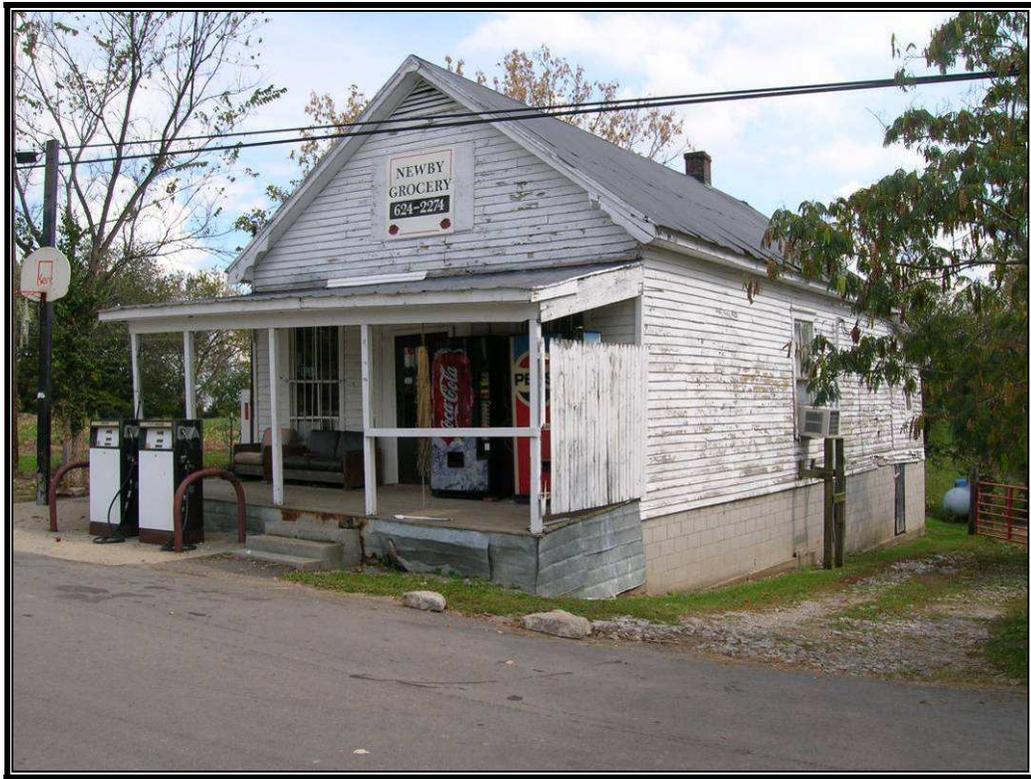
Figure 8.14. Site 22, Newby Grocery Store (MA-463).

NRHP Evaluation: Eligible. Historic community stores are becoming rare in central Kentucky and throughout the state. In many cases, the local community store is the last extant evidence of the existence of smaller communities. The Newby Grocery Store retains a high degree of integrity. Although its foundation has been replaced, the building retains its siding, windows, and a majority of its decorative trim. The building does not appear to be associated with a significant person in history, but it does appear to be associated with early twentieth century commercial activity in the Newby community in rural Madison County. As a result, the Newby Grocery Store appears to be eligible for inclusion in the NRHP under Criterion A, for its association with early twentieth-century commercial activity in Newby and rural Madison County, Kentucky.

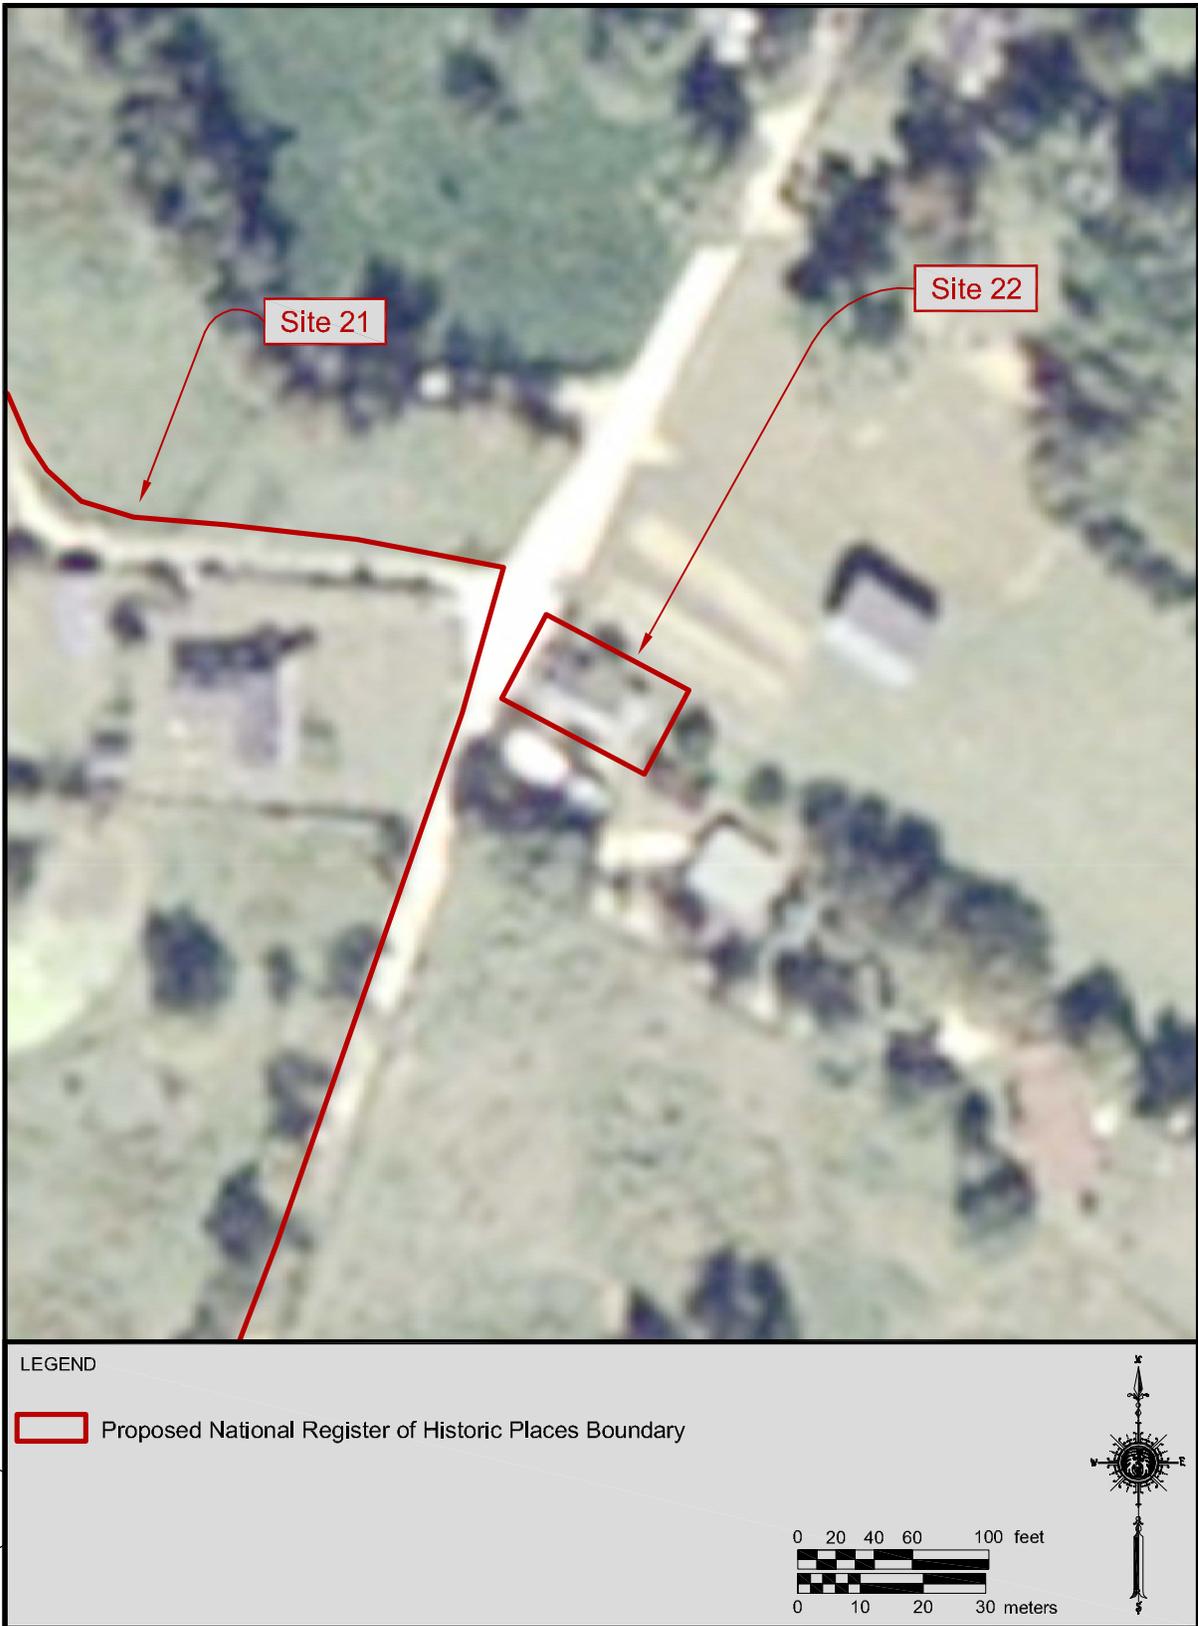
The proposed NRHP boundary includes the building and a small footprint surrounding it, with the gravel drive on the south side serving as the southern boundary (Figure 8.16).

Figure 8.16. Site 22 proposed NRHP boundary.

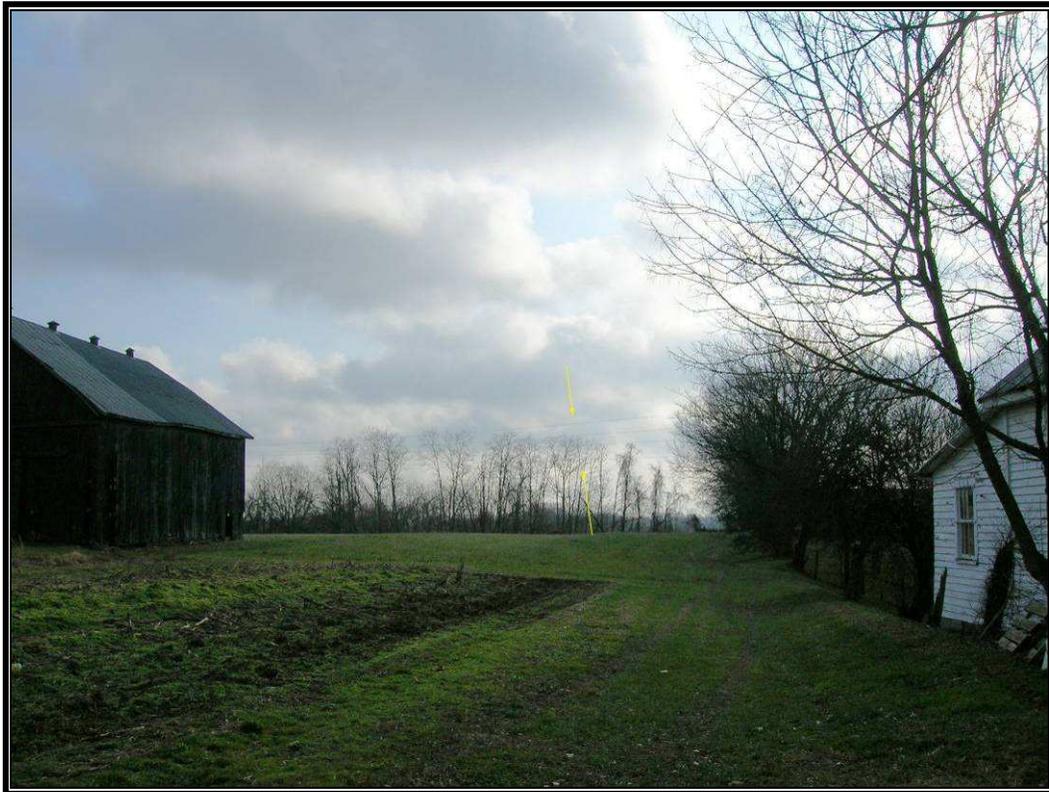
Figure 8.17. Site 22, Looking southeast toward existing line from side of Site 22. Yellow arrows are pointing to the line.

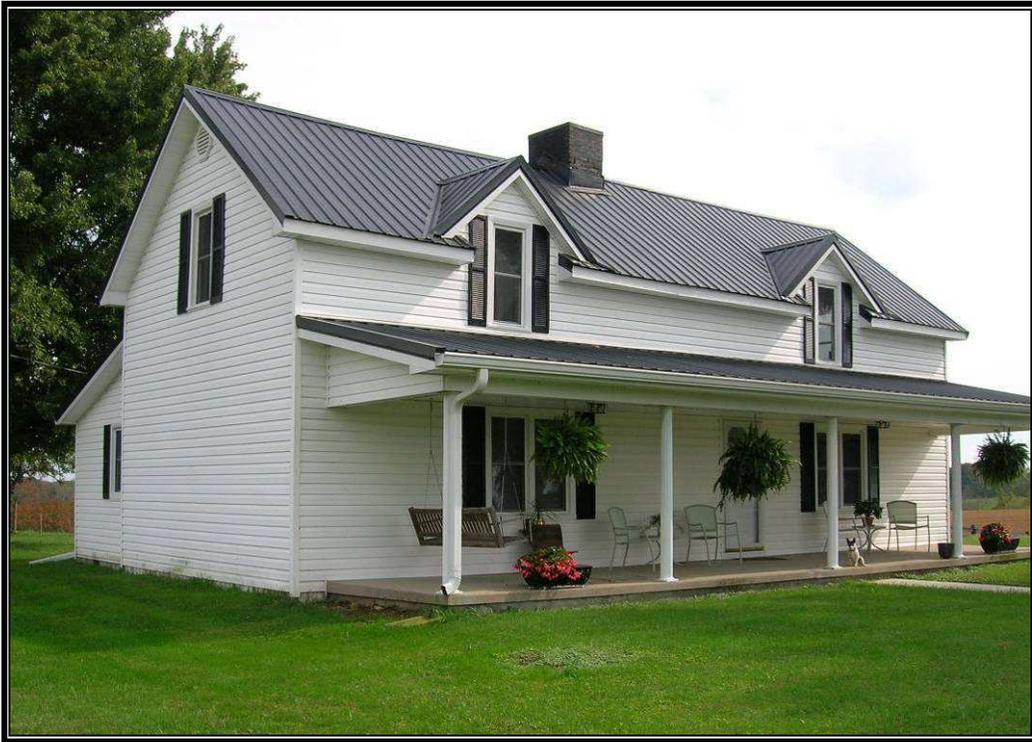
Figure 8.24. Site 24, One-and-one-half-story, three-bay, side-gable frame house (MA-873).

NRHP Evaluation: Not Eligible. With its replacement siding, windows and doors, this house's integrity of design, materials, and workmanship have been diminished. Additionally, the house does not have any distinctive character defining elements and does not appear to be a particularly outstanding example of a common type. Nor do the associated outbuildings impart significance to the site as a whole. The house does not appear to be associated with a significant person or event in history. As a result, this house does not appear to be eligible for the NRHP under Criterion A, B, C, or D.

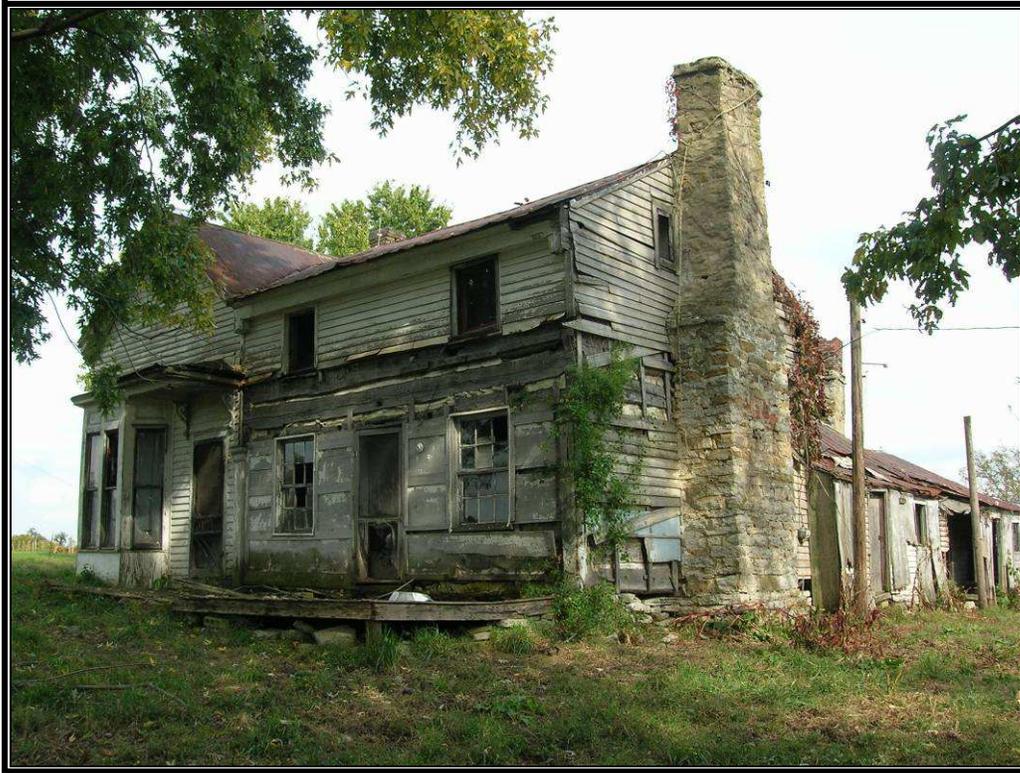
Figure 8.28. Site 25, One-and-one-half-story, three-bay (w/d/w), single-pen log house with a two-bay box-frame addition and log ell (MA-156).

NRHP Evaluation: Eligible. The 1980 survey form completed for this house includes pictures of the house as it looked at that time. Among the major changes the house has undergone since the original survey is the removal of the front porch, and the overall neglect or lack of maintenance. Many of the window sashes or lights are missing, portions of the siding are missing, the rear of the ell is collapsing, and portions of the foundation are deteriorating. The house does, however, retain a majority of its siding, windows, window and door trim, and, most importantly, its structural makeup. Although the house's integrity of design, materials, and workmanship has been diminished, it retains the key structural components that convey its construction methods and technique that date from the early to late nineteenth century. The combination of the single-pen log house, double-pen and single-pen log ell, and late nineteenth century balloon frame addition represents an excellent example of early and late nineteenth century vernacular construction methods in rural Madison County. Although the house appears to be associated with a member of the Million family, who were significant property owners in the area, research has not revealed any further significance of any one family member. The house does, however, appear to date to the settlement of the area. For these reasons, this house appears eligible for inclusion in the NRHP under Criterion A, for its association with local settlement, and Criterion C, as an excellent example of early and late nineteenth century vernacular construction methods in rural Madison County, Kentucky.

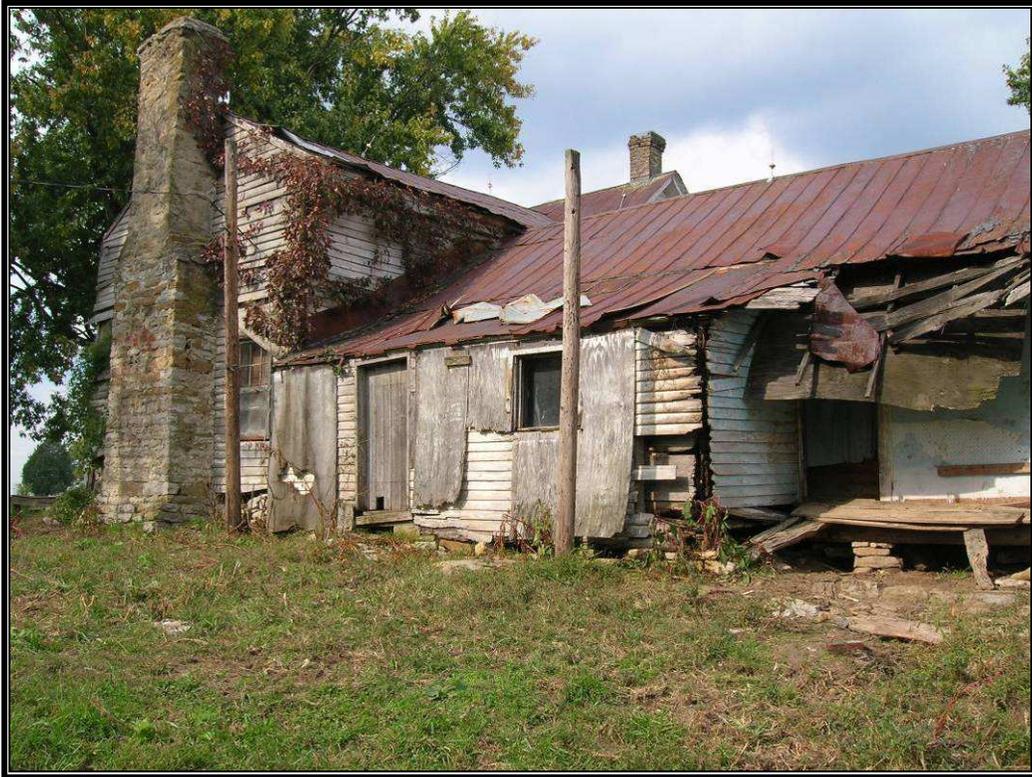
Both portions of the ell are resting on a dry-laid stone foundation and are clad in weatherboard siding. The south side of the ell has a shed-roof enclosed porch resting on a stone pier foundation; this side of the ell is in a deteriorated condition (Figure 8.33). A single-leaf entry with a vertical board door and a rectangular, boarded over window are located on the south side of the first section of the ell. A late nineteenth-century one-and-one-half-story, front-gable, two-bay (w/d) frame addition is located on the north side of the log house (Figure 8.34). A three-sided bay with one-over-one-light double-hung wood sashes is located on the left side of the addition's facade. The bay has wood panels with molding above the windows as well as a wood cornice with molding. A single-leaf entry with a wood panel door and a wood screen door is located to the right of the bay. The entry has a wood surround with molding. A small hip-roof porch with a molded wood cornice and decorative carved brackets shelters the entry. A window with two-over-two-light double-hung wood sashes and a molded wood surround is located on the north elevation of

Figure 8.33. Site 25, Rear and south elevation of house.

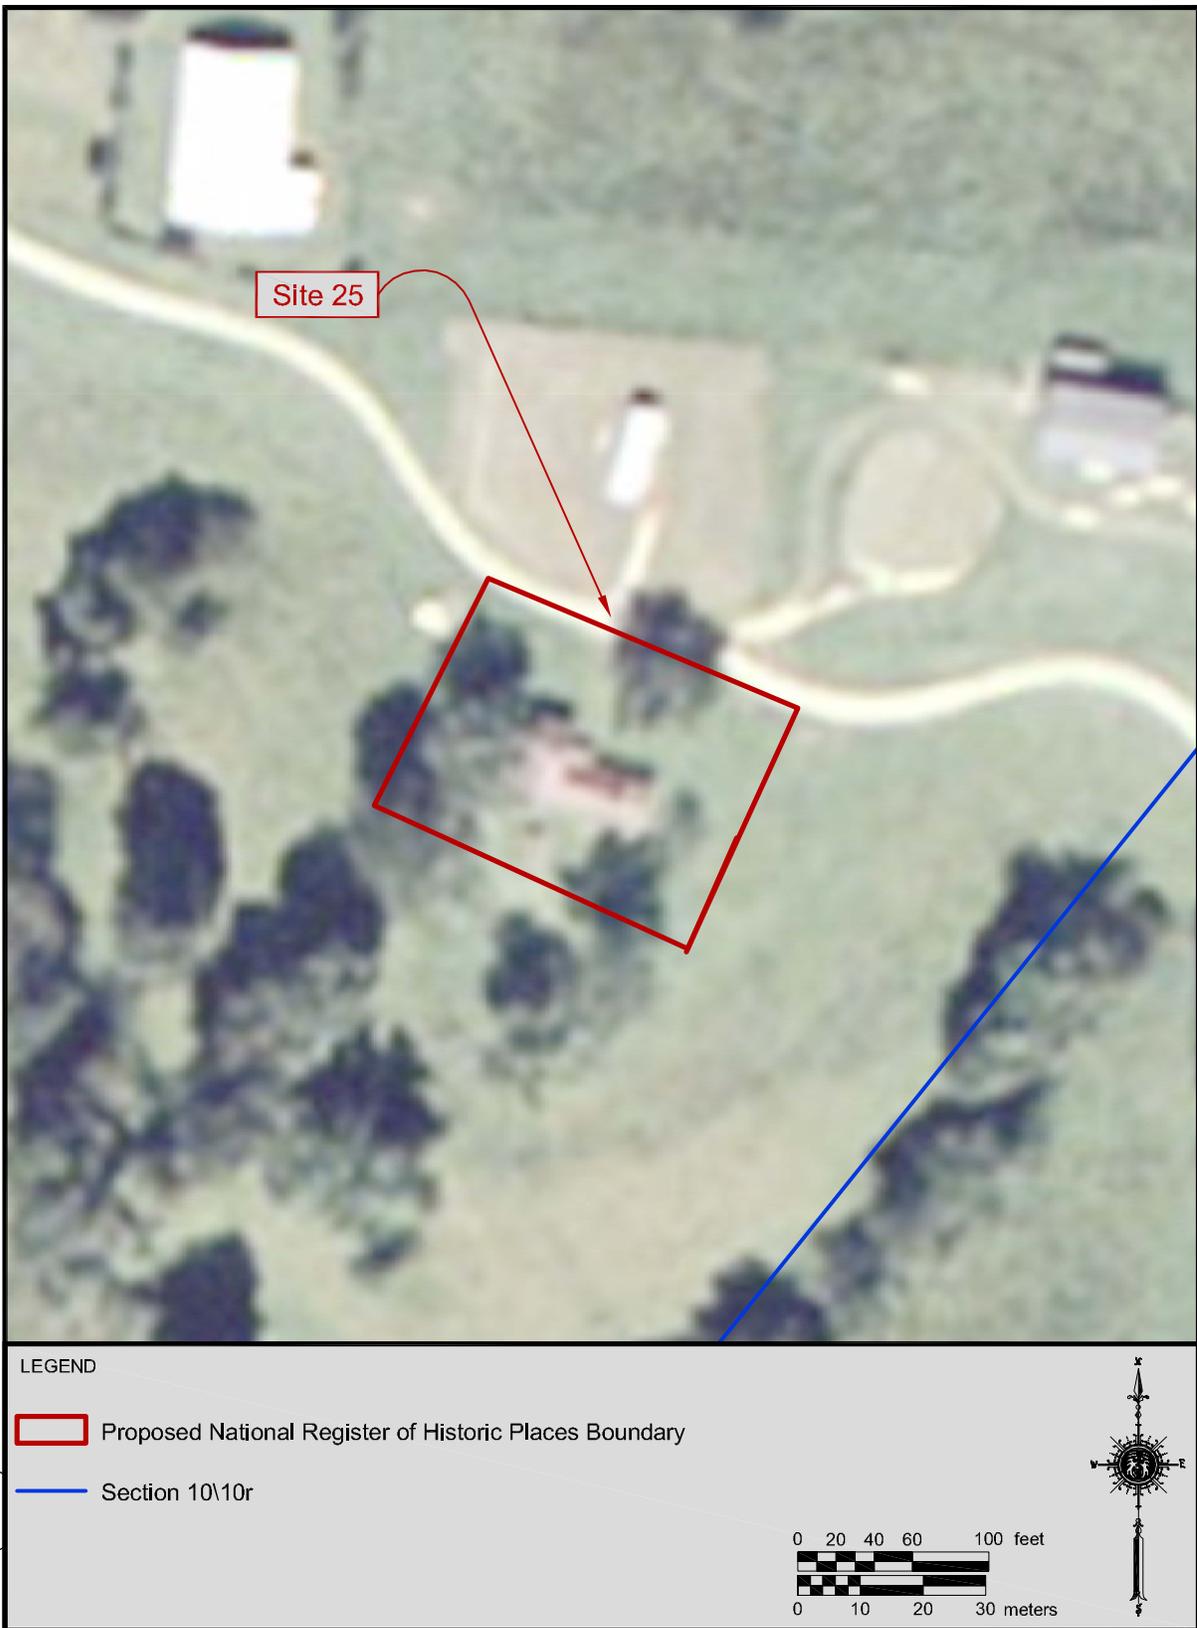
Section 10r of the proposed transmission line will be constructed in place of the existing transmission line, located approximately 230 ft to the southeast of Site 25 (Figure 8.38). Section 10r is a portion of Alternatives Ar, Br, Cr, Dr, Er, Fr, Gr, and Hr. The existing transmission line is located behind the house and the proposed line will be in place of the existing line. It appears the proposed project will have an effect on the site, as it will be visible from the rear and side of the house. However, because there has been an existing transmission line already within the viewshed of Site 25, and because it appears the proposed line will not intersect with the proposed NRHP boundaries, it does not appear the proposed line will have an adverse effect on the site.

Figure 8.37. Site 25 proposed NRHP boundary.

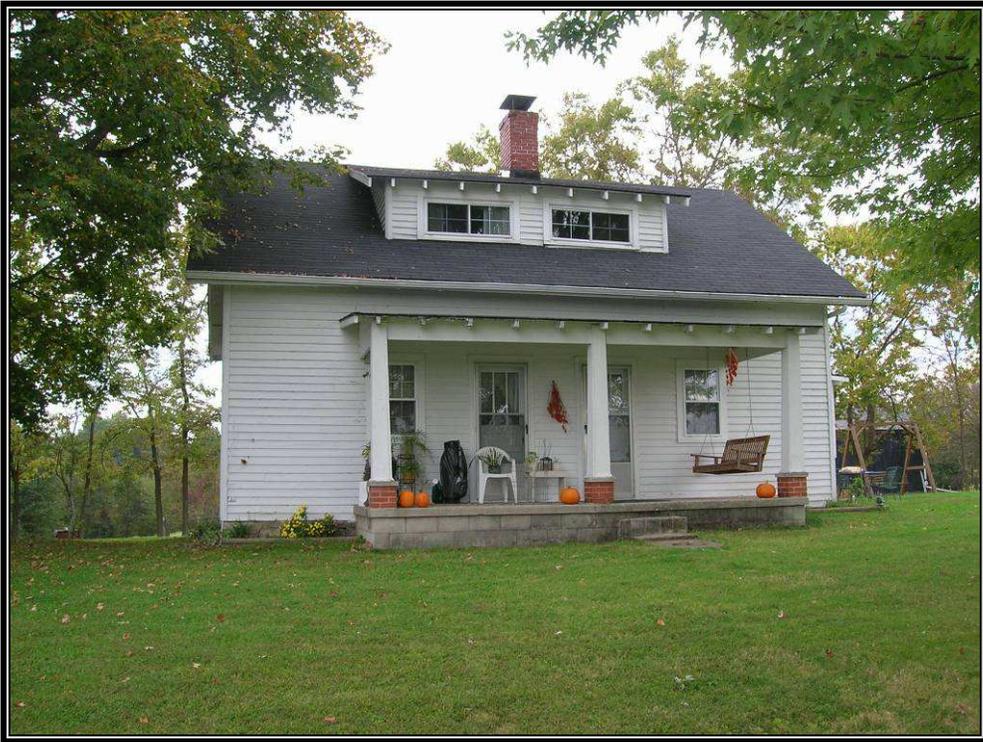
NRHP Evaluation: Not Eligible. While this house retains its original siding, its replacement windows, addition, and wrapped window surrounds diminish its integrity of design, materials, and workmanship. Additionally, the house lacks distinctive features that other eligible early twentieth century houses possess, such as multi-light-over-single-light windows and knee braces or rafter tails. This site does not appear to be associated with a significant person or event in history. As a result, this site does not appear to be eligible for inclusion in the NRHP under Criterion A, B, C, or D.

Figure 8.39. Site 26, One-and-one-half-story, four-bay, side-gable frame house (MA-874).

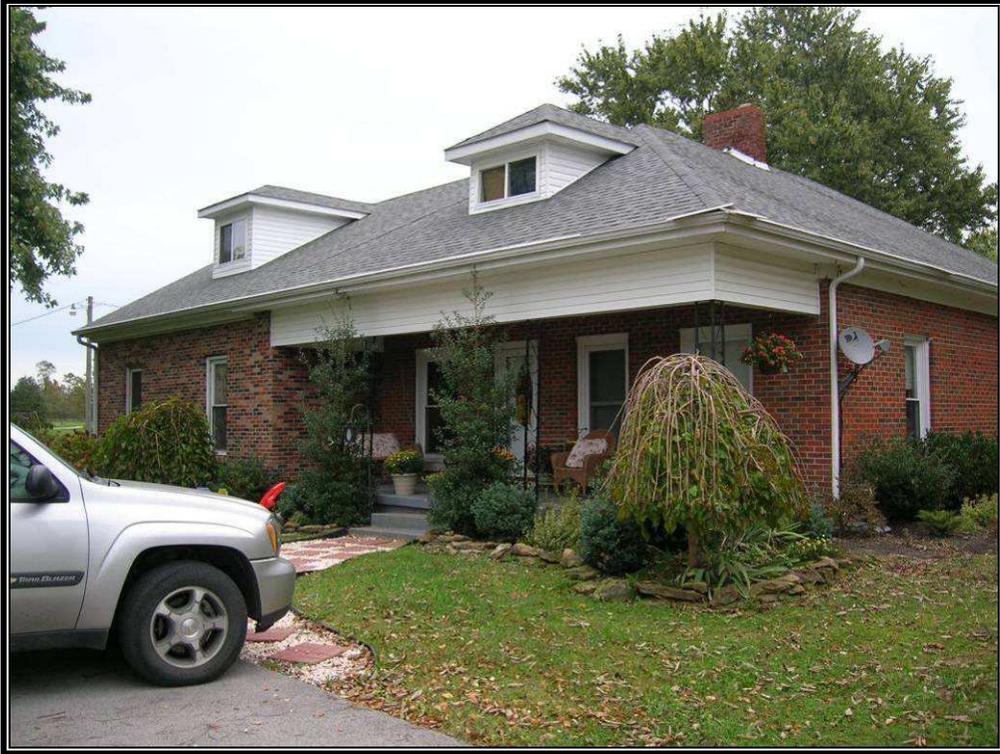
Figure 8.42. Site 27, One-and-one-half-story, six-bay, hip-roof house (MA-875).

NRHP Evaluation: Not Eligible. With its large side addition and replacement windows, this house's integrity of design, materials, workmanship, and feeling have been compromised. This does not appear to be a particularly outstanding example of an early twentieth century house. Additionally, this house does not appear to be associated with a particular person or event in history. As a result, this house does not appear to be eligible for inclusion in the NRHP under Criterion A, B, C, or D.

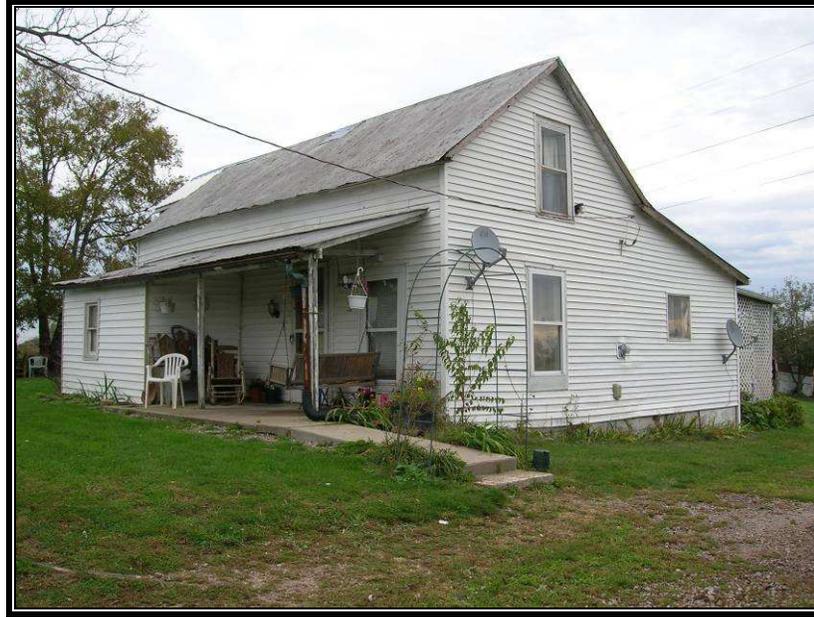
Figure 8.48. Site 29, One-and-one-half-story, three-bay, side-gable house (MA-877).

NRHP Evaluation: Not Eligible. With its replacement siding and windows, partially enclosed front porch, and lack of distinctive characteristics, this house does not appear to be a particularly outstanding example of a side-gable house in rural Madison County. This site does not appear to be associated with a significant person or event in history. As a result, this site does not appear to be eligible for inclusion in the NRHP under Criterion A, B, C, or D.

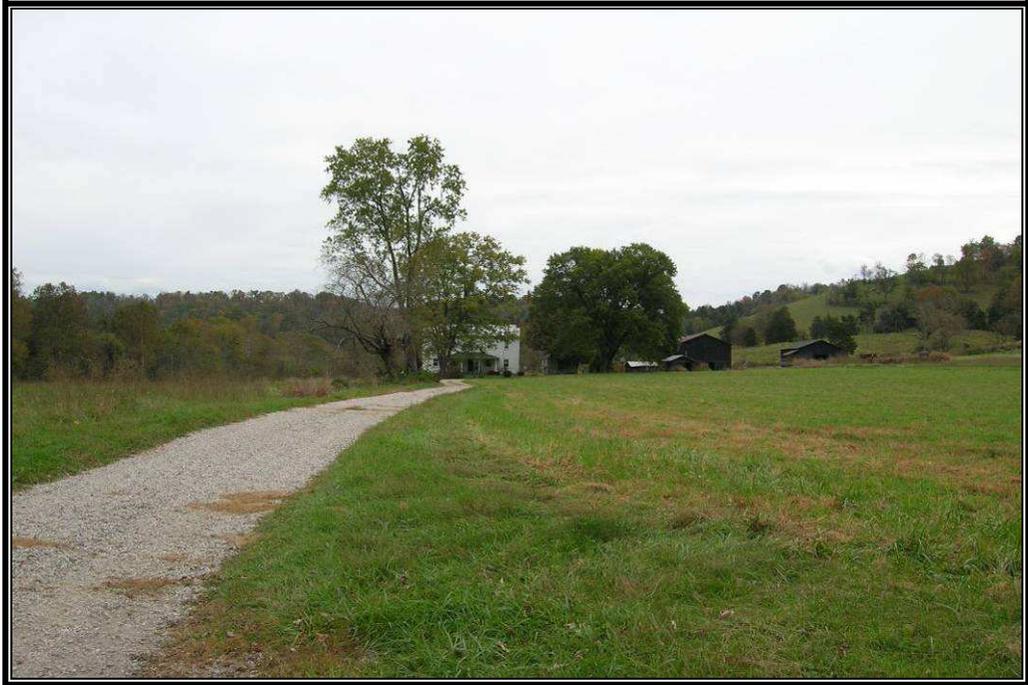
Figure 8.49. Site 30, Two-story, five-bay, brick I-house and associated outbuildings, looking northeast (MA-157).

Although the house has replacement windows, replacement cornice, wrapped window surrounds, and an altered ell, it retains much of its original historic fabric in the form of its brickwork, the front door surround, and the overall form of the house. Extant early brick I-houses in rural Madison County are not common, and this house is a relatively intact example from the early nineteenth century. As a result, the house appears eligible under Criterion C, as an excellent example of a brick I-house in rural Madison County.

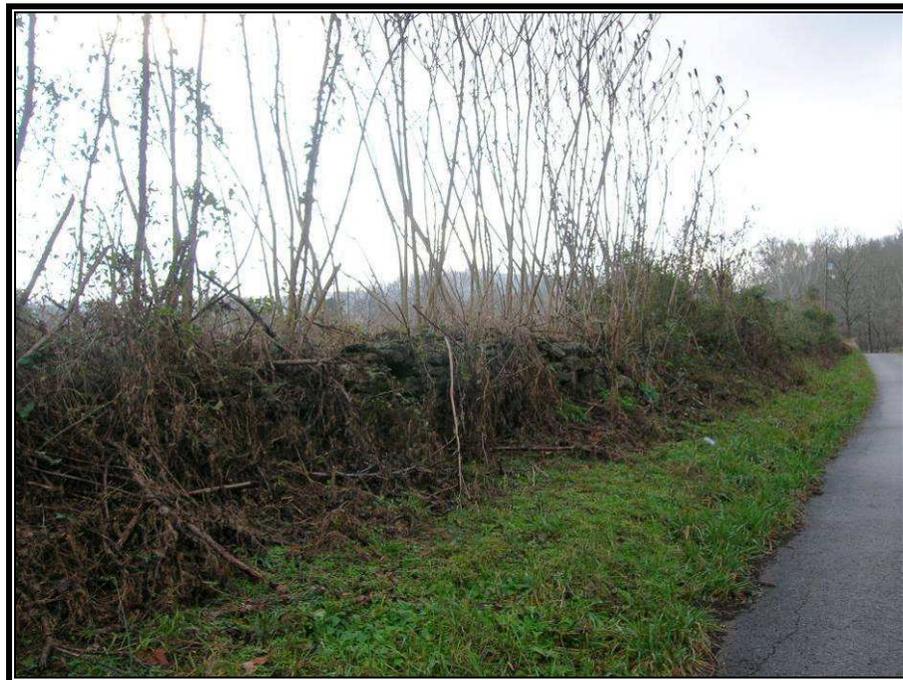
Figure 8.60. Portion of dry-laid rock fence located on the northwest side of property, looking southward.

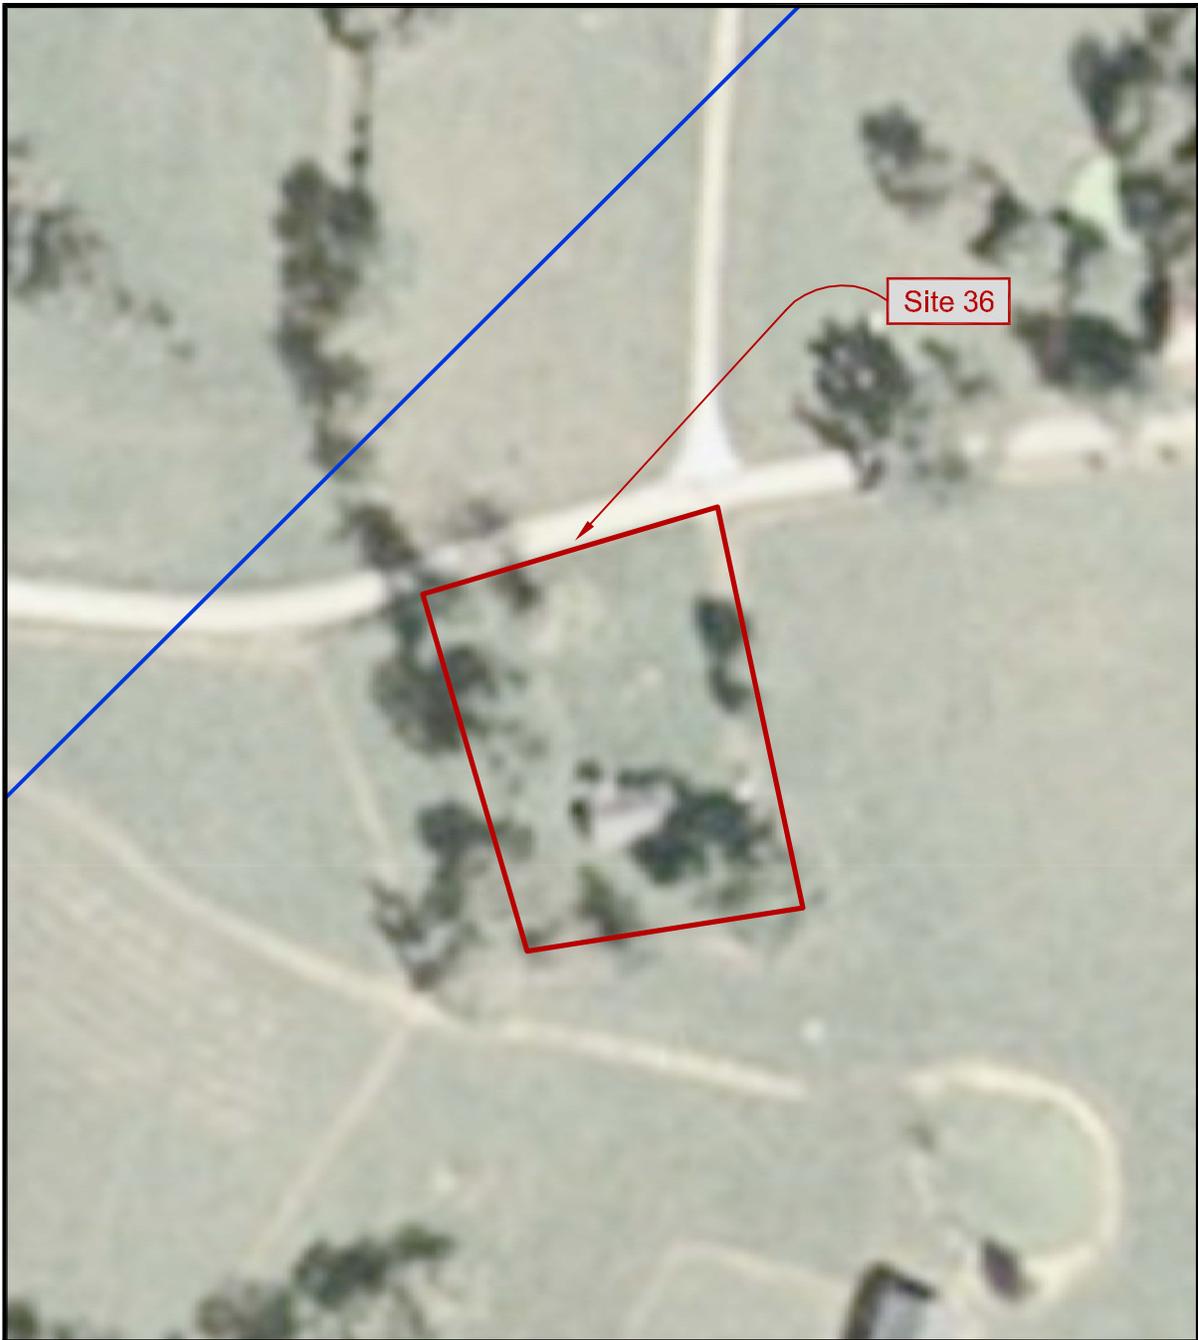
Section 10r of the proposed transmission line will be constructed in place of the existing transmission line, located approximately 227 ft to the northwest of Site 36 (Figure 8.91). Section 10r is a portion of Alternatives Ar, Br, Cr, Dr, Er, Fr, Gr, and Hr. Because there has been a continued presence of the existing transmission line near the house, it does not appear the proposed line will have an adverse effect on the site, nor does it appear that the proposed line will adversely effect the qualities for which the house is considered eligible, for its architectural significance. As a result, a no adverse effect determination is recommended for Site 36.

Figure 8.90. Site 36 proposed NRHP boundary.
