Progress Report

WA2XMY

Northpoint - DBS Compatibility Tests

October, 1999

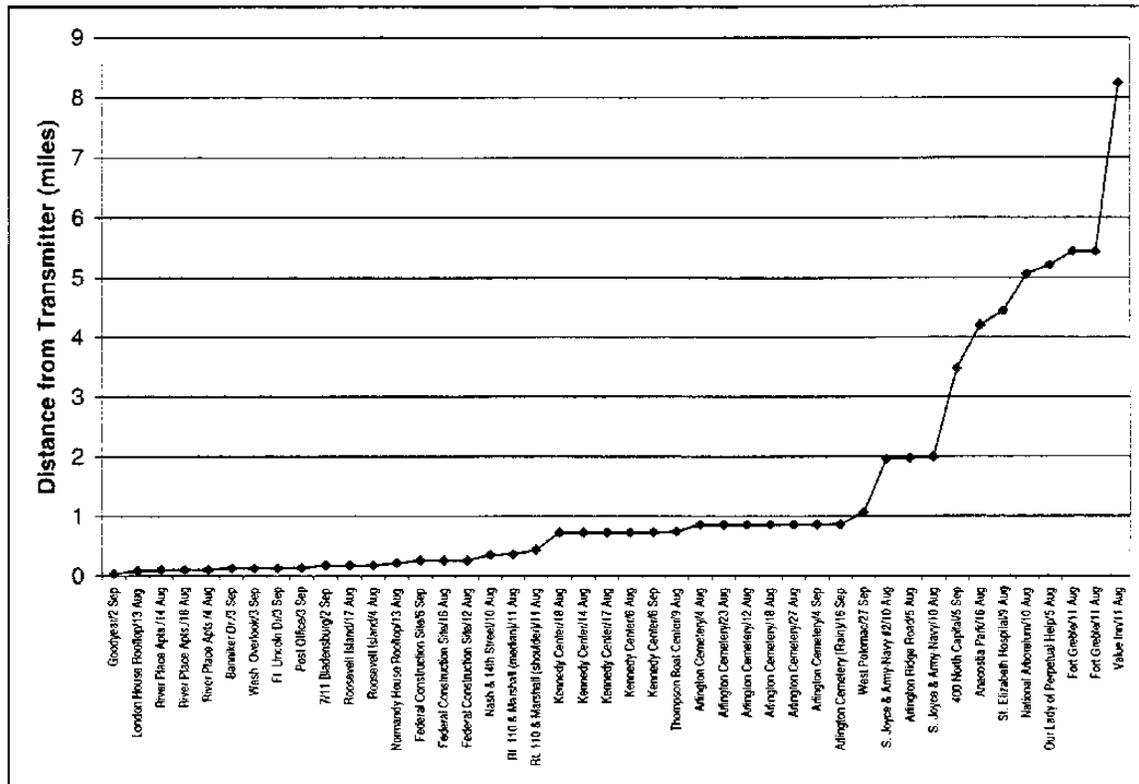
Figure 1. Measurements and Distance from Transmitter

three percent (73%) of these measurements were within one mile of a transmitter or repeater, in the area where the Northpoint signal is the strongest (see Appendix I). Other test locations were selected to measure the performance of DBS with multi-cell Northpoint transmissions during Phase III, and to verify performance of Northpoint at various distances. A repeater was installed at the Ft. Lincoln transmit site for Phase III of the test.

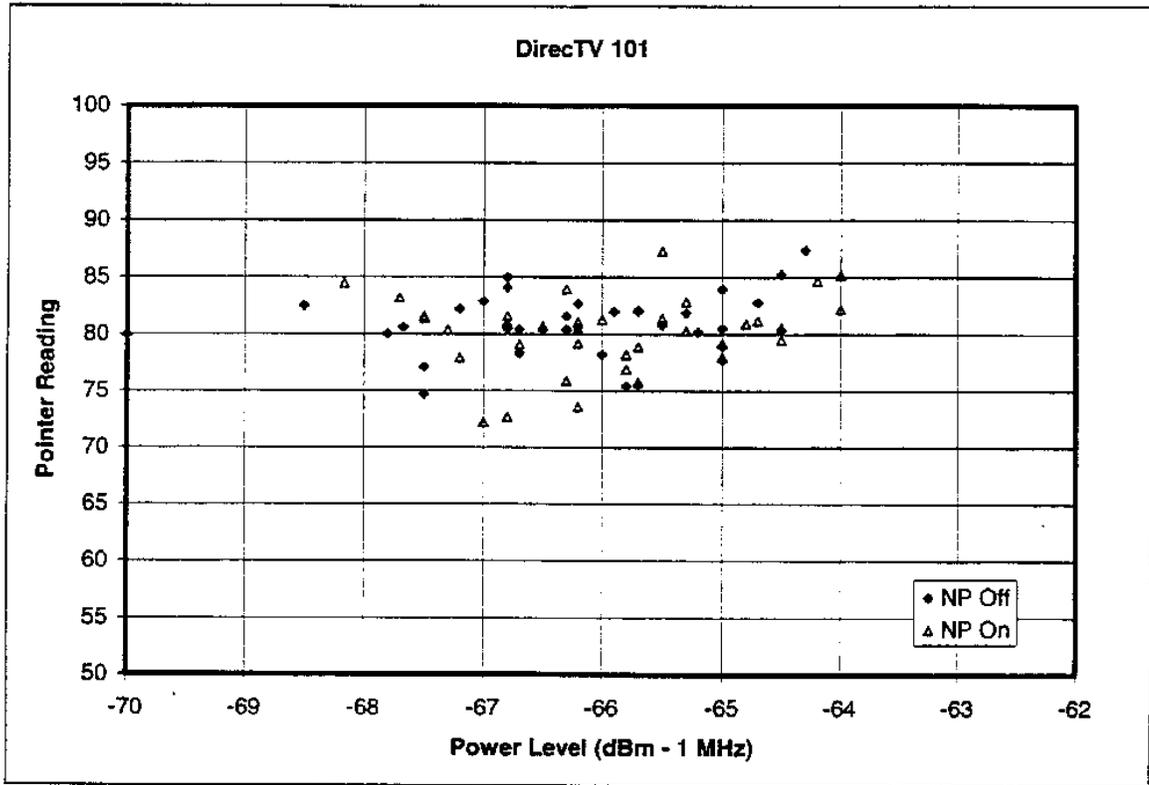
Figure 2. Plot of Pointer Reading vs. Power Density Level for DirecTV

The power density (in a 1 MHz reference band at the center of a DBS transponder, typically transponder 18) was also measured and recorded at all locations, with the Northpoint transmitter both on and off. All of the clear-air test data are plotted in the scatter plots Figures 2-4, which show that there is no obvious difference between the Northpoint "on" and "off" conditions.

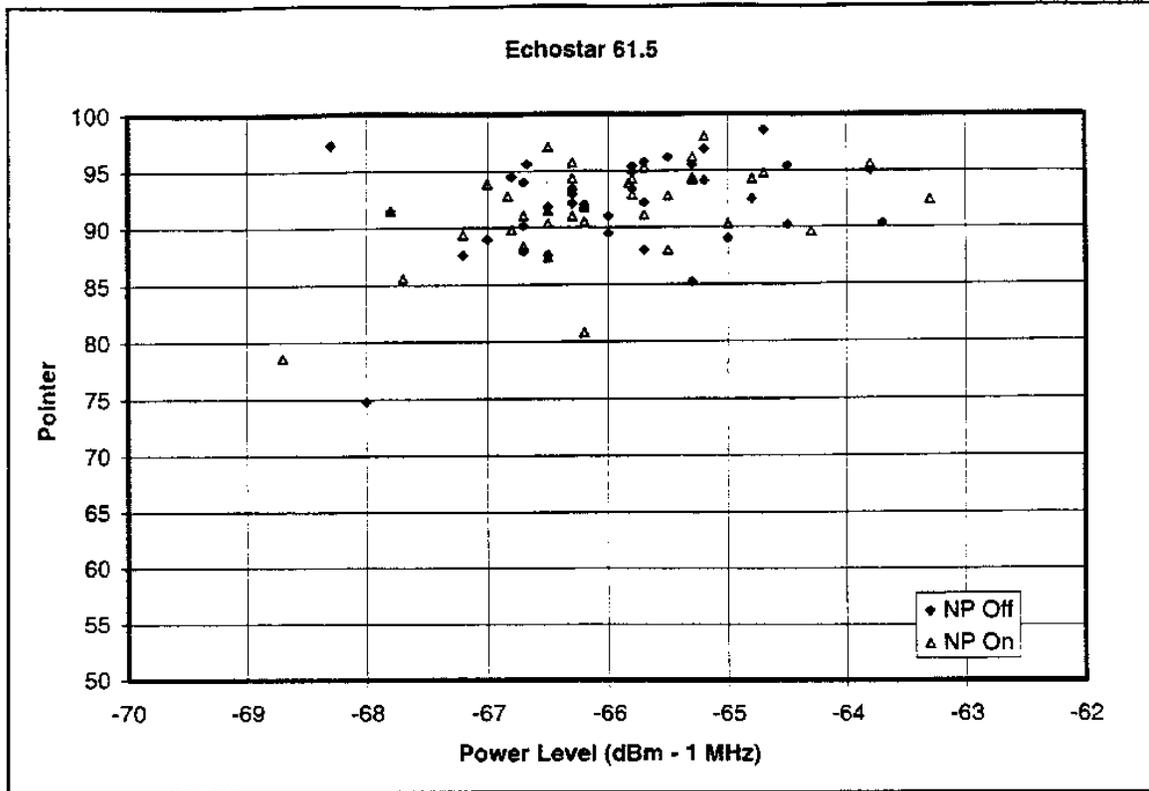
Figure 3. Plot of Pointer Reading vs. Power Density Level for EchoStar 61.5

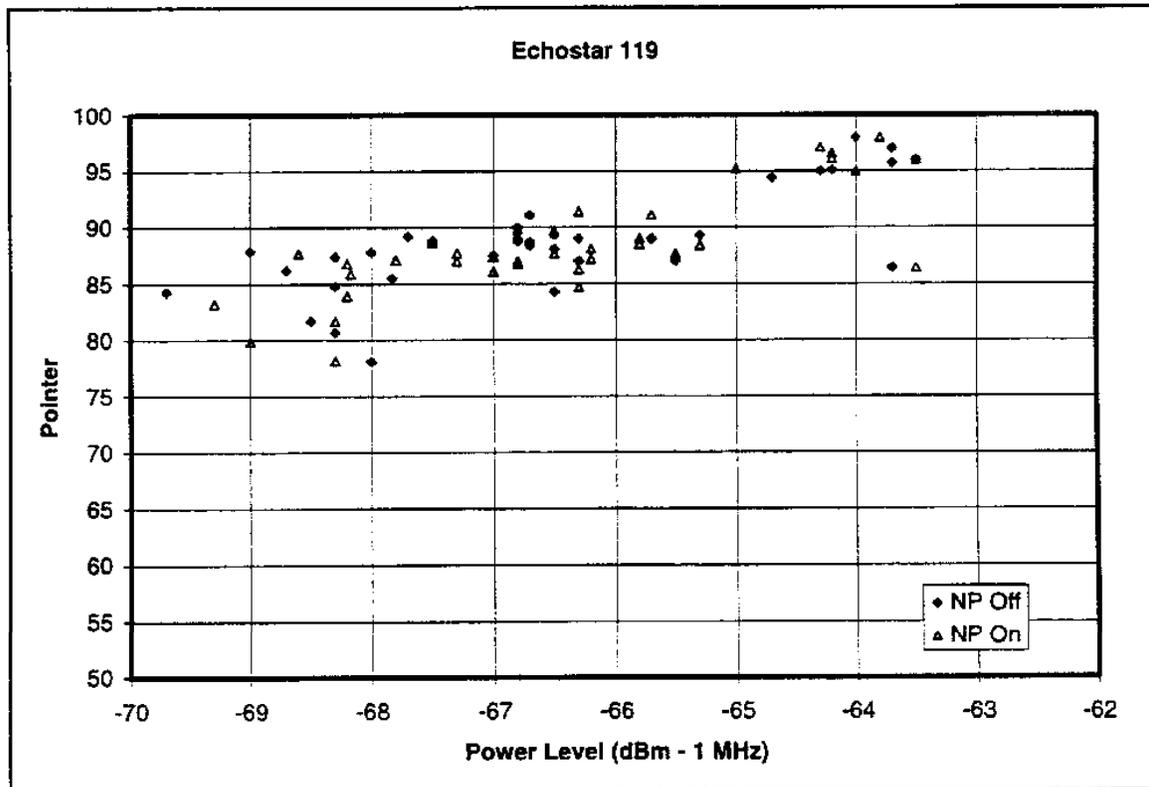
Figure 4. Plot of Pointer Reading vs. Power Density Level for EchoStar 119

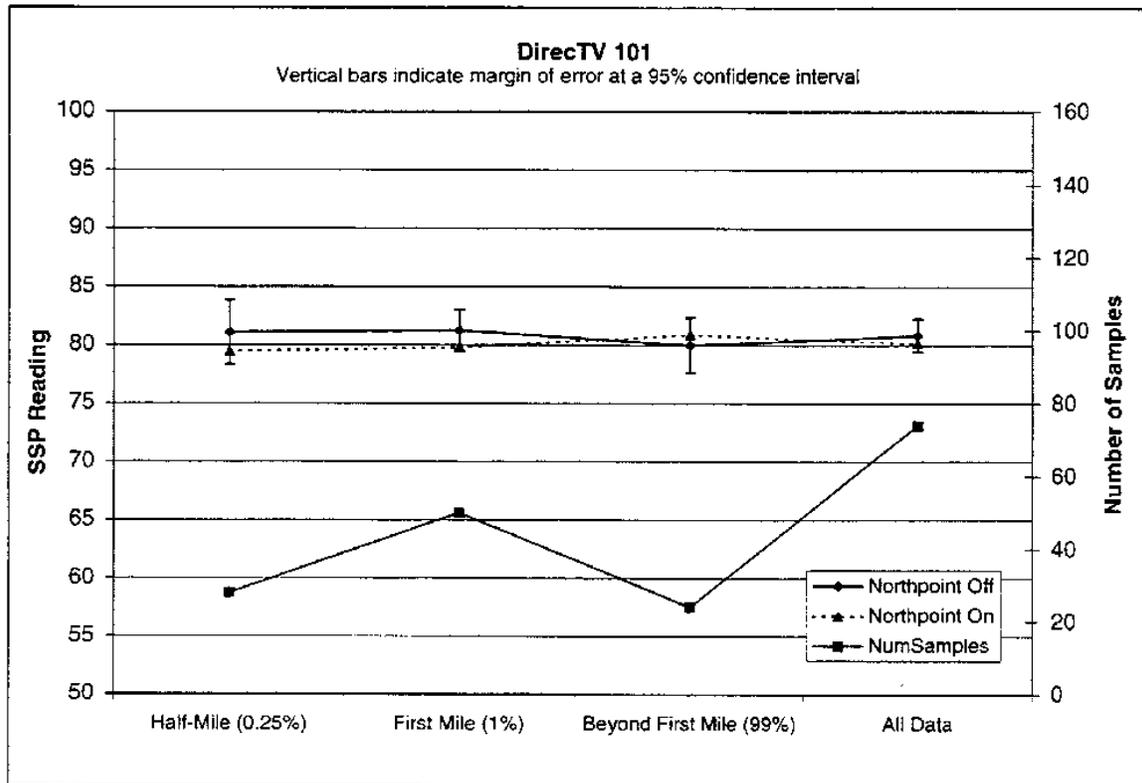
Figure 5. No Statistical Difference Between “On” and “Off” Conditions for DirecTV 101

Two values for each case are shown; the average of the observations within that zone for each of the Northpoint “on” and “off” conditions. The vertical bars represent the confidence intervals given by the *t*-test, or the range of averages that can be expected to be found 95% of the time. The scale to the right shows the number of samples used in that test. In all cases, the measured average with the Northpoint transmitter “on” falls within the range of expected variation, with a 95% confidence level. These observations support the finding that Northpoint has less impact on DBS than the normal variation of DBS’s own performance.

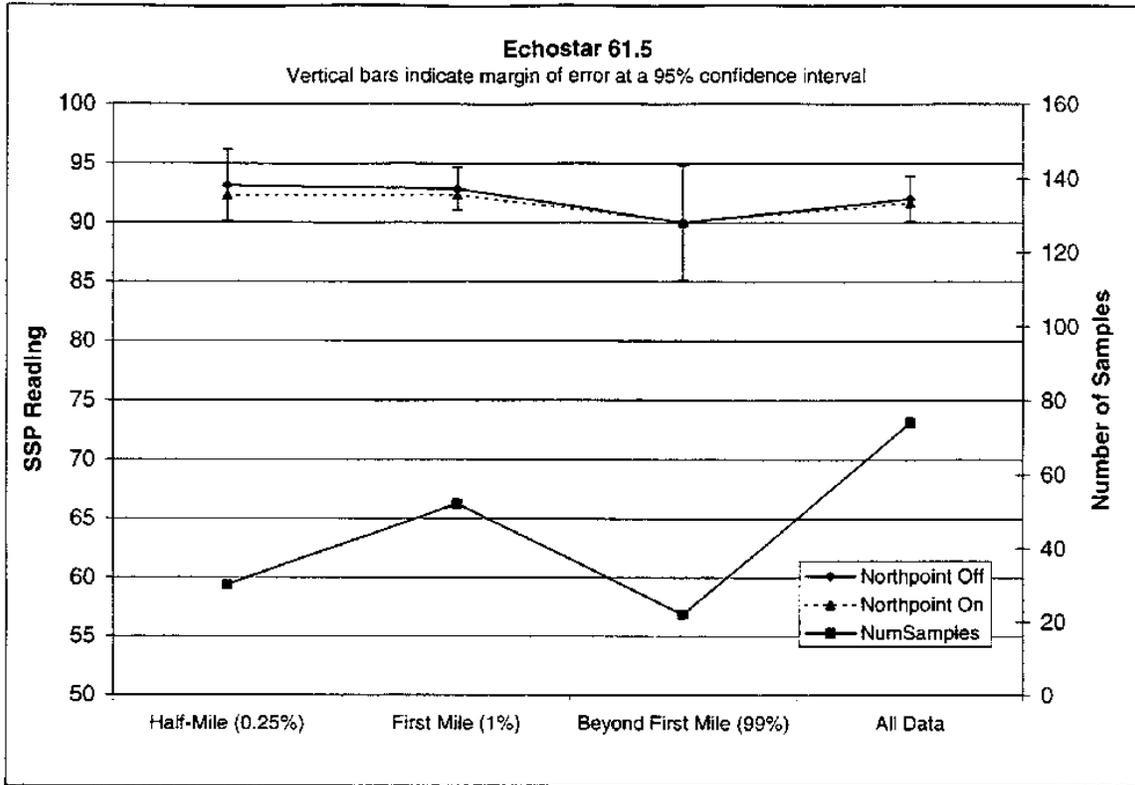
Figure 6. No Statistical Difference Between “On” and “Off” Conditions for Echostar 61.5.

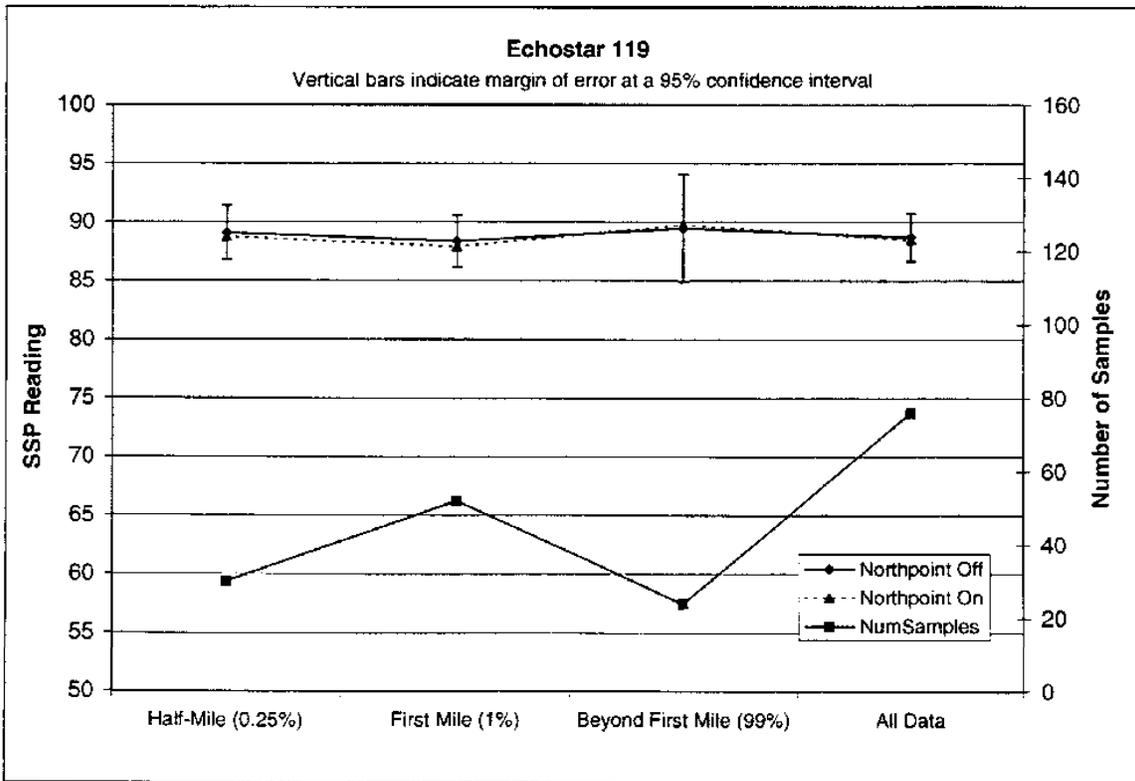
Figure 7. No Statistical Difference Between “On” and “Off” Conditions for Echostar 119

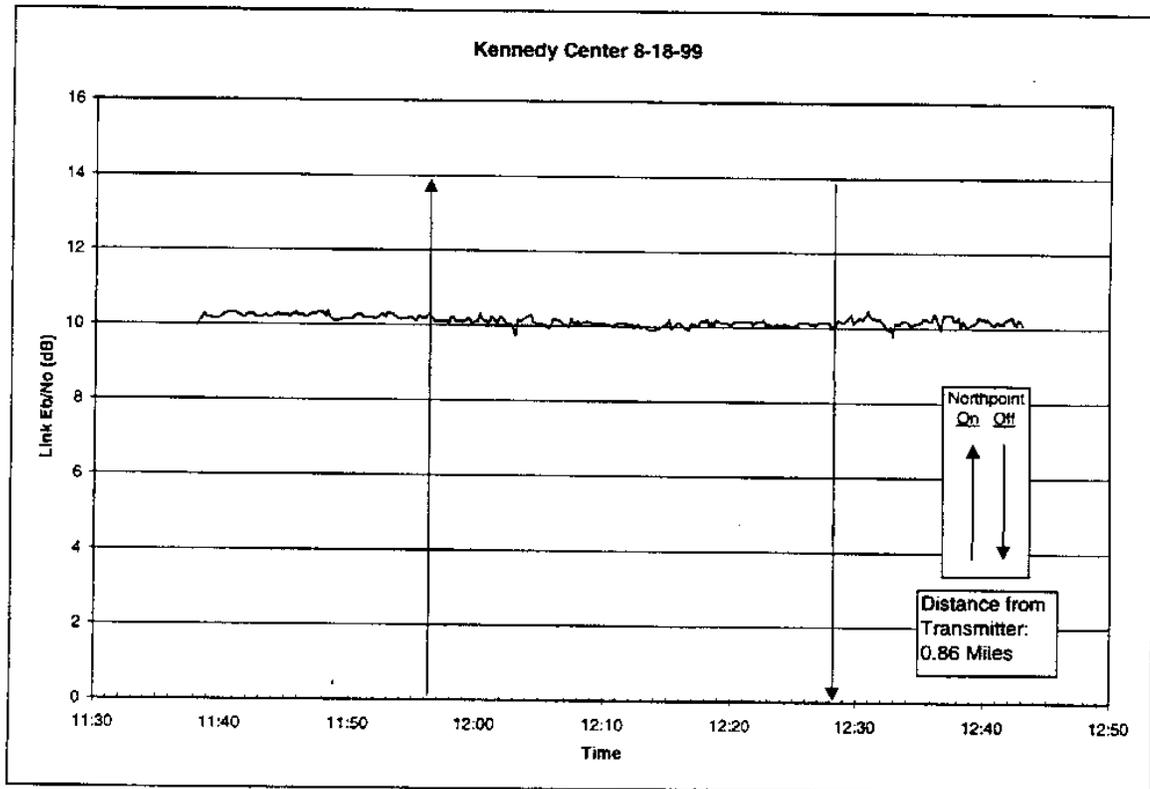
Figure 8. Link Degradation for Echostar 119, Kennedy Center

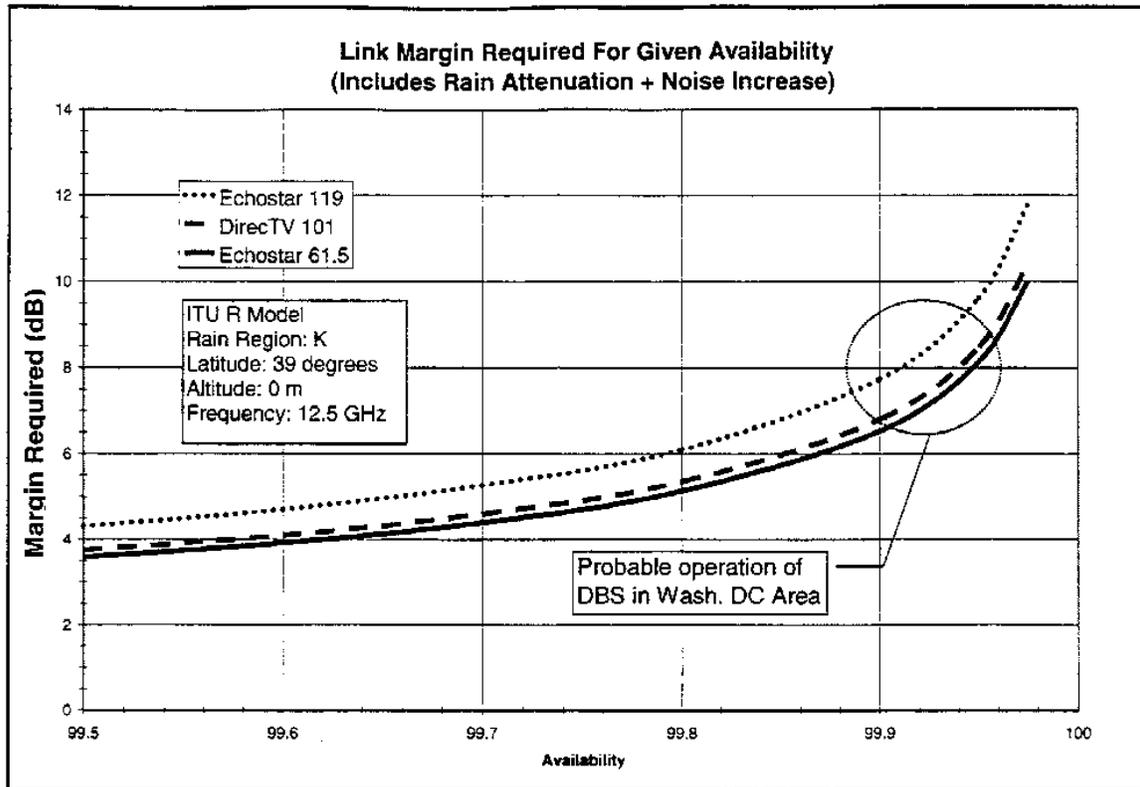
Figure 9 . Link Margin Required for Given Availability (rain attenuation + thermal noise increase).

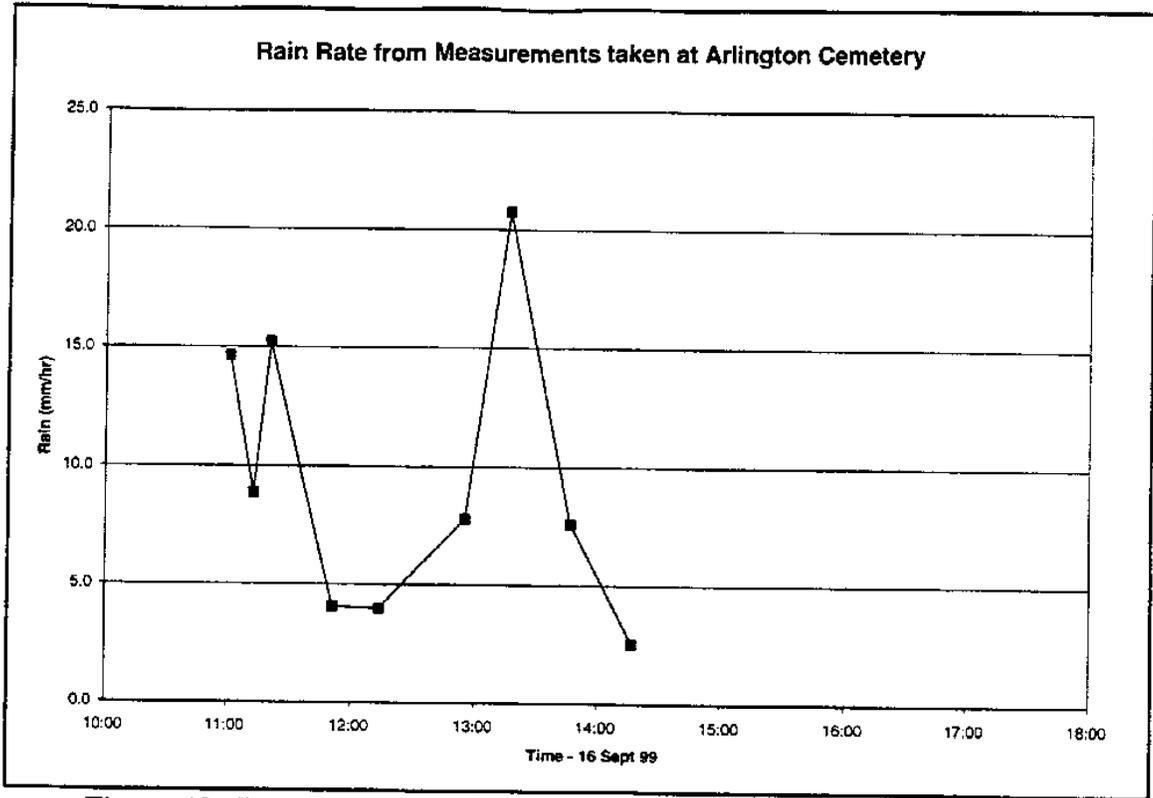
Figure 10. Rain Rates from Measurements taken at Arlington Cemetery

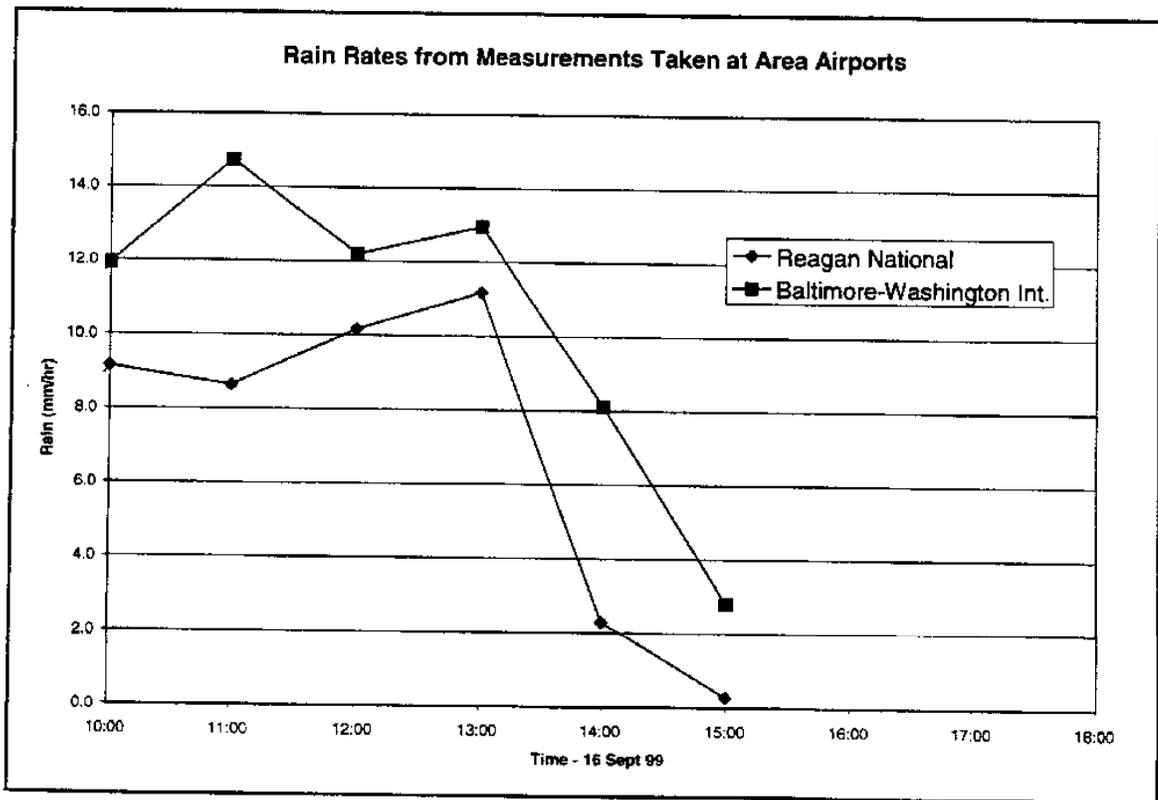
Figure 11. Rain Rates from NOAA Measurements at Area Airports

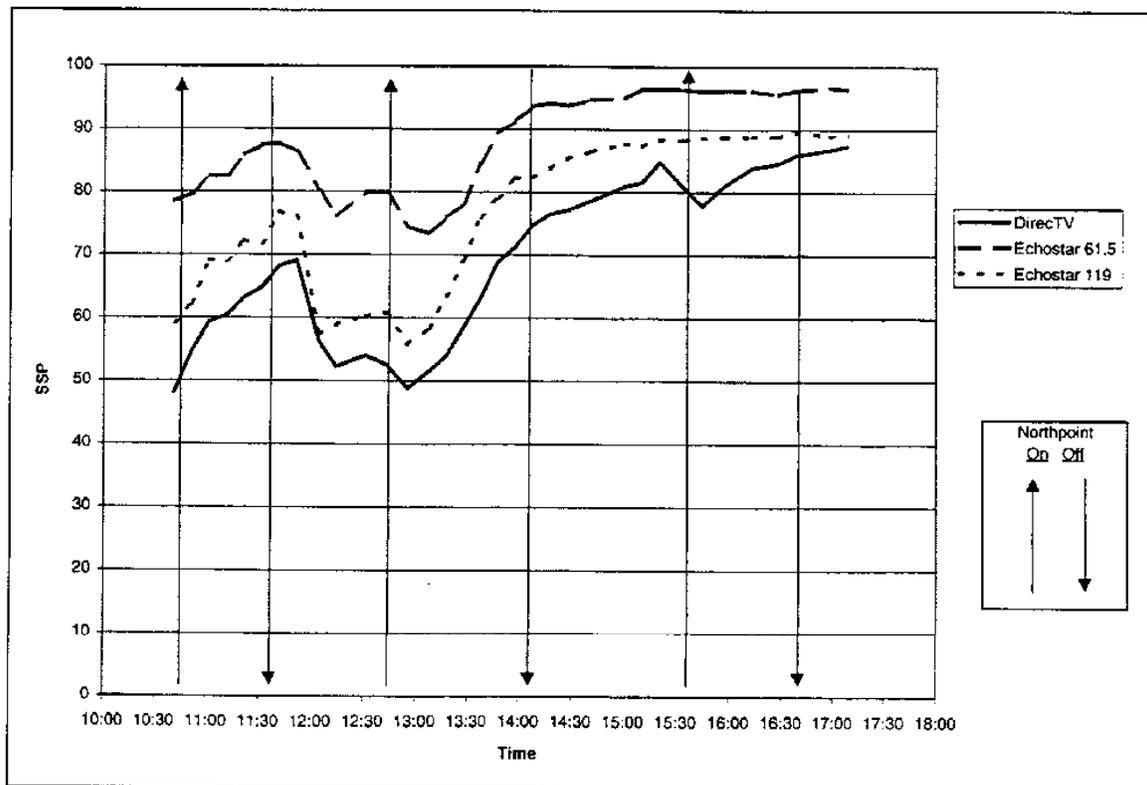
Figure 12. SSP Readings during Hurricane Floyd, September 16, 1999

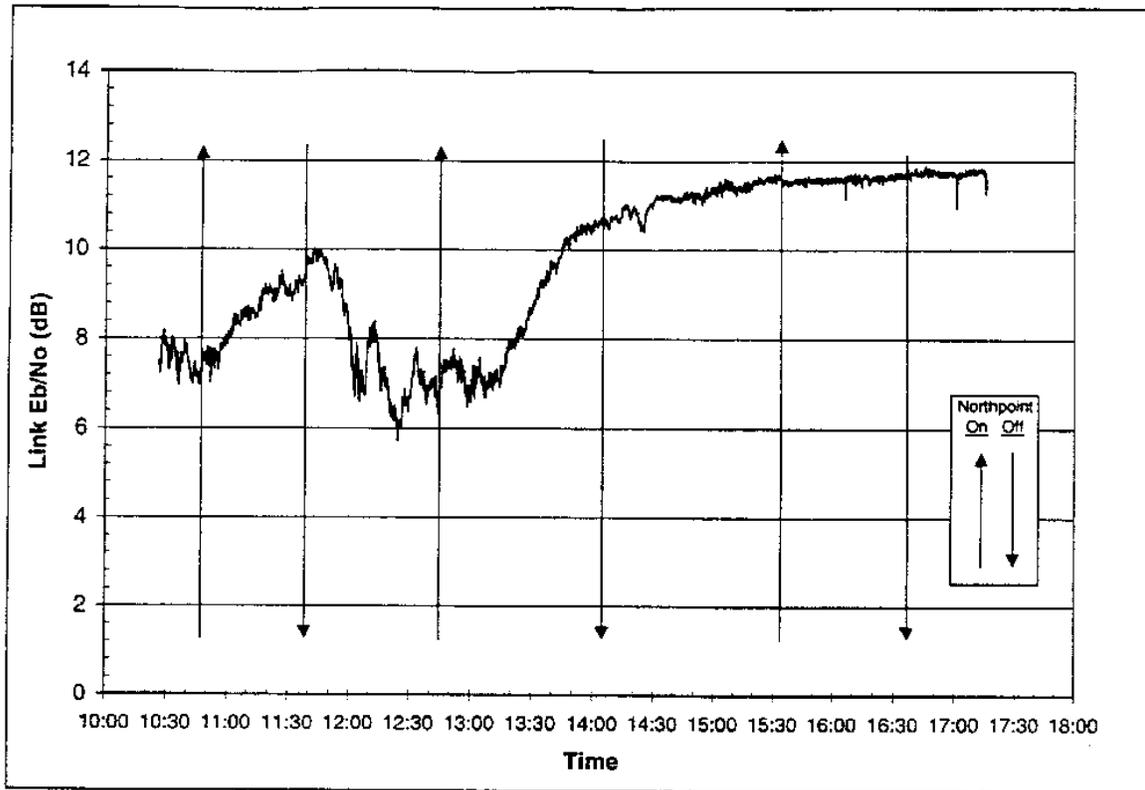
Figure 13. Observed Eb/No for Echostar @ 119 W, Hurricane Floyd

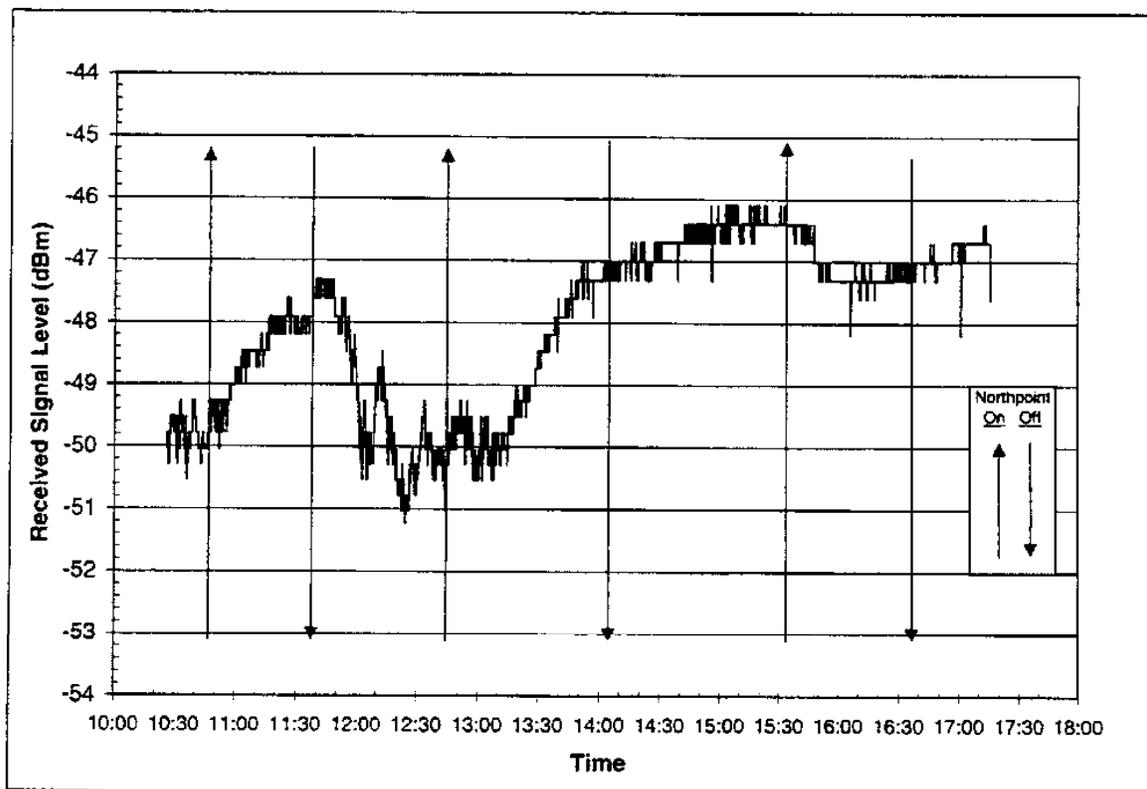
Figure 14. Echostar 119 W Received Signal Level during Hurricane Floyd

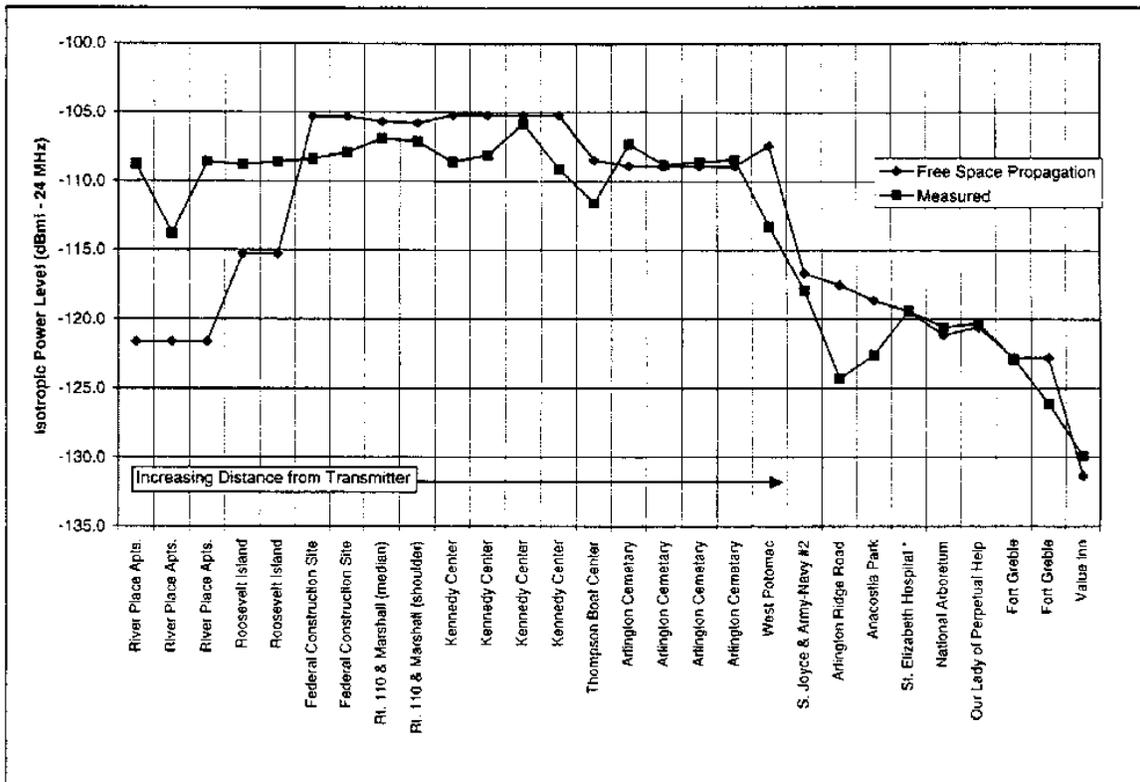
Figure 15. Northpoint Signal Strength

The measurement of the Northpoint signal power generally conforms to free-space propagation predictions, when making allowances for terrain clutter, as seen in Figure 15. The notable exception was within 200 meters of the USA Today building, where a higher than predicted power level was measured. It is believed that that close in to the USA Today building, the signal is effected by the building structure itself (which is composed of 31 stories of leaded glass and aluminum) and the fact that the transmit antenna is mounted on the face of the building rather than on the top.

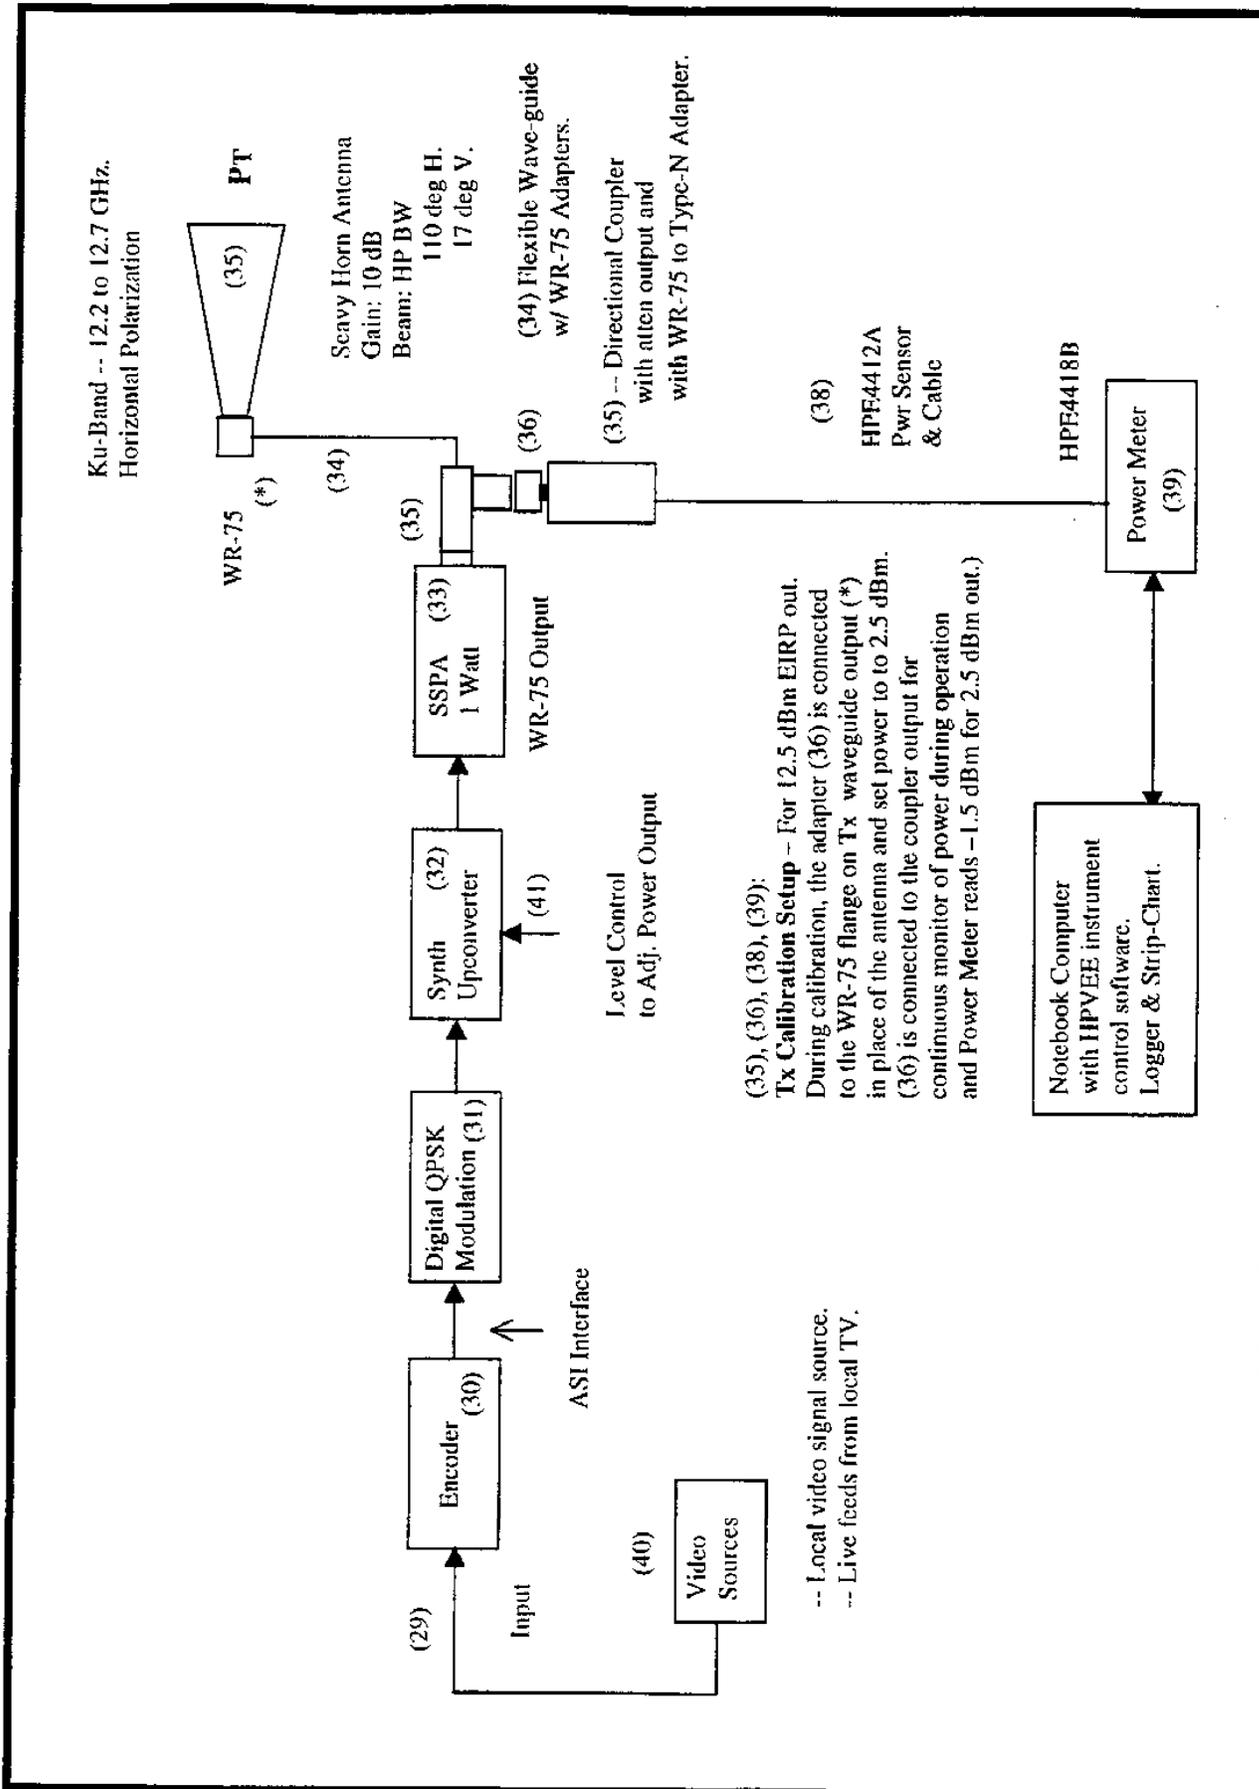
Fig. II-1: Northpoint Terrestrial Transmitter Block Diagram.

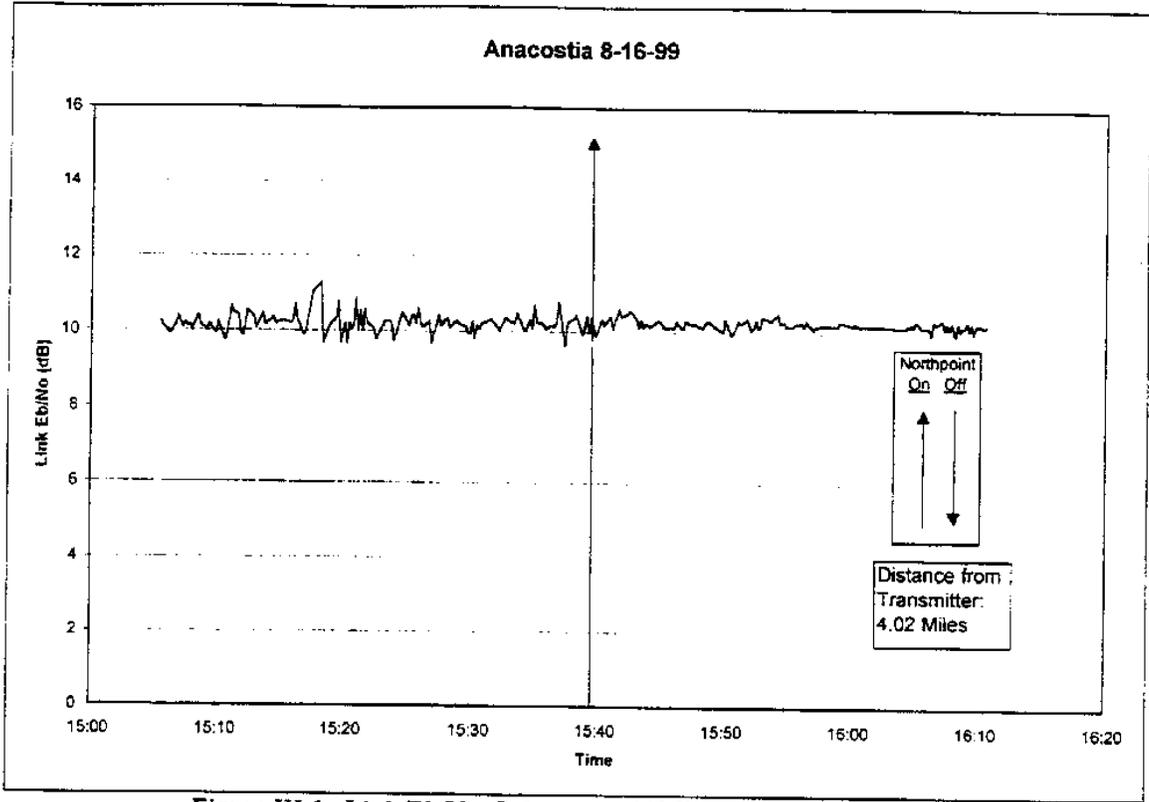
Figure III-1. Link Eb/No, Echostar at 119 W. Longitude, Anacostia

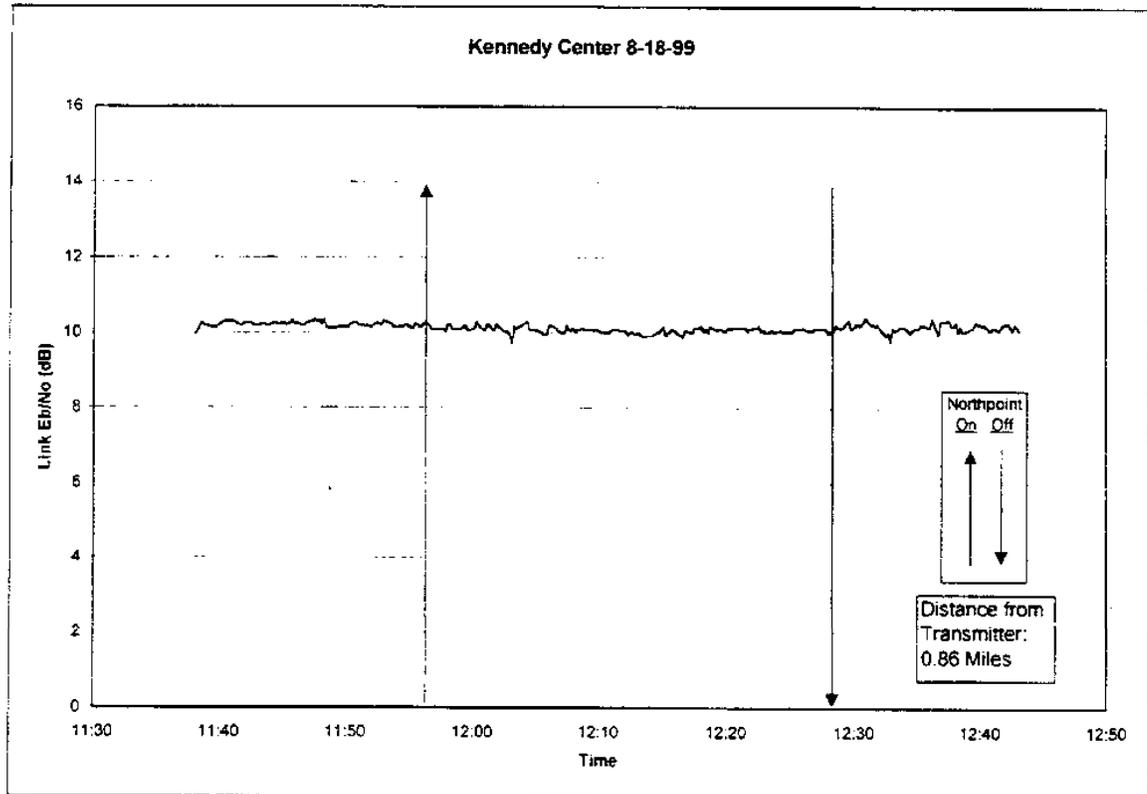
Figure III-6. Link Eb/No, Echostar at 119 W. Longitude, Kennedy Center

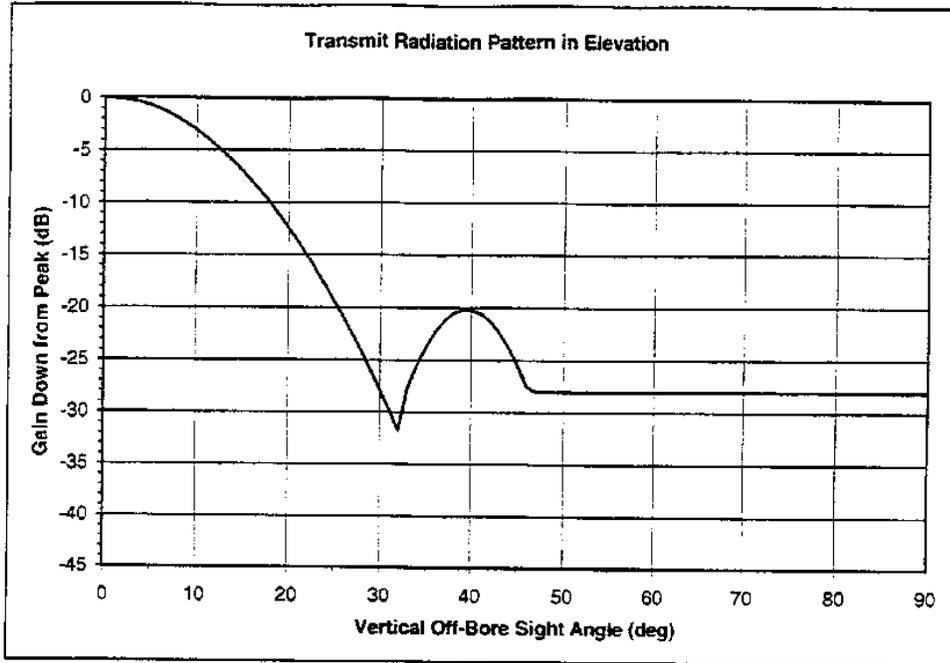
Figure 1. Transmitter Radiation Pattern in Elevation

Transmit Antenna Discrimination in the Vertical Plane — The Northpoint transmitter antenna pattern allows for 20 - 30 dB of discrimination in the area near the transmitter (See antenna pattern in Figure 1).

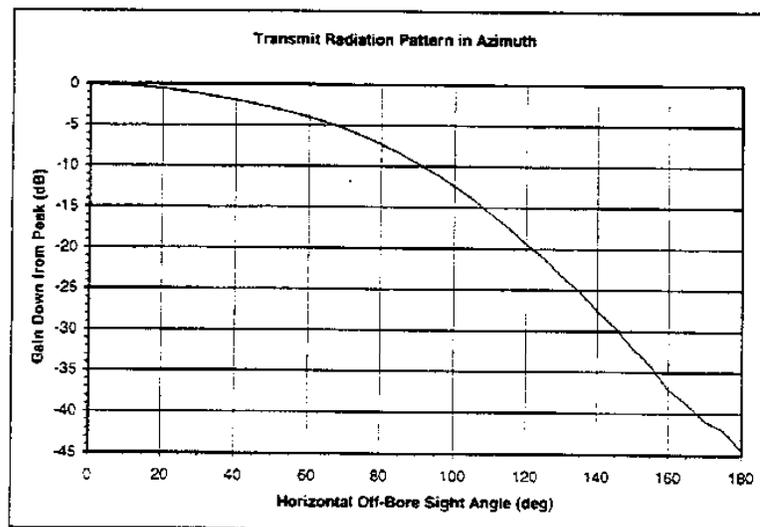
Figure 2. Transmitter Horizontal Radiation Pattern

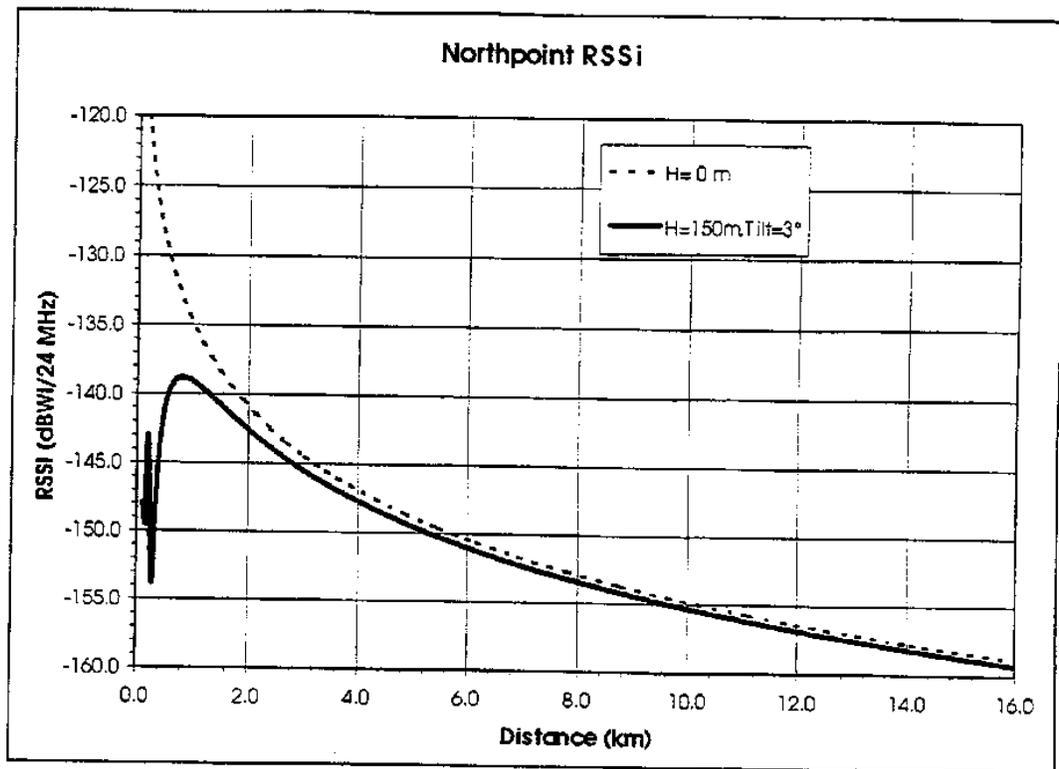
Figure 3. Northpoint Isotropic Signal Level, 24 MHz Bandwidth

Figure 3 depicts the Northpoint isotropic received signal level in a 24 MHz bandwidth, due south of the transmitter, for two cases:

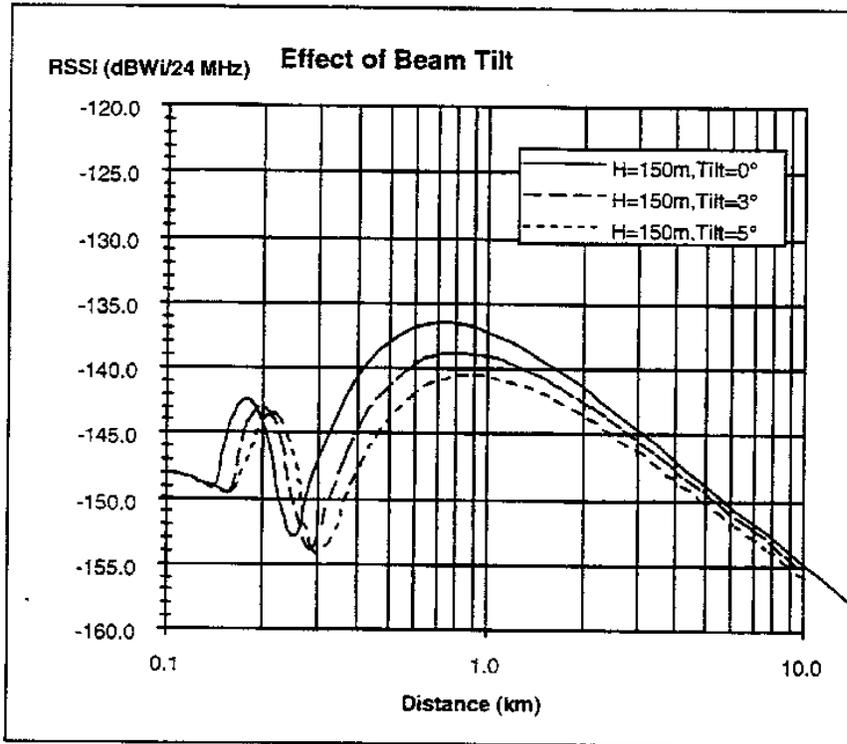
Figure 4. Effect of Beam Tilt on the Received Signal Strength relative to isotropic (RSSi).

Beam Tilting— By tilting the transmitter up from the horizon, signal level is further reduced in the area of the transmitter, as shown in Figure 4.

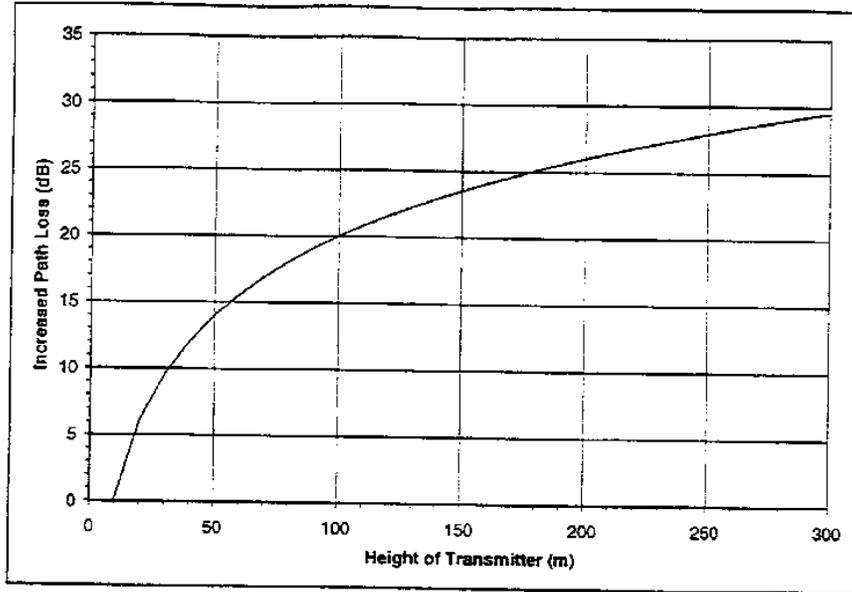
Figure 5. Increased Path Loss over 10 meter Transmitter Height

Maximum Height Antenna Placement— Increased free space loss at transmitter heights of 50 meters or more (see Figure 5) significantly reduce the signal power in the area of the transmitter, by 15 - 30 dB.

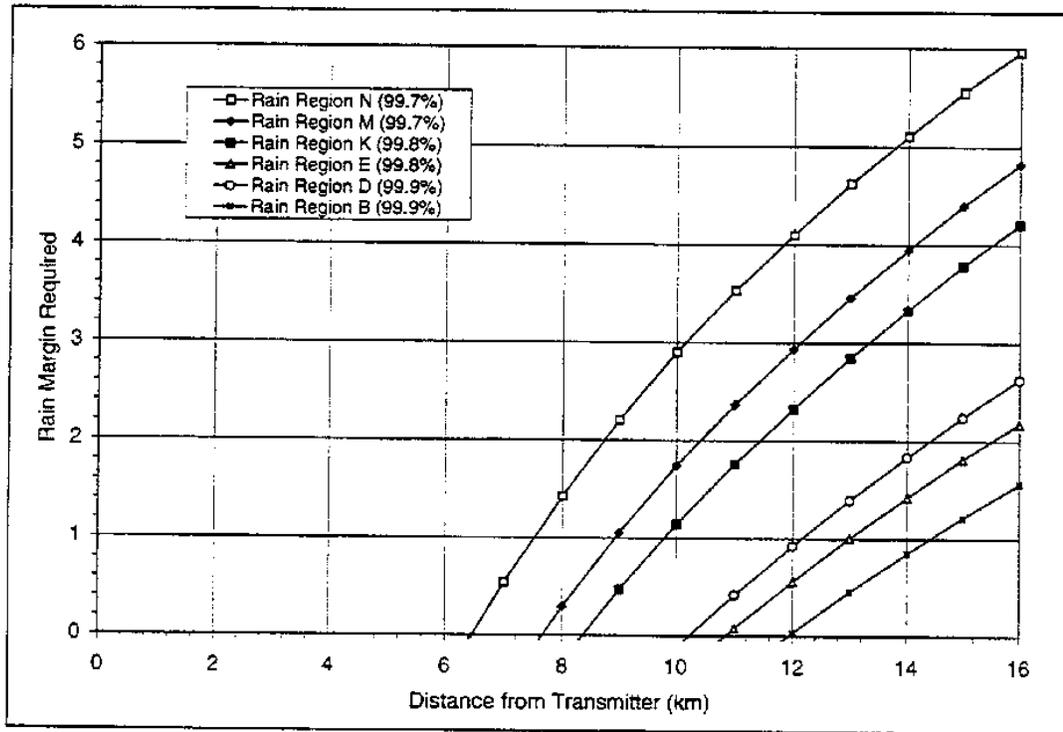
Figure 6. Rain Margin Requirements for all ITU-R rain regions in the U.S.

Rain Attenuation and Gaseous Absorption — The Northpoint link is designed for robust availability (99.7 - 99.9%), at the edge of coverage, throughout the U.S. In Figure 6 the rain margin, as a function of distance from the Northpoint transmitter, is shown taking into account variations in free-space loss. The Northpoint link budget, with a 34 dBi gain antenna, allows for 2.6 dB of degradation due to rain attenuation. At this level, reliable service can be provided everywhere in the U.S. at 10 -16 km from the transmitter, and more than 16 km in rain regions E, D and B, which comprise about 50% of the U.S.
