Progress Report

WA2XMY

Northpoint - DBS Compatibility Tests

October, 1999

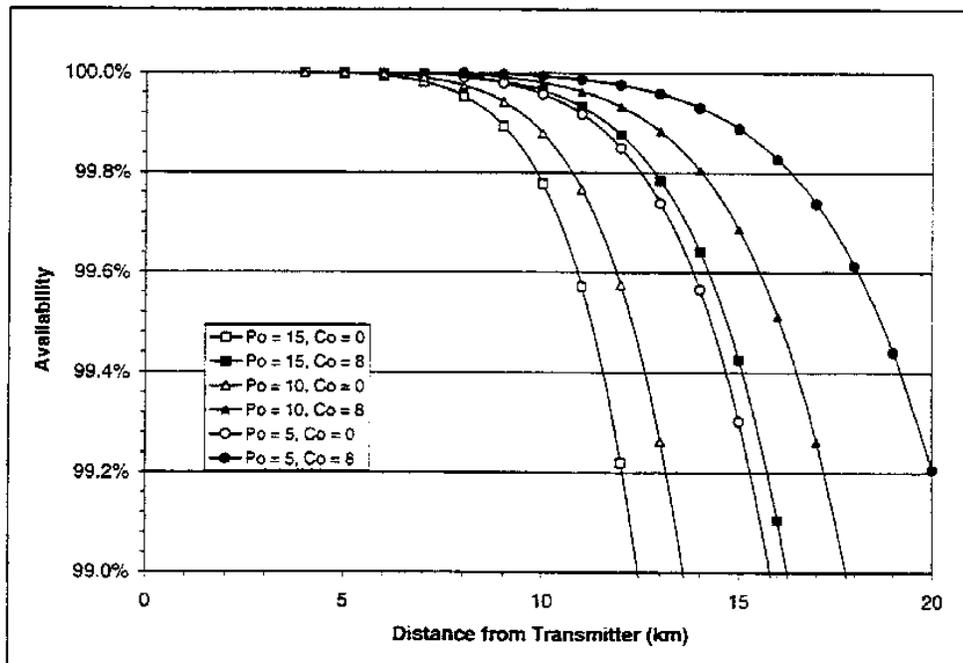
Figure 7. Northpoint Availability in Point-to-Point Fading Conditions

Clearly, Northpoint offers sufficient availability for cell sizes greater than 10 km, and in many parts of the country, for cell sizes of up to 18 km. Again, Northpoint has the option

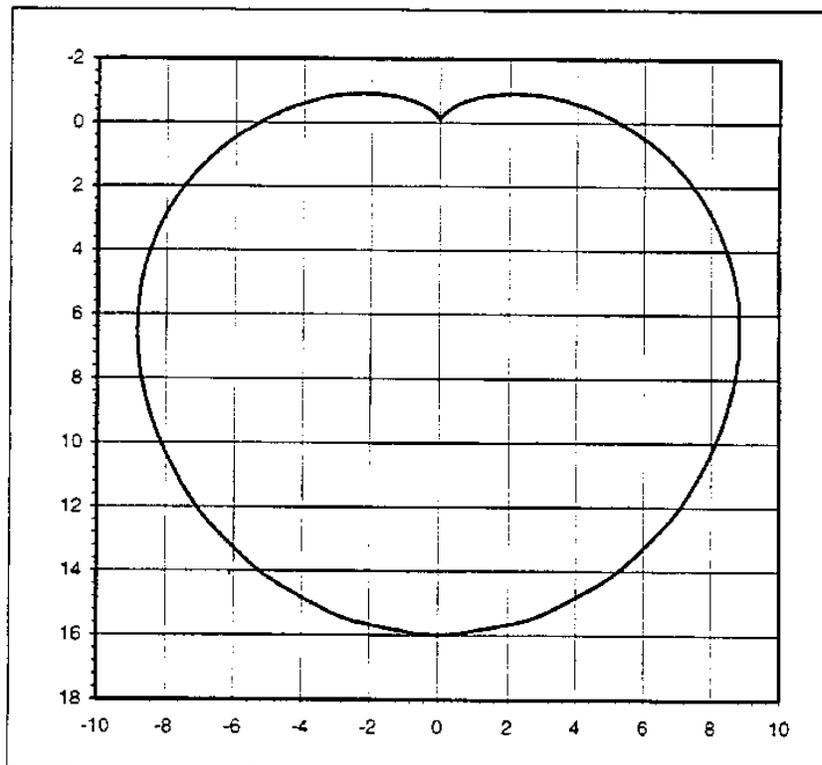
Figure 8. Northpoint Service Area, (ITU Rain Regions B, D and E)

The Northpoint Service area is shown in Figure 8 for Rain Regions B, D and E. For other parts of the country, the maximum distance may be slightly shorter, but in all cases will be at least 10 km.

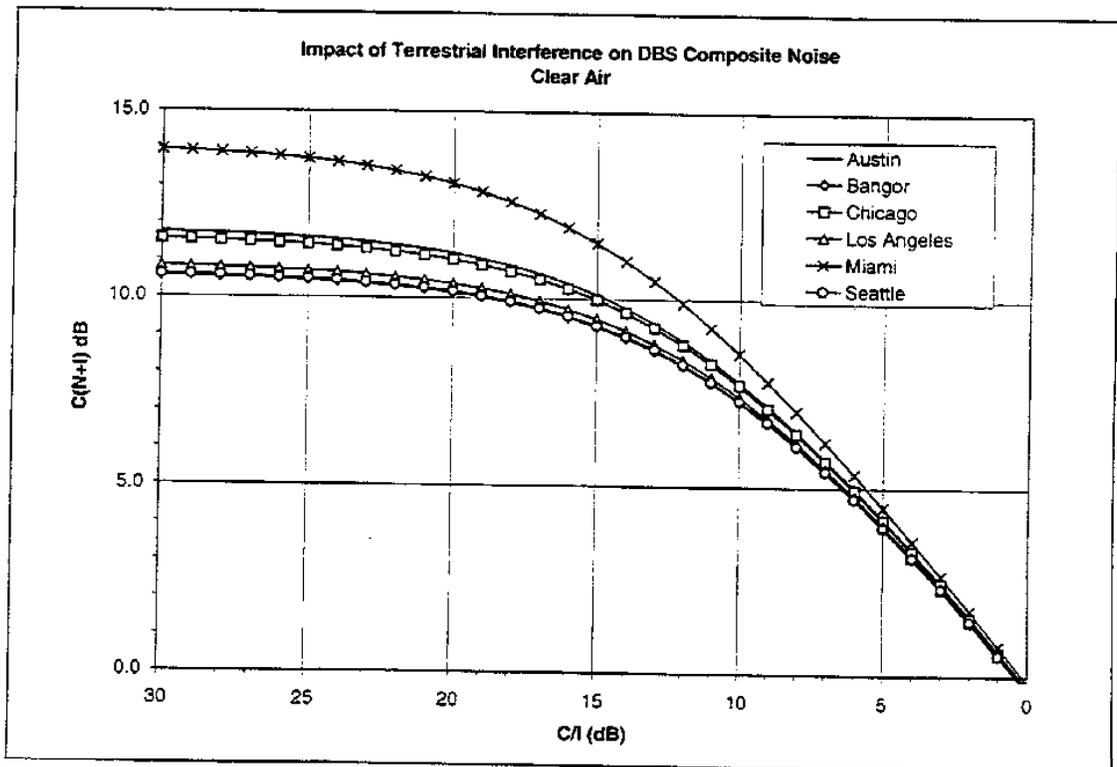
Figure 9. Terrestrial effect on C/(N+I), Clear Air

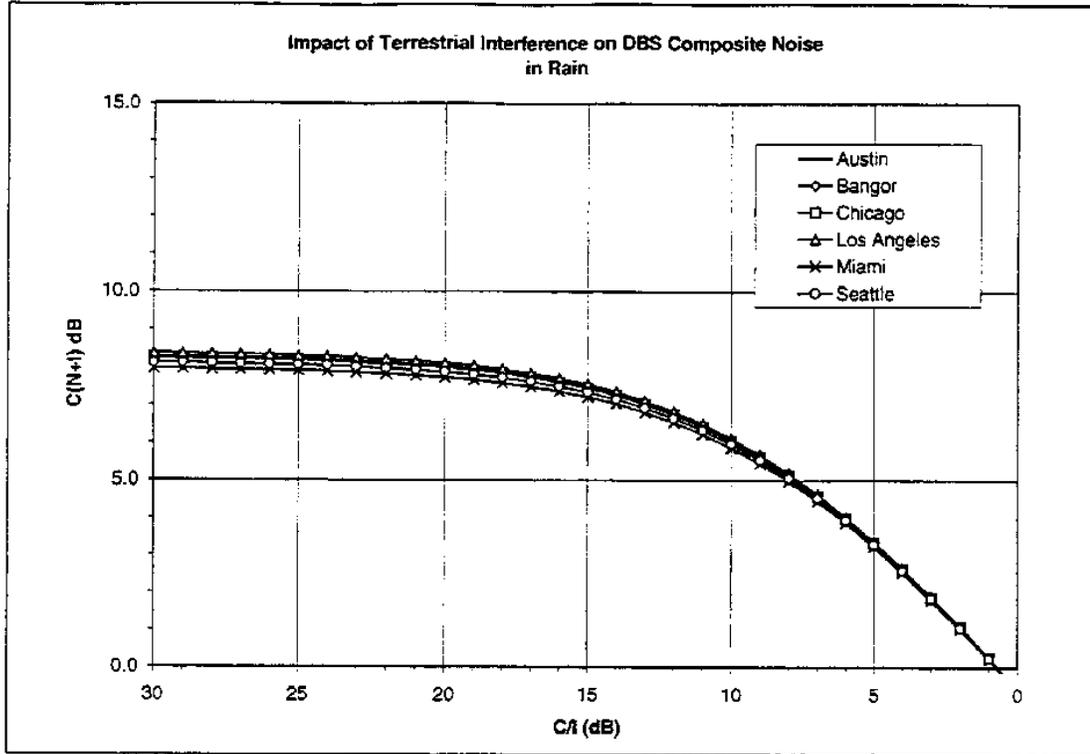
Figure 10. Terrestrial Interference Effect on DBS Link C/(N+I) In Rain

The DBS link tolerates a carrier to interference level of 8 dB (as shown in Figure 10, and Table 4), in rain, at the stated availability of 99.7% or greater. That is to say, a C/I of 8 dB from terrestrial sources will neither cause an outage, nor seriously degrade the signal of DBS customers, even during rain. Although a C/I of 8 dB will not cause harmful interference, Northpoint Technology will provide a much higher level of protection throughout the service area.

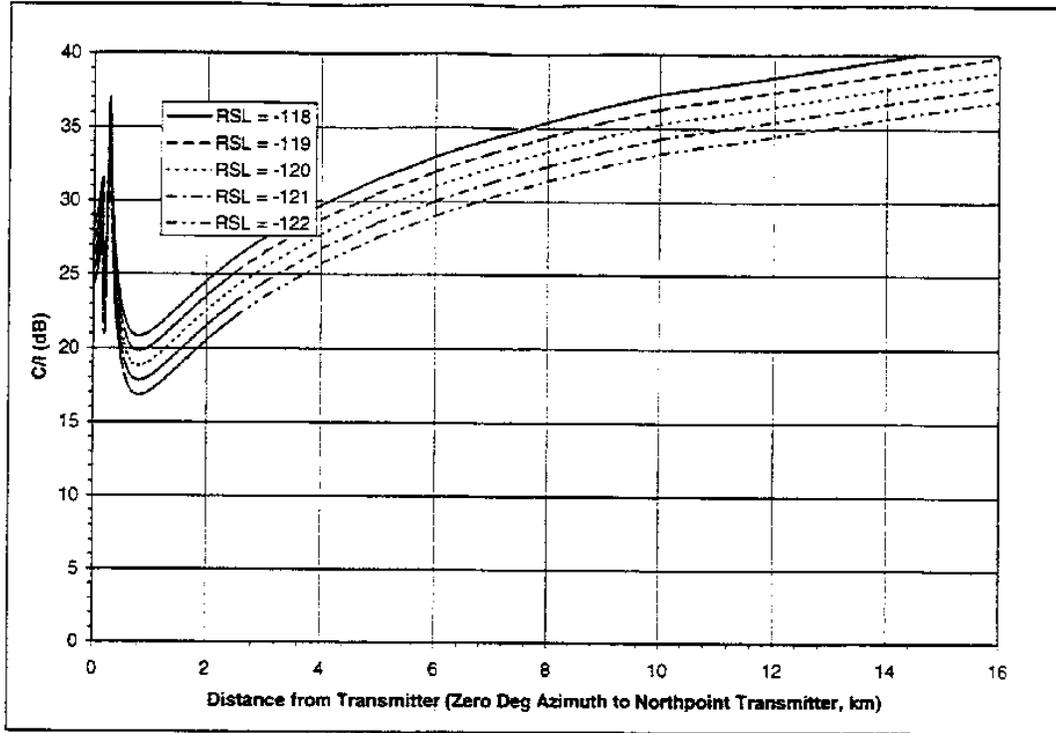
Figure 11. Worst-case C/I ratios

The minimum carrier to interference isolation in the worst case is plotted in Figure 11. The worst case for DBS is a 0 dBi gain towards the Northpoint transmitter, and this is a rare and unusual circumstance. Most DBS customers will have isolation far greater than 0 dBi, up to -16 dBi or higher. Note the C/I ratios given in Figure 12.

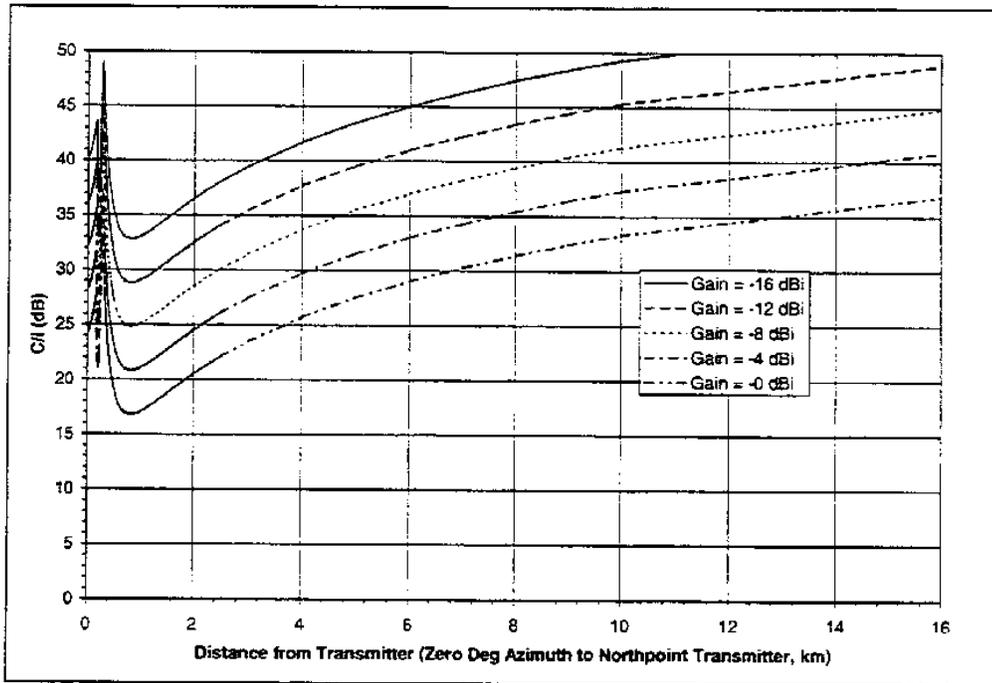
Figure 12. Typical C/I for variation in DBS gain towards Northpoint Transmitter
