<b>Client Name:</b> Associated Electric Cooperative, Inc.	<b>Site Location:</b> Norborne, Missouri	<b>Project No.</b> 21561720.00200
--	---	--------------------------------------

*Preliminary Jurisdictional Report  
Carroll County, Missouri*

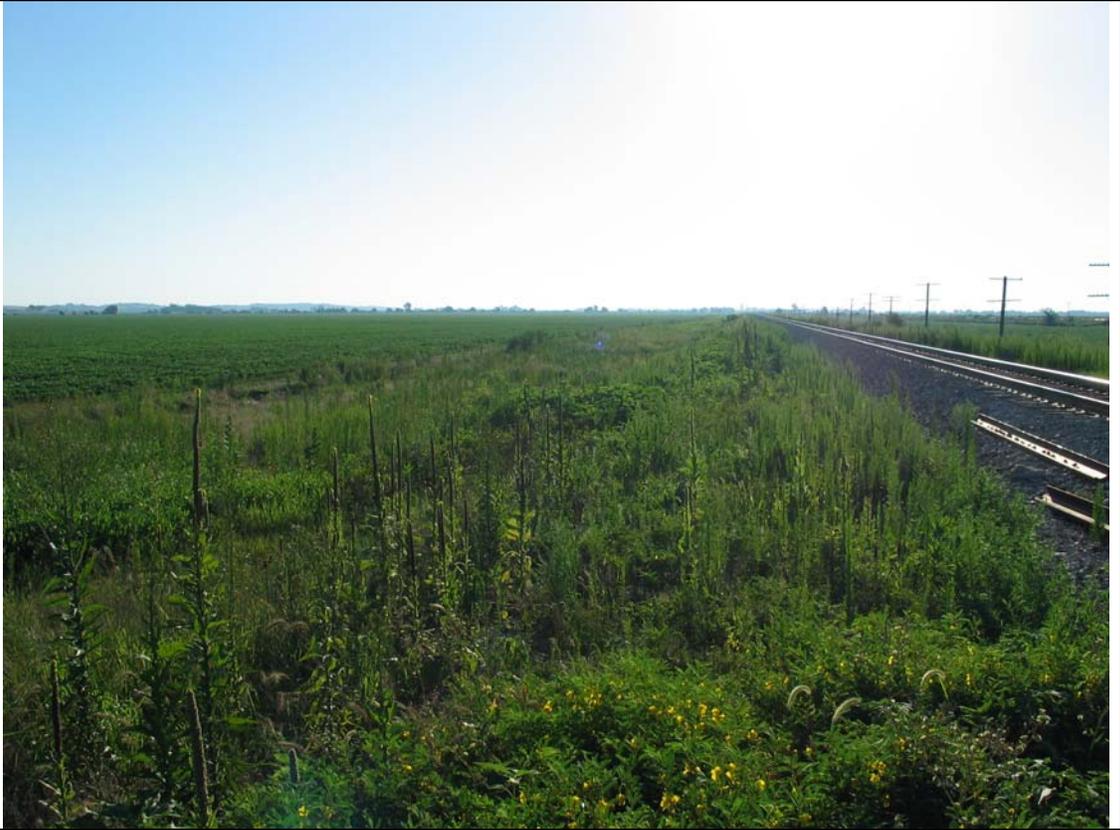
From southwest corner of AECl property, looking east. Corridor of volunteer vegetation. Notice rail line on right side of photo.

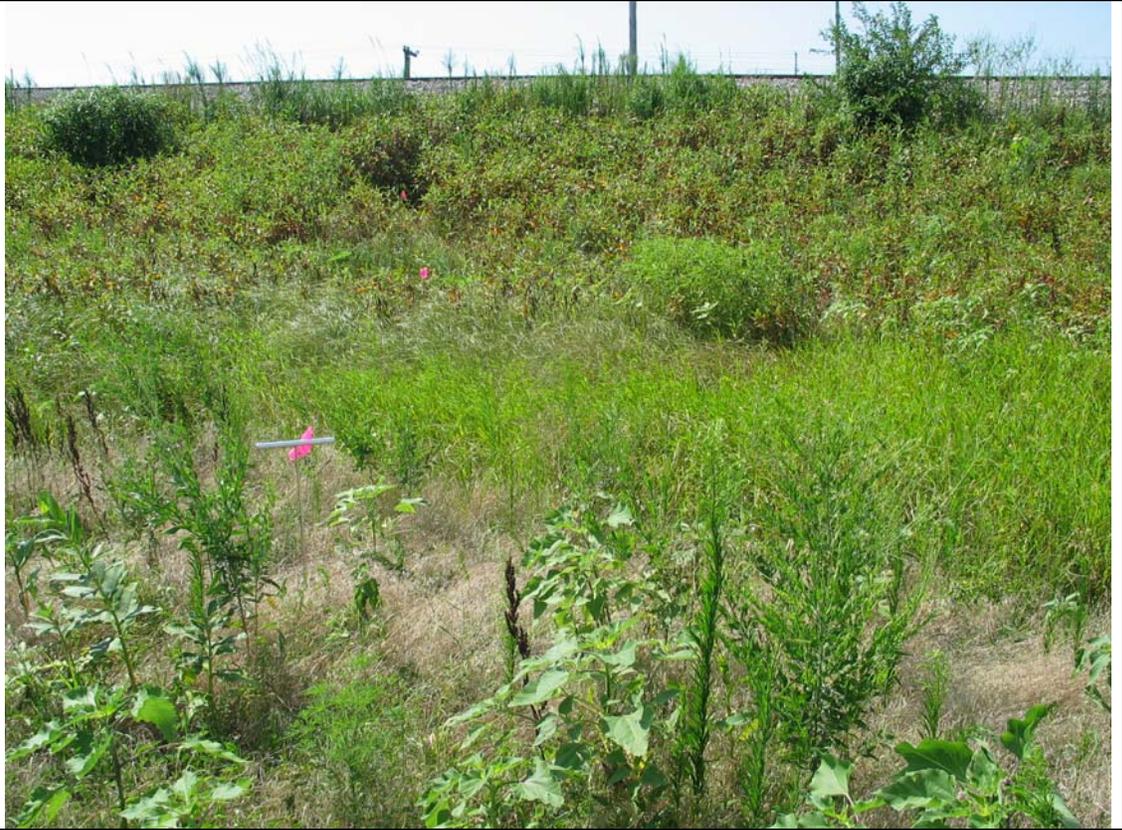
<b>Photo No.</b> <b>3</b>	<b>Date:</b> 8/1/06
<b>Description:</b>  Plot area 2. Plot 2A is nearest the railroad. Plot 2B is in the center and Plot 2C is nearest the roadway at the base of the photo.

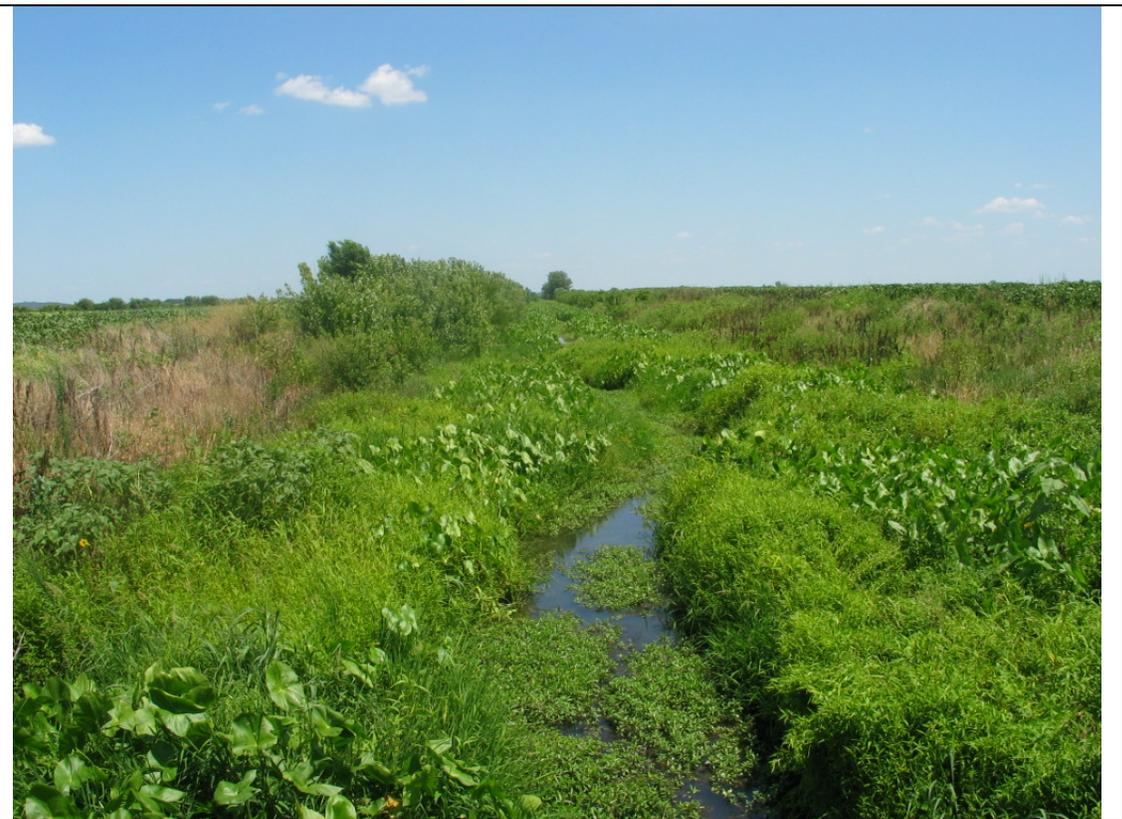
<b>Photo No.</b> <b>4</b>	<b>Date:</b> 8/1/06
<b>Description:</b>  From the intersection of County Road 103 and the north edge of the George Hale Trust property. Looking east at drainage ditch.

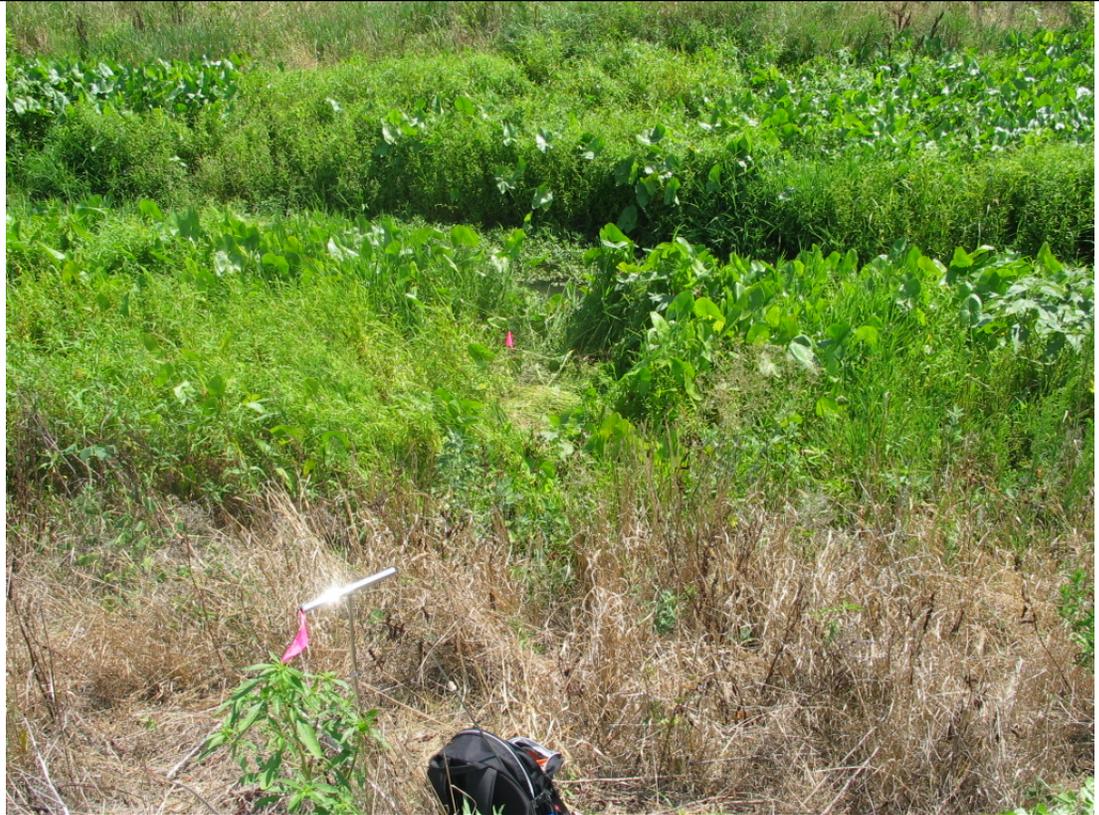
<b>Photo No.</b> <b>5</b>	<b>Date:</b> 8/1/06
<b>Description:</b>  Plot area 4. Plot 4A is upland and 4B is adjacent to the drainage ditch.

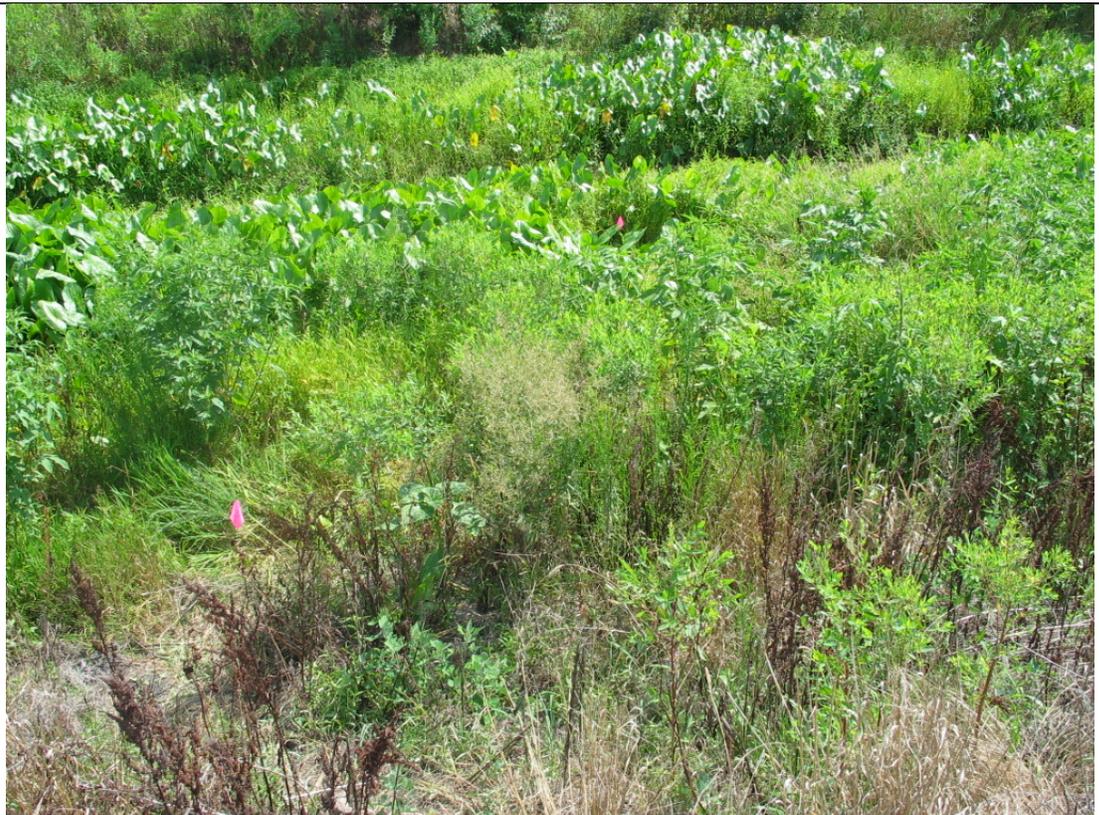
<b>Photo No.</b> <b>6</b>	<b>Date:</b> 8/1/06
<b>Description:</b>  Plot area 5. Plot 5A is upland and 5B is downland.

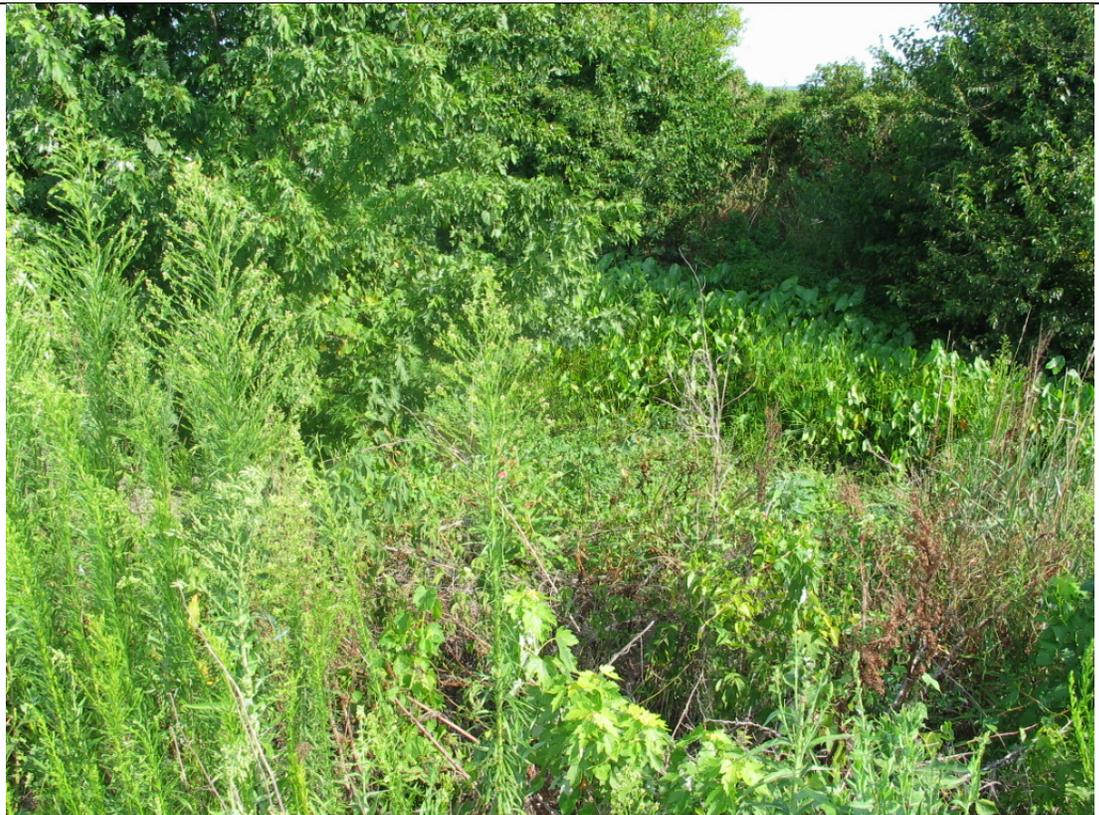
<b>Photo No.</b> <b>8</b>	<b>Date:</b> 8/1/06
<b>Description:</b>  Plot area 7. Looking southeast. Note steep bank on this side of the ditch and more gradual slope on opposite side.

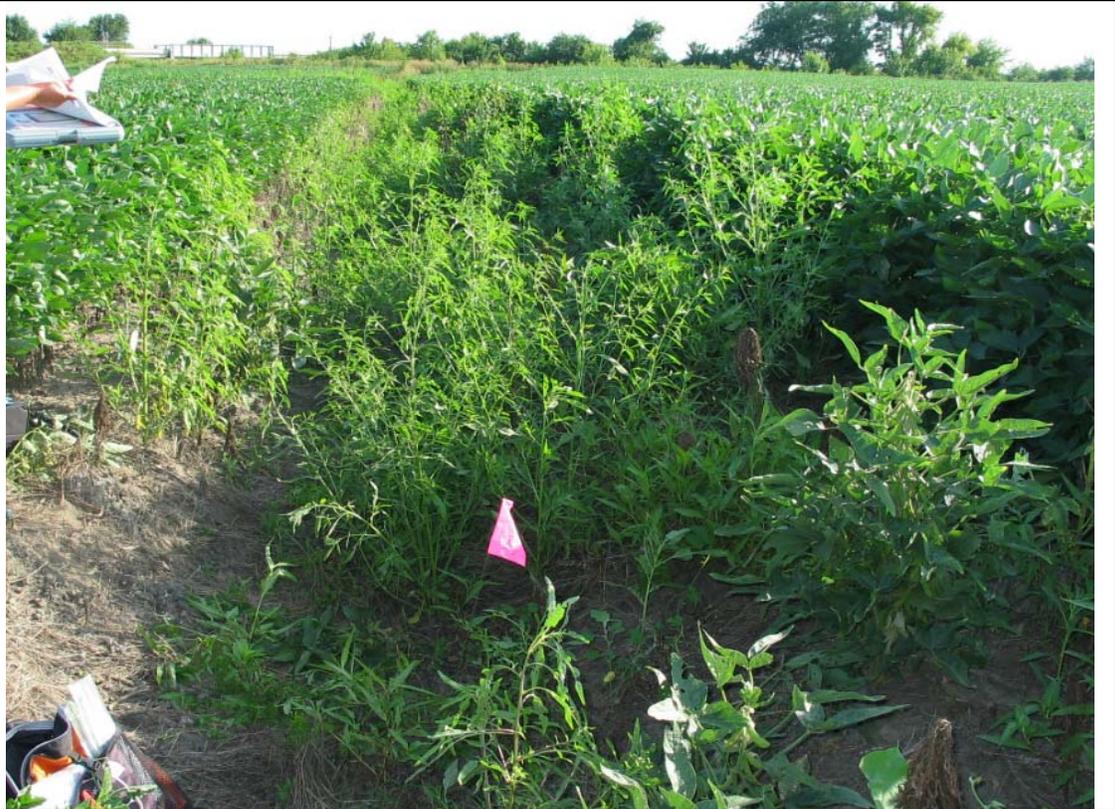
<b>Photo No.</b> <b>9</b>	<b>Date:</b> 8/1/06
<b>Description:</b>  Plot area 8. Looking south at ditch through soybean field.

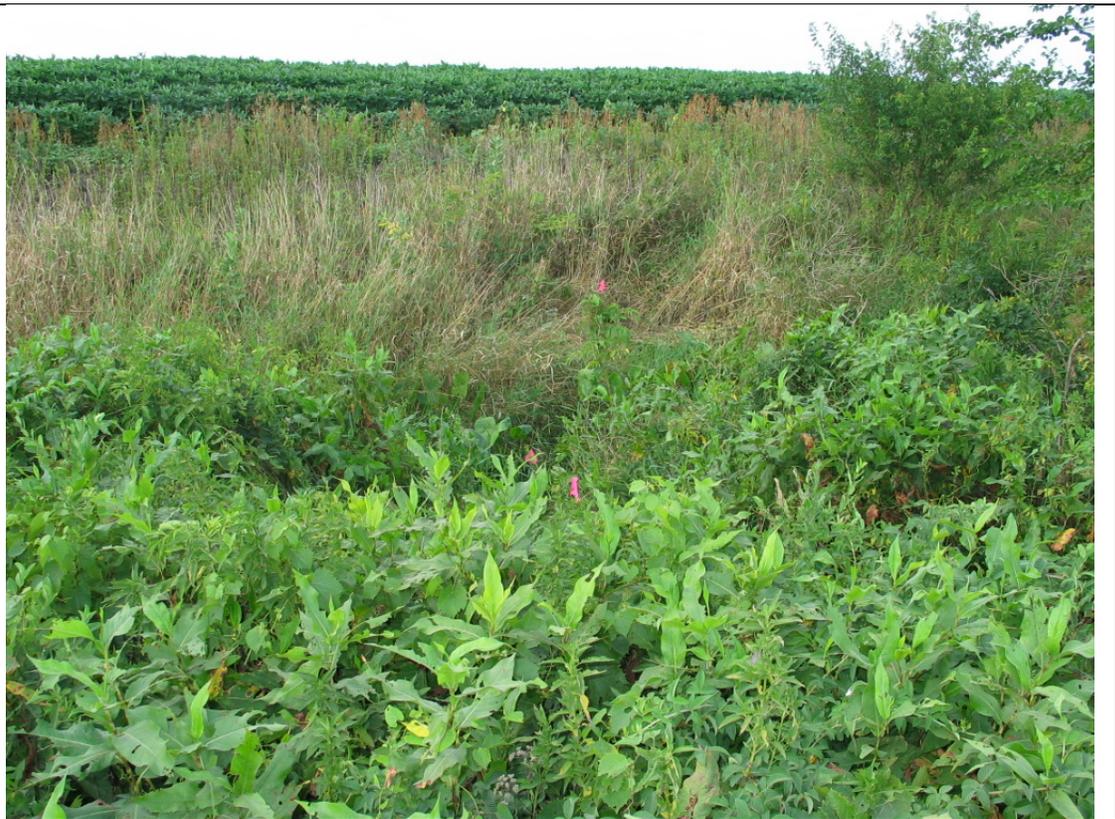
<b>Photo No.</b> <b>10</b>	<b>Date:</b> 8/2/06
<b>Description:</b>  Plot area 9. Looking south from County Road 300. Plot 9B is in the drainage ditch, with Plots 9A and 9C upland on either side of the ditch.

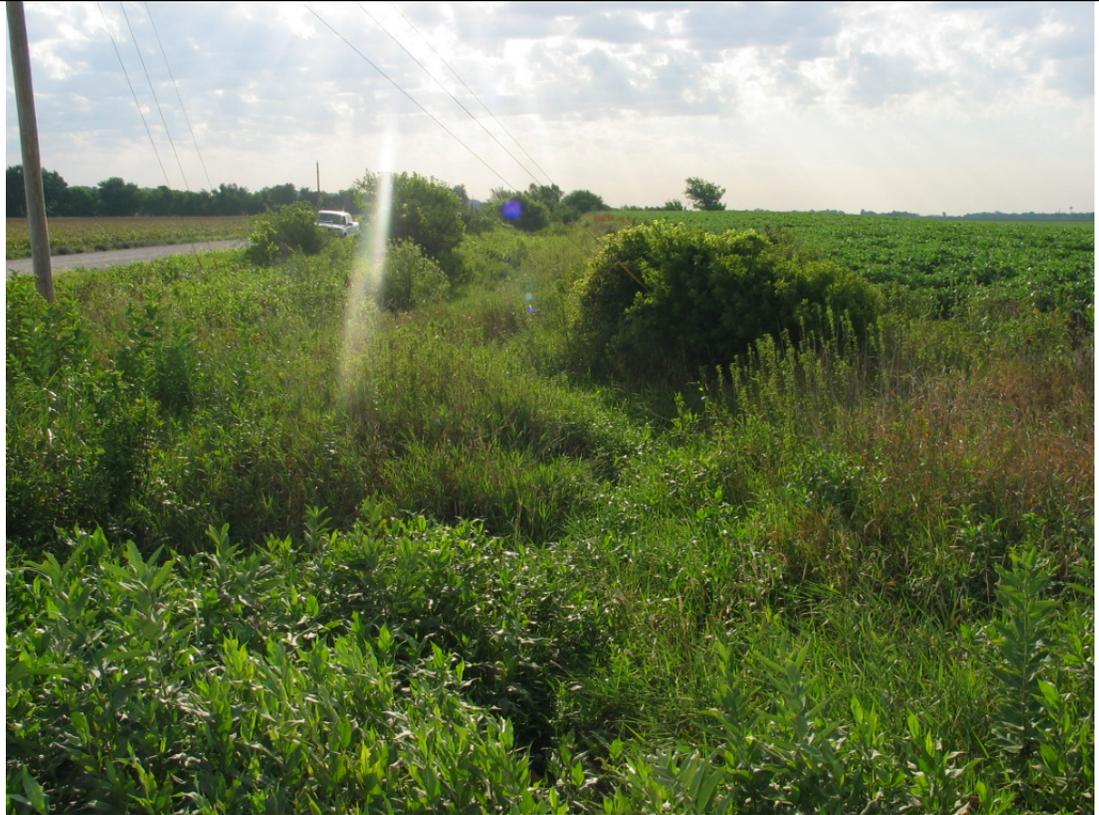
<b>Photo No.</b> <b>11</b>	<b>Date:</b> 8/2/06
<b>Description:</b>  Drainage ditch running parallel to County Road 300, immediately south of road. Photo taken from intersection of Road JJ and County Road 300, looking east. Culvert pipe runs under Road JJ.

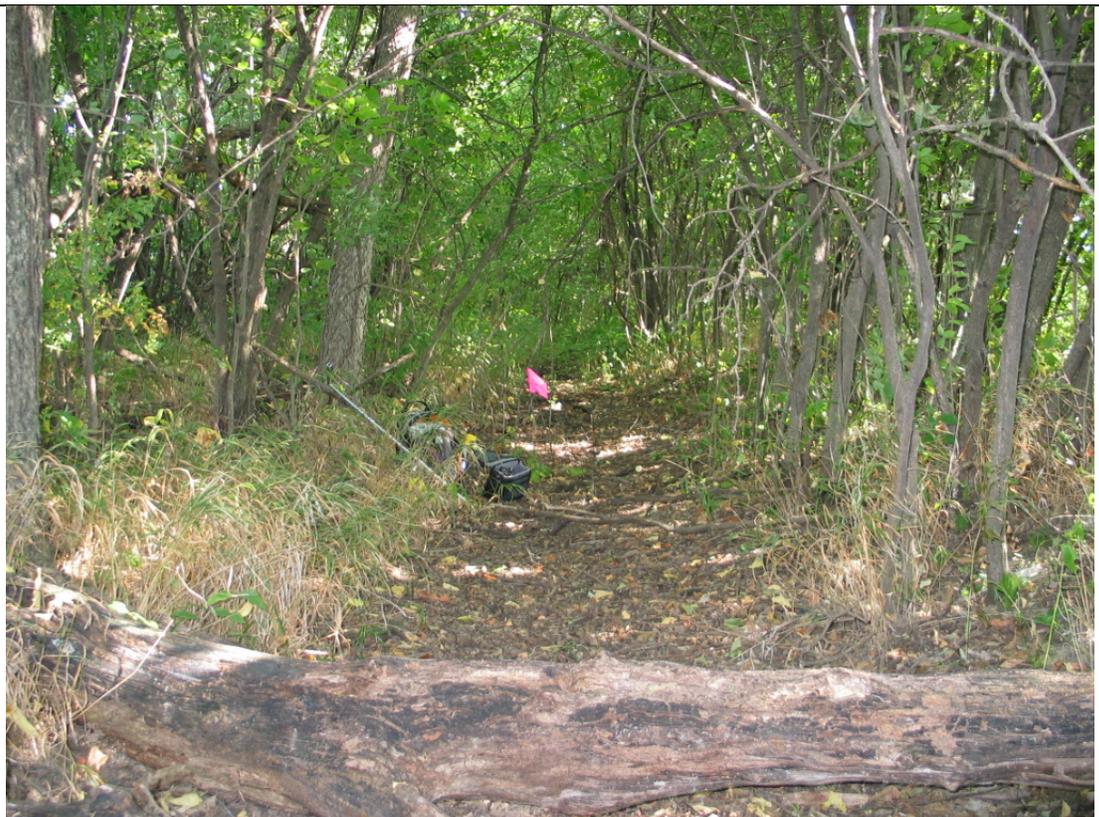
<b>Photo No.</b> <b>12</b>	<b>Date:</b> 8/2/06
<b>Description:</b>  Plot area 10. Looking north from center of drainage way. Plot 10B is within the drainageway. Plots 10A and 10C are on either side of the drainageway.

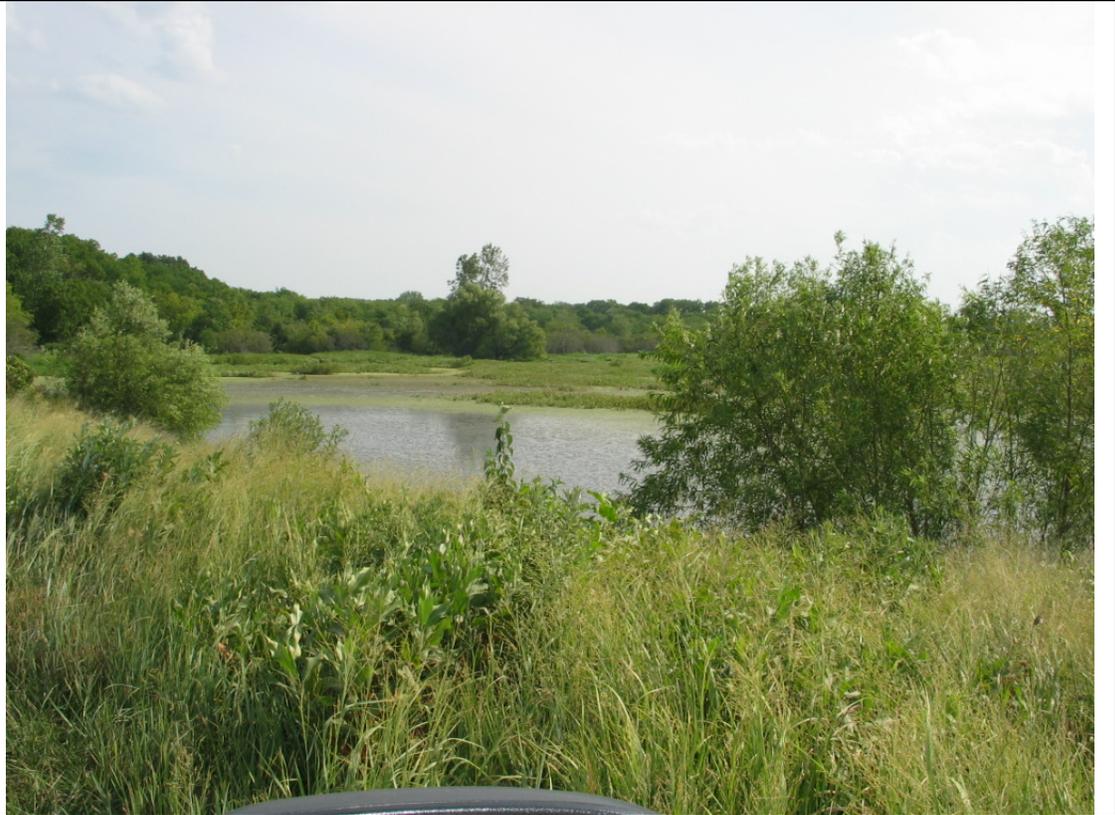
<b>Photo No.</b> <b>13</b>	<b>Date:</b> 8/2/06
<b>Description:</b> <p>Wet area immediately north of County Road 300. A pond lies west of this area. Appears that this area serves as an overflow for the pond to the west. Based on apparent hydrology and visual identification of species present along water's edge, wetland areas do exist here; however they were not field delineated, as this area appears to be outside of the facility property owned by AECL.</p>

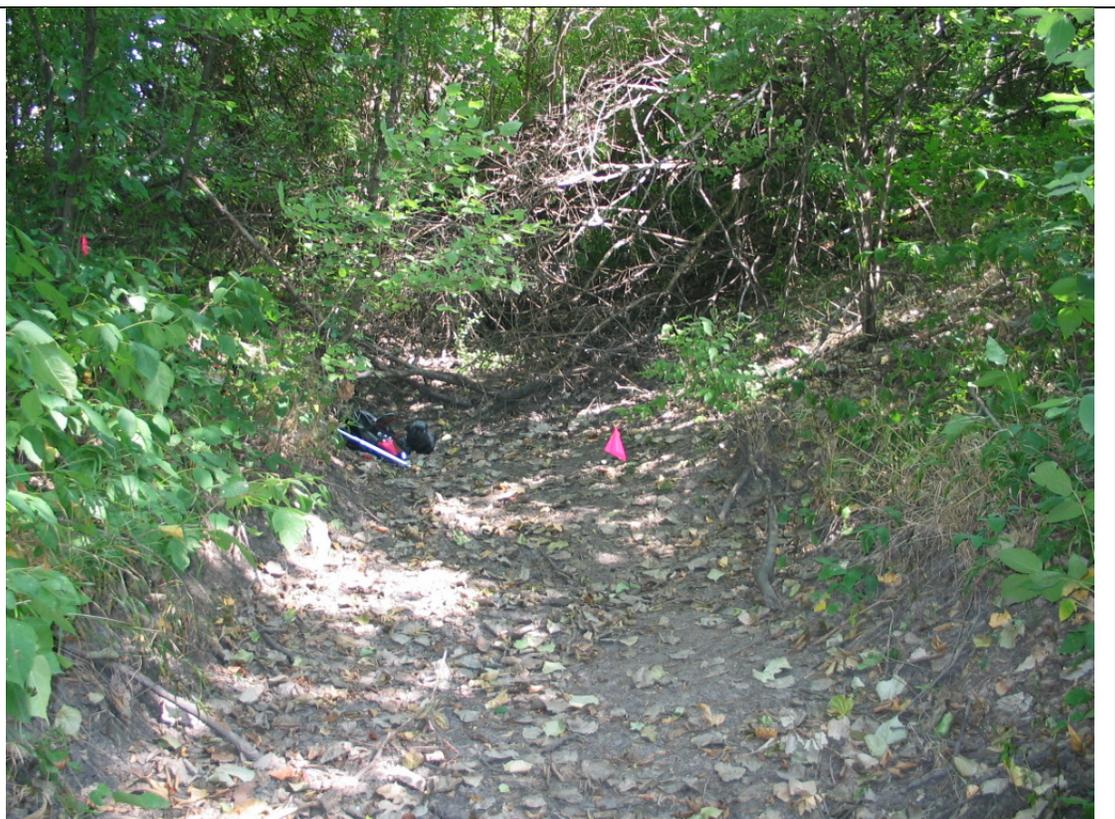
<b>Photo No.</b> <b>14</b>	<b>Date:</b> 8/2/06
<b>Description:</b> <p>Plot area 11. Standing in drainage way, looking north. Plot 11B is in drainage way, Plot 11A is to the east and Plot 11C to the west.</p>

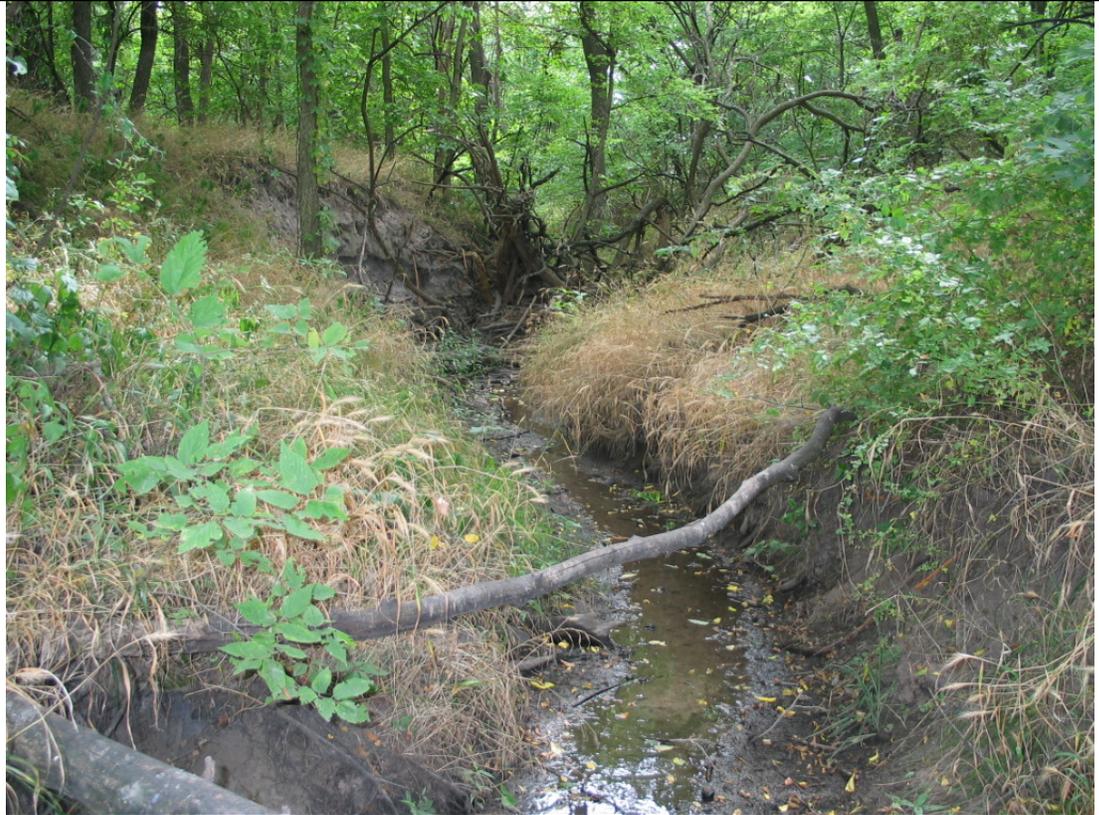
<b>Photo No.</b> <b>17</b>	<b>Date:</b> 8/2/06
<b>Description:</b>  Creek on the Kevin Edgar property. Standing at north property boundary where creek enters property, looking south. Notice the steep cut of the bank.

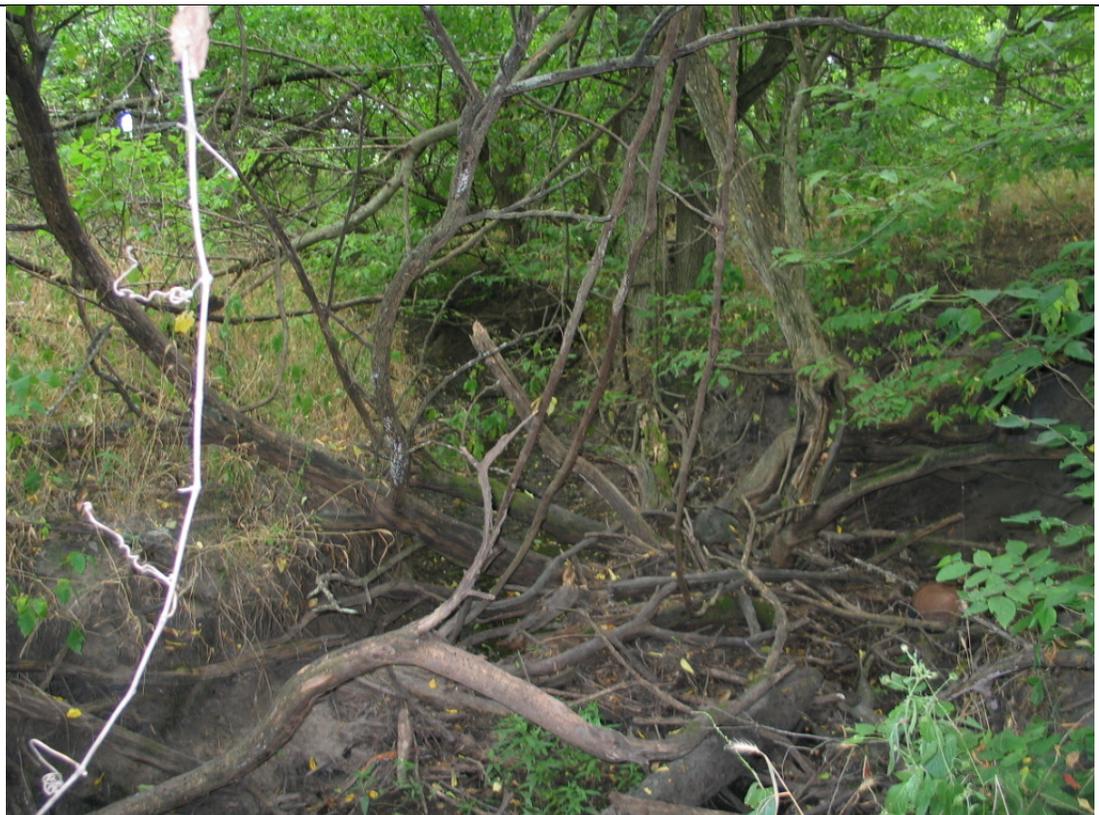
<b>Photo No.</b> <b>18</b>	<b>Date:</b> 8/2/06
<b>Description:</b>  Creek on the Kevin Edgar property. Further south of creek point pictured in Photo 17. Downed trees at various points of creek may impeded water flow, leading to some of the erosion/cutting observed along the bank. Advanced the soil probe at edge of the creek, at an elevation below opposite bank cut. Soils are hard and dry and do not appear hydric.

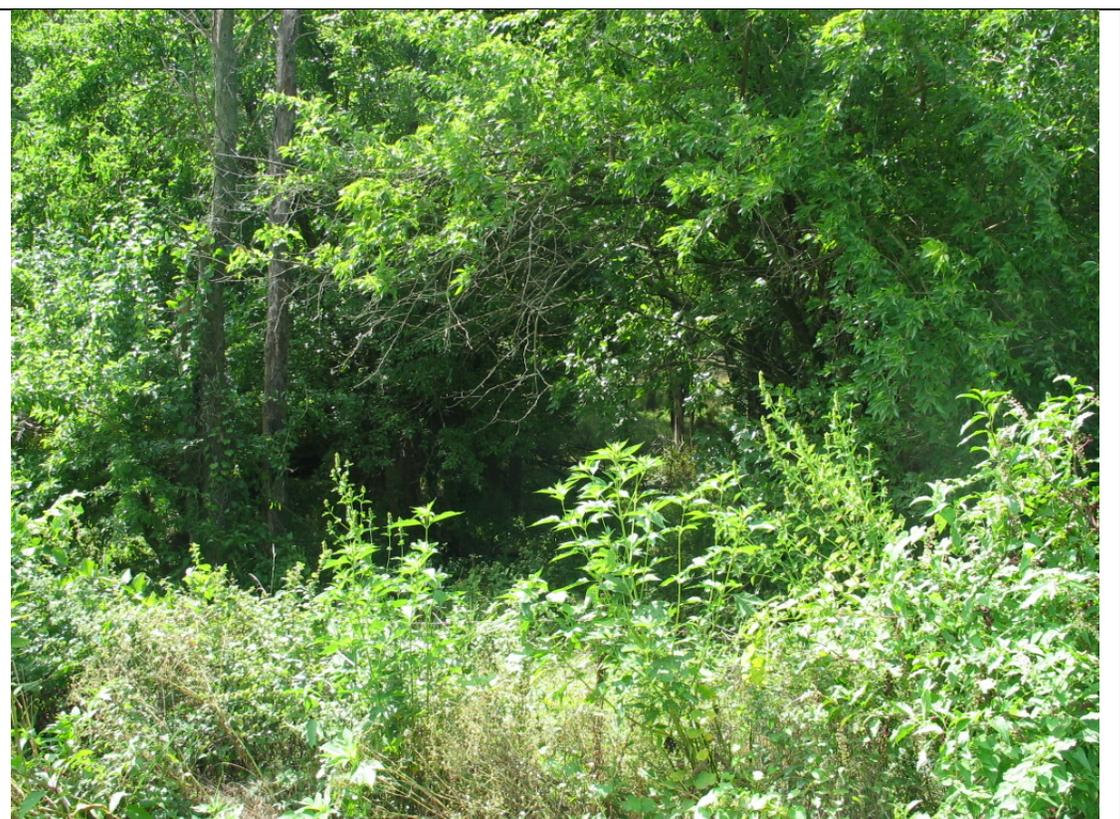
<b>Photo No.</b> <b>30</b>	<b>Date:</b> 8/3/06
<b>Description:</b>  Potential wooded wetland immediately south of County Road 290 between County Roads 111 and 121. This area represents a topographical low, vegetated and mapped drainage way.

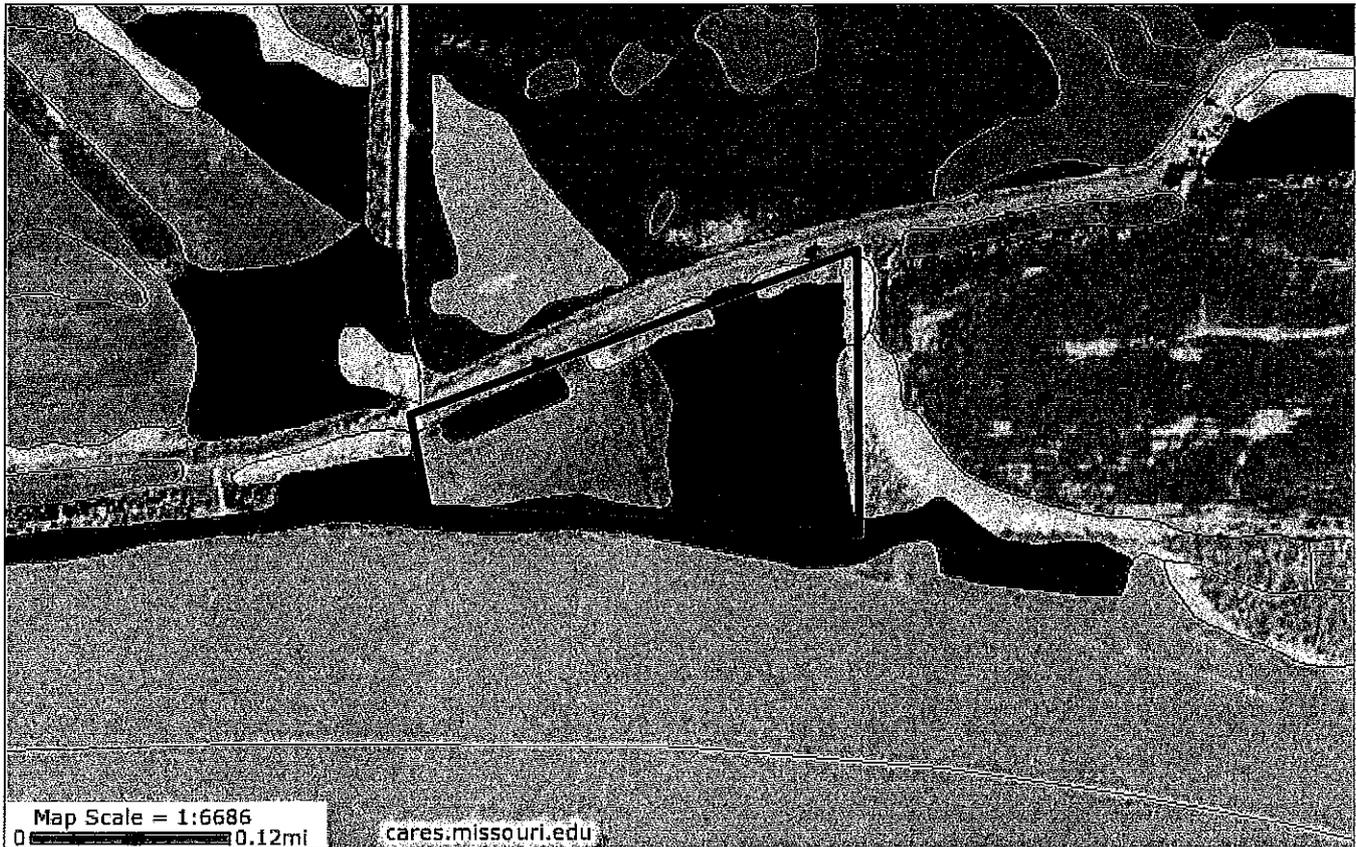
# Figure 4

Source: NWI Map, Carroll County, Missouri

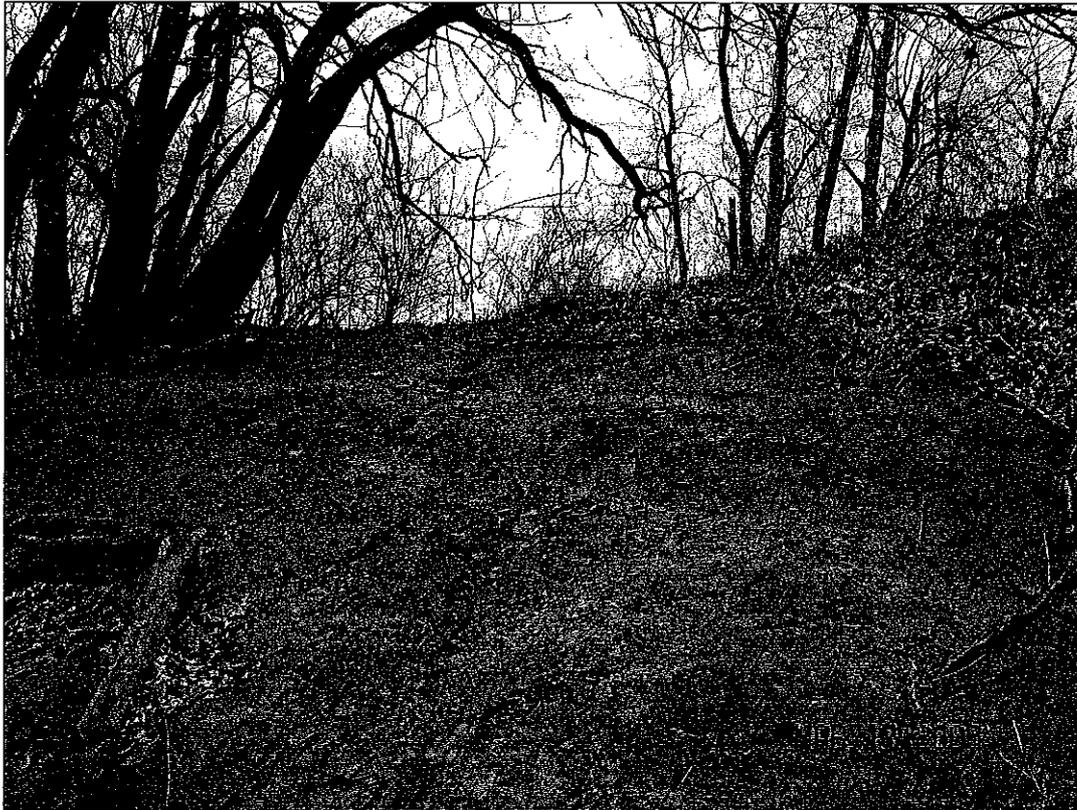
**Photo 6 – Haynie very fine sandy loam**
