**REPORT OF SITE RECONNAISSANCE FOR
THE PROPOSED WAR FORK AND STEER
FORK DAM SITE**

Proposed Dam Site
Turkey Foot Recreation Area
Jackson County, Kentucky

Re: Site Reconnaissance
Proposed Dam Site
Turkey Foot Recreation Area
Jackson County, Kentucky

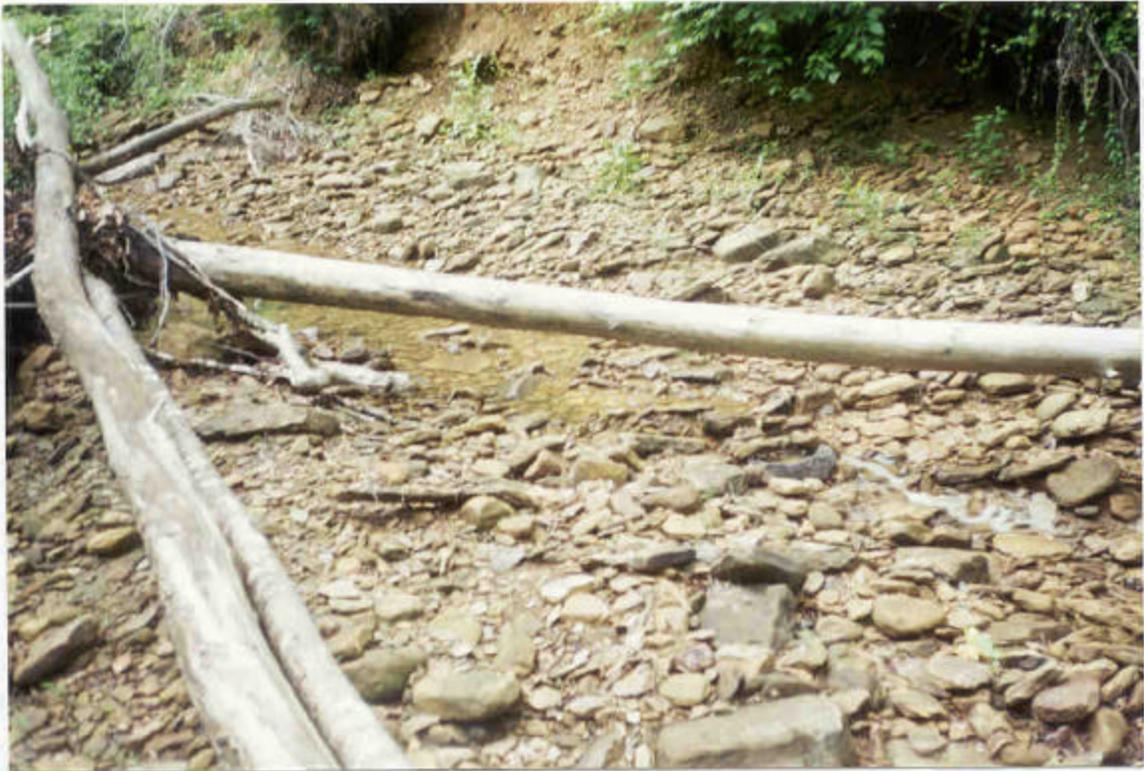
Upon arriving at the site, it was noted that there was no flow in War Fork at the Turkey Foot Road bridge. While stream base flows in Kentucky are still somewhat depressed due to the 1999 drought conditions, the no flow condition was unexpected given the size of the watershed and the near normal precipitation of the past six months. Moving upstream from the bridge approximately 800 feet, it was observed that War Fork abruptly sinks in an alluvium filled streambed swallet.

Photo No. 1 Stream Bed Swallet 800 Feet Upstream of Turkey Foot Road Bridge

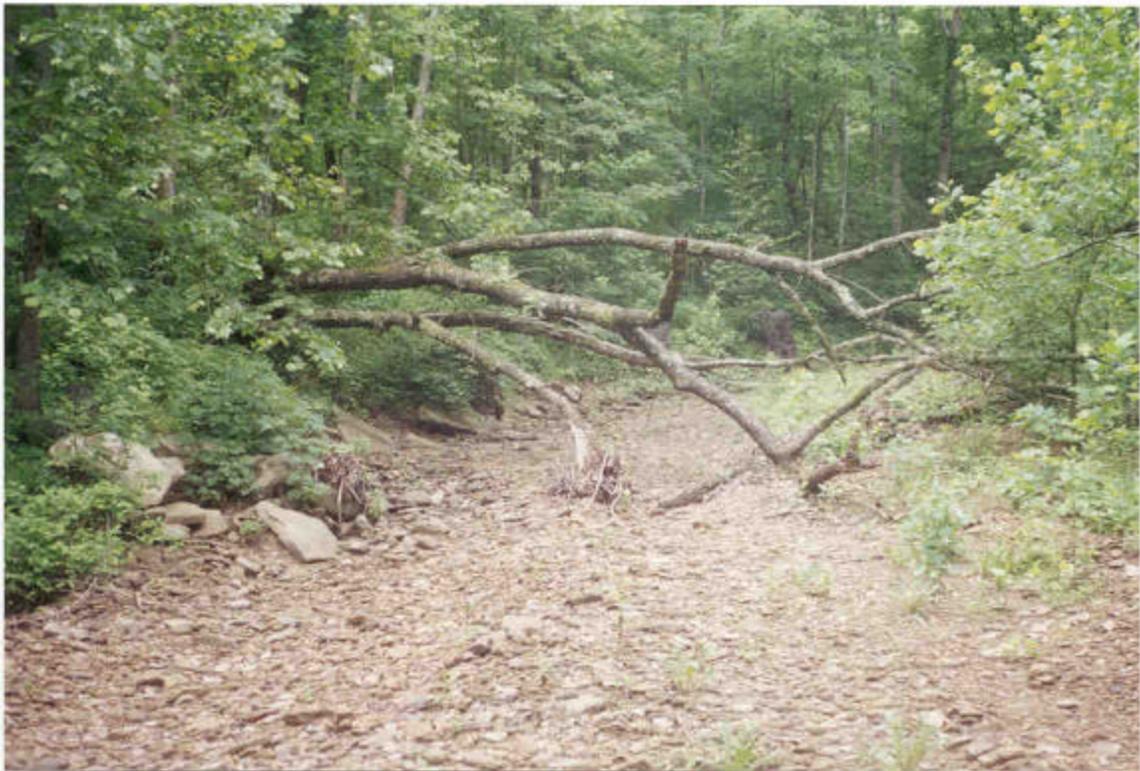
Photo No. 2 Dry Stream Bed Between Swallet and Hughes Fork

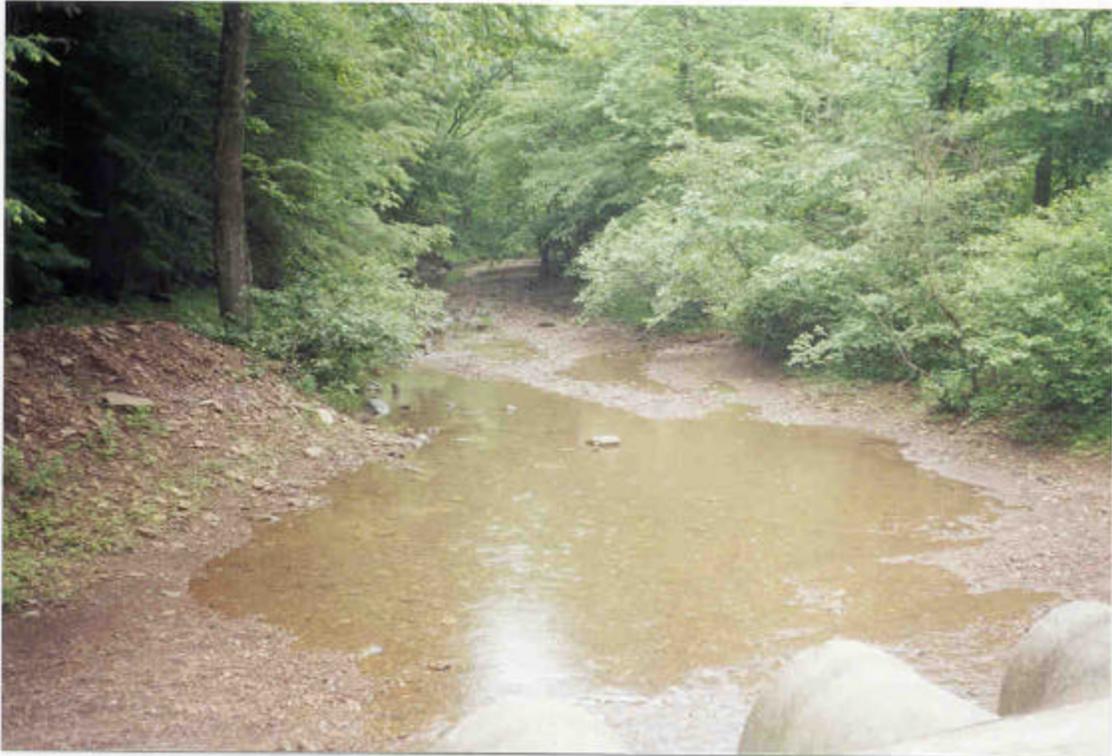
Moving downstream from the bridge, flow returned to War Fork at confluence with Hughes Fork. This flow consisted solely of the discharge from Hughes Fork. No flow was observed from Elsam Fork at its confluence with War Fork. At the entrance to the Turkey Foot campgrounds, War Fork is traversed by a low water bridge. On the upstream side of the bridge, flow in War Fork consists solely of the discharge from Hughes Fork. On the downstream side of the bridge, the flow increases significantly as the result of spring discharge beneath a large ledge of the Newman Limestone that is located near the bridge. It is probable that these springs are the resurgence of the flow in War Fork that sank above the Turkey Foot Road bridge; however, that can not be ascertained without dye testing.

Photo No. 3 War Fork Upstream of Low Water Bridge

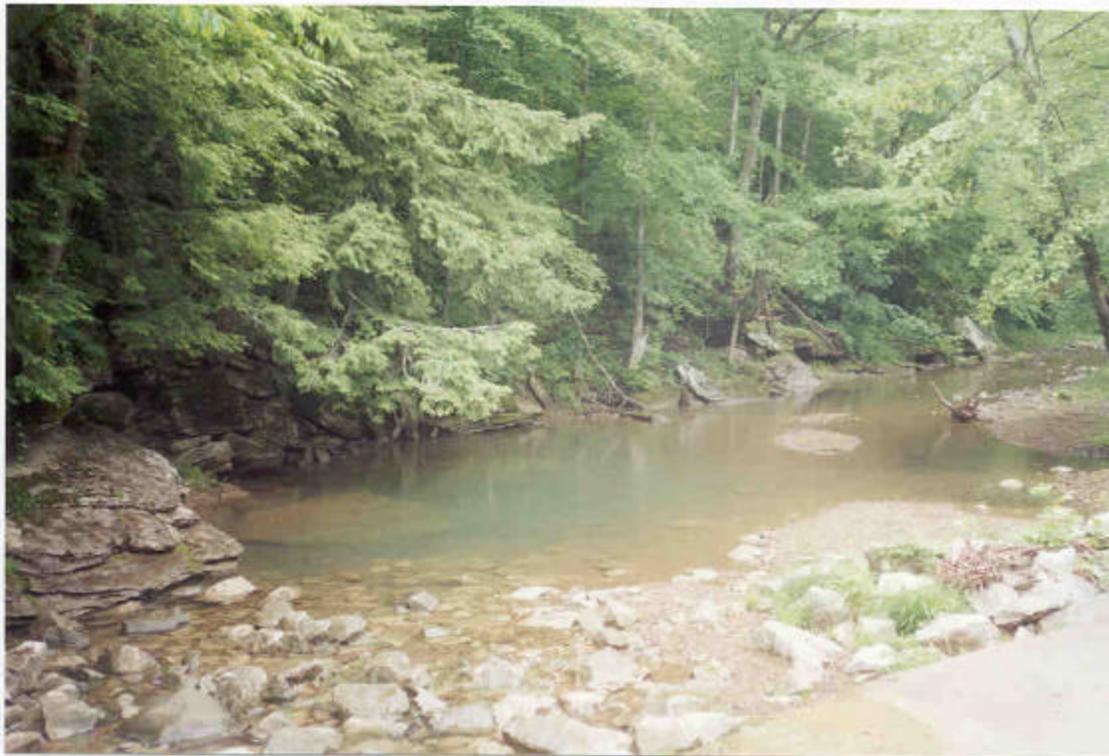
Photo No. 4 War Fork Downstream of Low Water Bridge
