Section 8. Inventory of Historic Resources: Sites 21–40

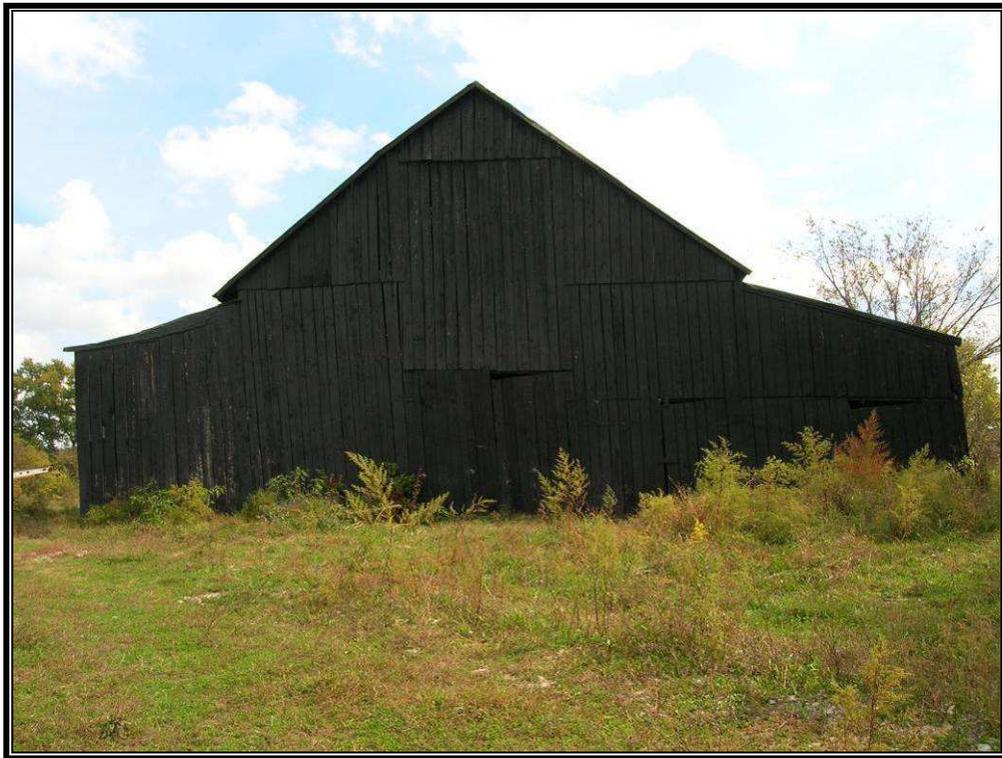
level. A shed-roof stripping room is located on the north side and the south side has five vertical vents. The western portion of the barn has shed-roof wings on either side (Figure 8.10). The barn has a V-groove metal roof. A pond located on the north side of the house has a dry-laid rock retaining wall on its western side (Figure 8.11). Portions of the wall, which is approximately 20 ft in length, have collapsed.

Figure 8.10. Site 21, Western end of tobacco barn.

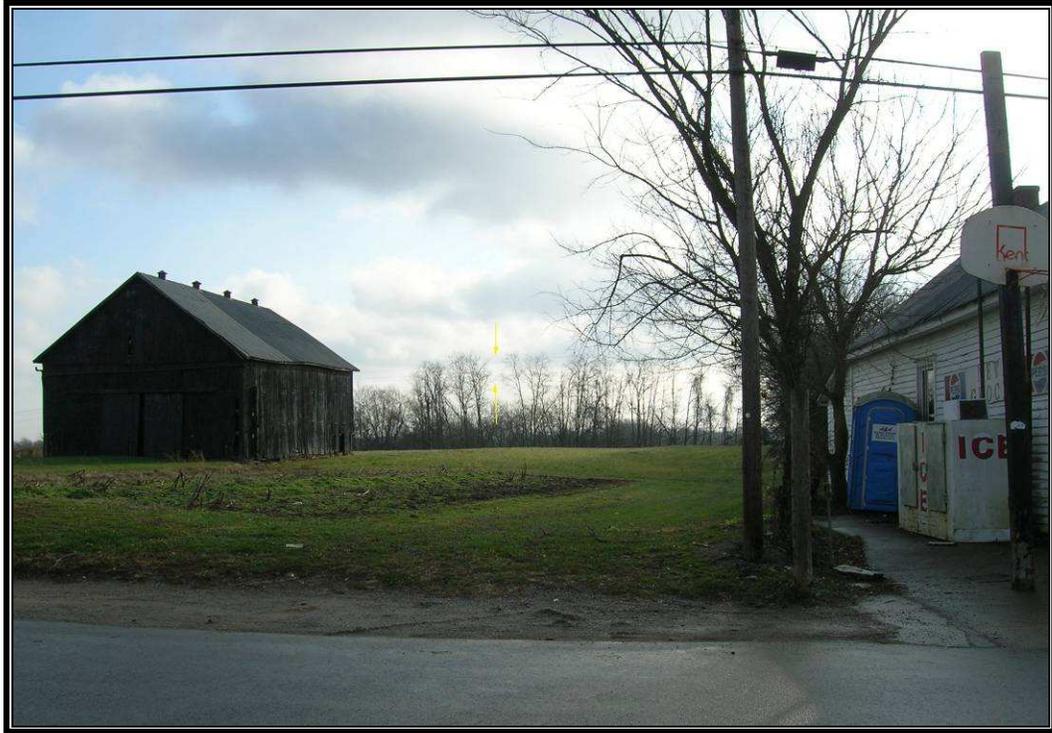
Section 10 of the proposed transmission line, which will parallel the existing line, is located approximately 1,394 ft to the southeast of Site 21. Section 10 is a portion of Alternatives A, B, C, D, E, F, G, and H. Figure 8.13 is a view looking towards the existing line from the front entry gateposts of Site 21. The yellow arrows in the figure point to the existing line. Because of the presence of the existing line, and the distance between Site 21 and the existing and proposed lines, it does not appear the proposed project will have an effect on Site 21.

Figure 8.13. Site 21, View, looking southeast to existing line from front entrance of Site 21. Yellow arrows are pointing to line.

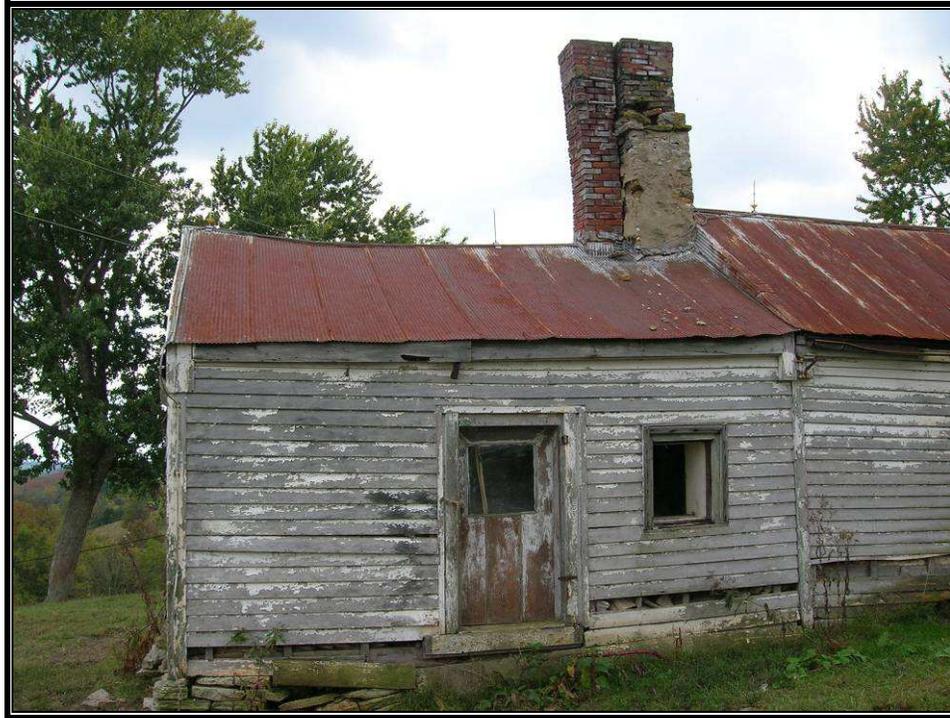
Figure 8.32. Site 25, Rear section of log ell.

Both portions of the ell are resting on a dry-laid stone foundation and are clad in weatherboard siding. The south side of the ell has a shed-roof enclosed porch resting on a stone pier foundation; this side of the ell is in a deteriorated condition (Figure 8.33). A single-leaf entry with a vertical board door and a rectangular, boarded over window are located on the south side of the first section of the ell. A late nineteenth-century one-and-one-half-story, front-gable, two-bay (w/d) frame addition is located on the north side of the log house (Figure 8.34). A three-sided bay with one-over-one-light double-hung wood sashes is located on the left side of the addition's facade. The bay has wood panels with molding above the windows as well as a wood cornice with molding. A single-leaf entry with a wood panel door and a wood screen door is located to the right of the bay. The entry has a wood surround with molding. A small hip-roof porch with a molded wood cornice and decorative carved brackets shelters the entry. A window with two-over-two-light double-hung wood sashes and a molded wood surround is located on the north elevation of

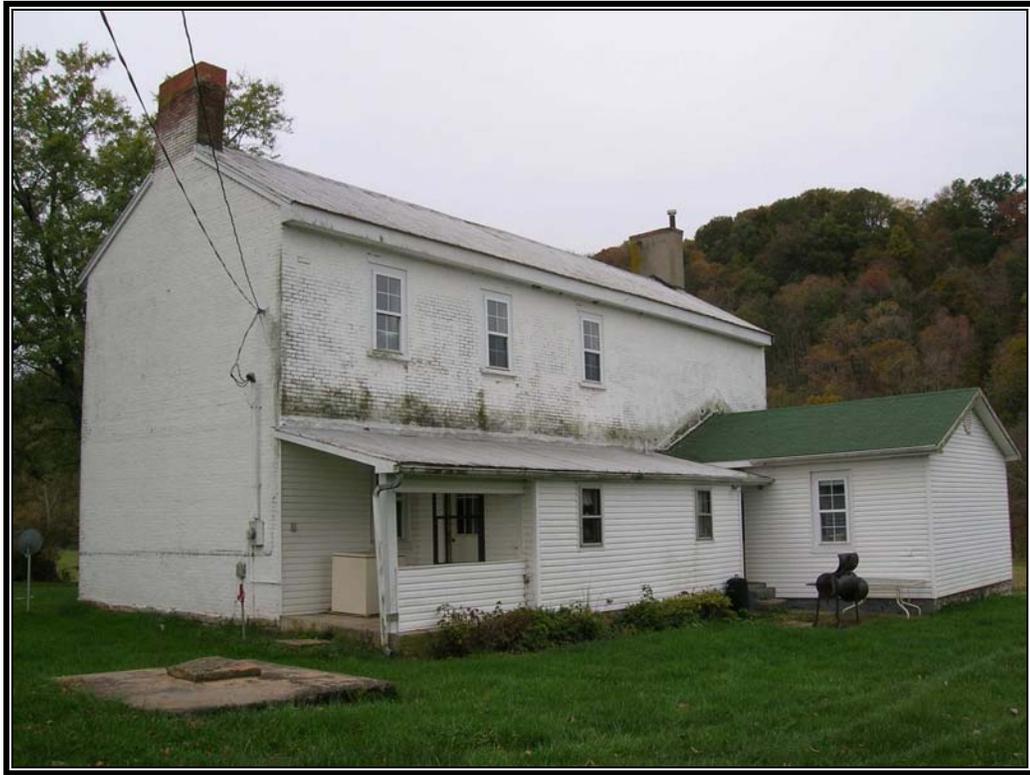
A shed-roof porch, which has been partially enclosed, is located on the rear elevation, adjacent to the ell (Figure 8.52). The porch has a poured concrete foundation and is clad in vinyl siding. A single-leaf entry with a multi-light nonhistoric door is located on the east side of the porch. Windows on the enclosed porch contain one-over-one-light sashes, while windows on the upper level of the rear elevation contain four-over-four-light double-hung vinyl sashes. The roofs of the house and the enclosed porch are covered with V-groove metal panels while the roof of the ell is covered with asphalt shingles.

Figure 8.52. Site 30, Rear and east elevations.

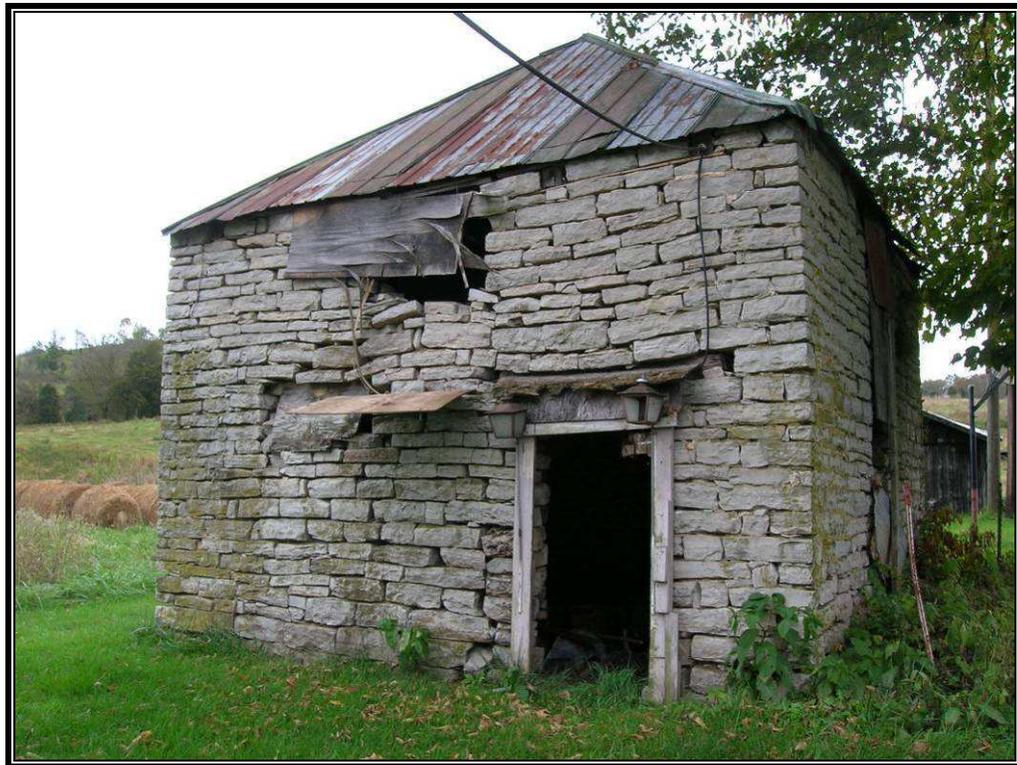
Five outbuildings are associated with the house. A pyramidal-roof stone outbuilding is located behind the house (Figure 8.53). The outbuilding, which follows the common form of a smokehouse (but may have originally served any number of purposes), has a single-leaf entry with a missing door on the east elevation. Rectangular window openings, appearing to be alterations, are found on all four elevations (Figure 8.54). Horizontal wood beams are found in the interior of the outbuilding, perhaps having served as poles from which to hang meat (Figure 8.55). The roof is covered with V-groove metal panels. A gable-roof, vertical board outbuilding with shed-roof additions is located to the west of

Figure 8.53. Site 30, Stone outbuilding (probable smokehouse), east elevation.

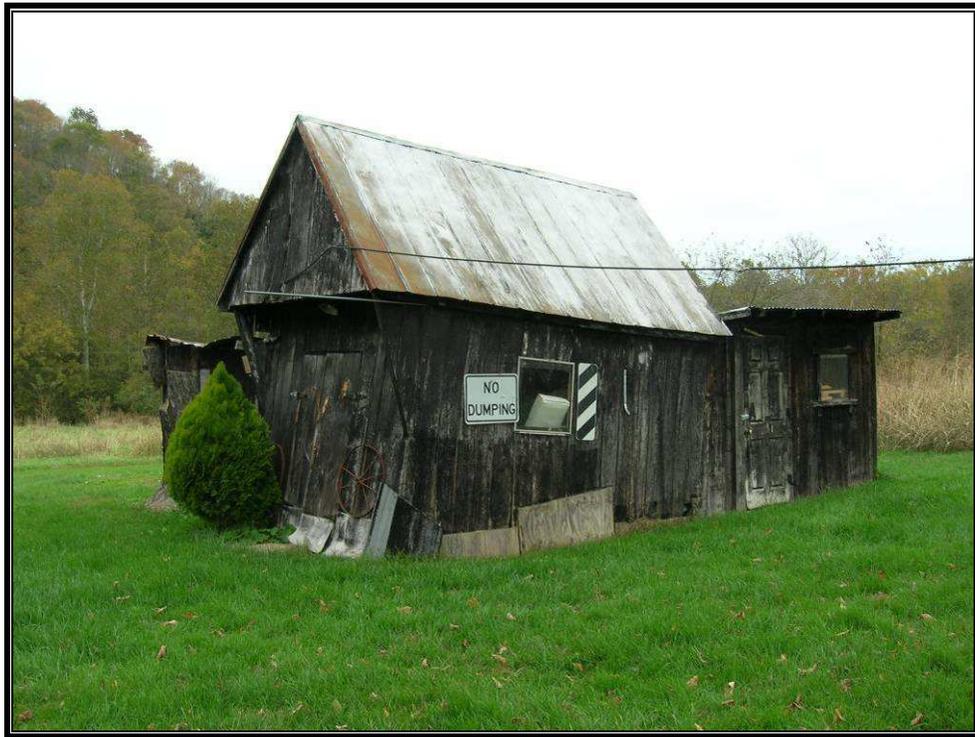
the stone outbuilding (Figure 8.56). The outbuilding has a double-leaf batten door entry on the gable end and a wood panel door on the shed-roof addition. A shallow overhang is located above the entry on the gable end. The roofs are a mixture of V-groove metal and corrugated metal panels. A gable-roof outbuilding clad in board and batten siding is located to the east of the house (Figure 8.57). A single-leaf batten door is located on the south elevation and a small metal stovepipe can be found on the front roof slope. A single-light fixed sash window is located next to the entry. The outbuilding has a corrugated metal roof.

Figure 8.56. Site 30, Gable-roof outbuilding.

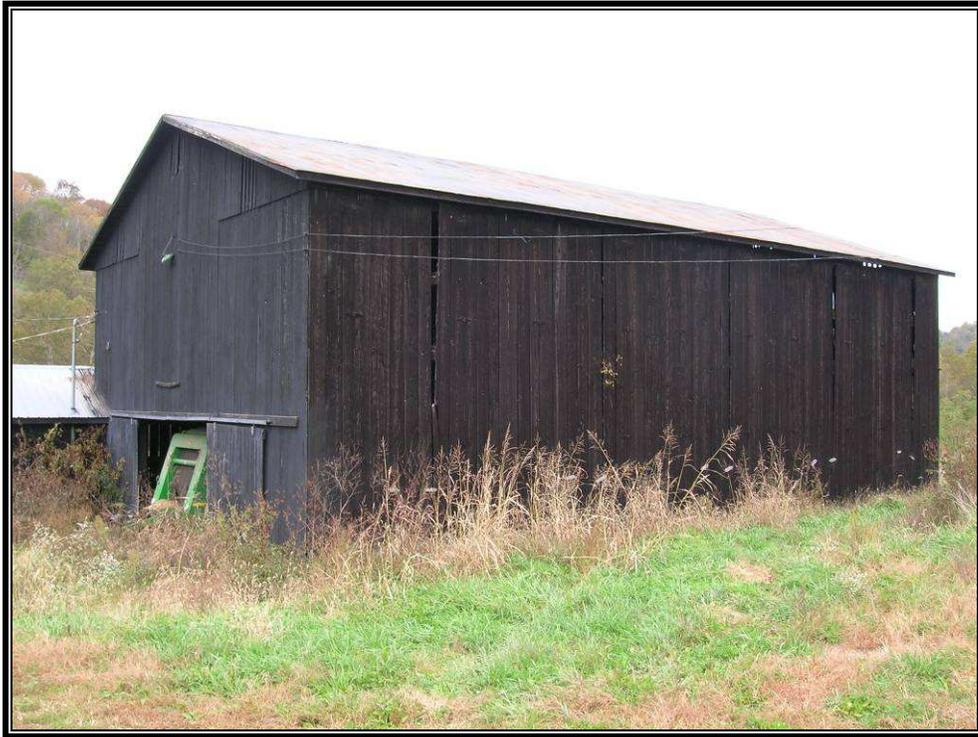
Two barns are located behind the house. The first is a gable-roof, vertical board tobacco barn (Figure 8.58). The tobacco barn is constructed of sawn lumber and wire cut nails and has 10 vertical side vents. A central sliding door is located at the gable end. The barn has additional vents at the upper gable and the roof is covered with V-groove metal panels. A gable-roof garage has been added to the west side of the barn. Adjacent to the tobacco barn is a gable-roof, vertical board, transverse-crib barn (Figure 8.59). The barn has a shed-roof crib addition on the west side and a V-groove metal roof.

Figure 8.58. Site 30, Tobacco barn.

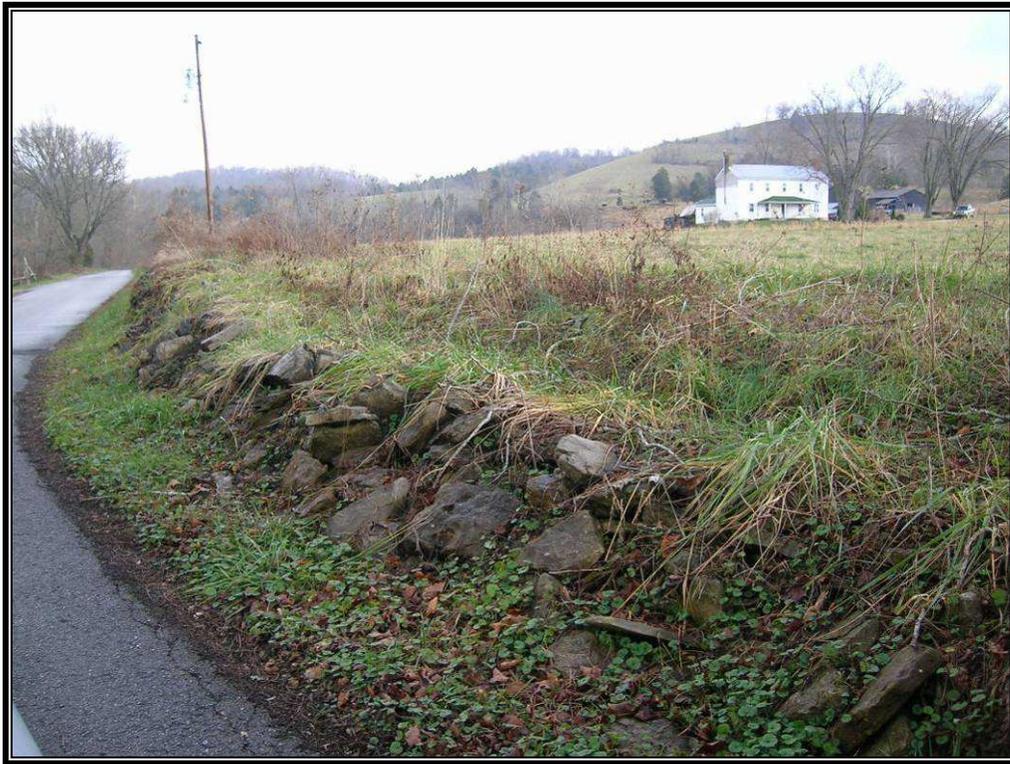
A dry-laid rock fence is located along the property's northwest and southwest boundaries. Several portions of the fence appear to act as a retaining wall (Figure 8.60). A majority of the fence is in disrepair, with several collapsed sections, and no coping visible on any portion of the fence (Figure 8.61). On the northwestern side of the property, the fence begins at the end of Bogie Mill Road, as the road runs parallel to the property line. The fence continues to the southwest, then curves to the southeast (Figure 8.62). The fence terminates on the west side of the driveway, then continues again on the east side. The portion of the fence that retains the most courses is located on the east side of the driveway (Figures 8.63-8.64).

Figure 8.61. Looking north at portion of rock fence located at corner of property.

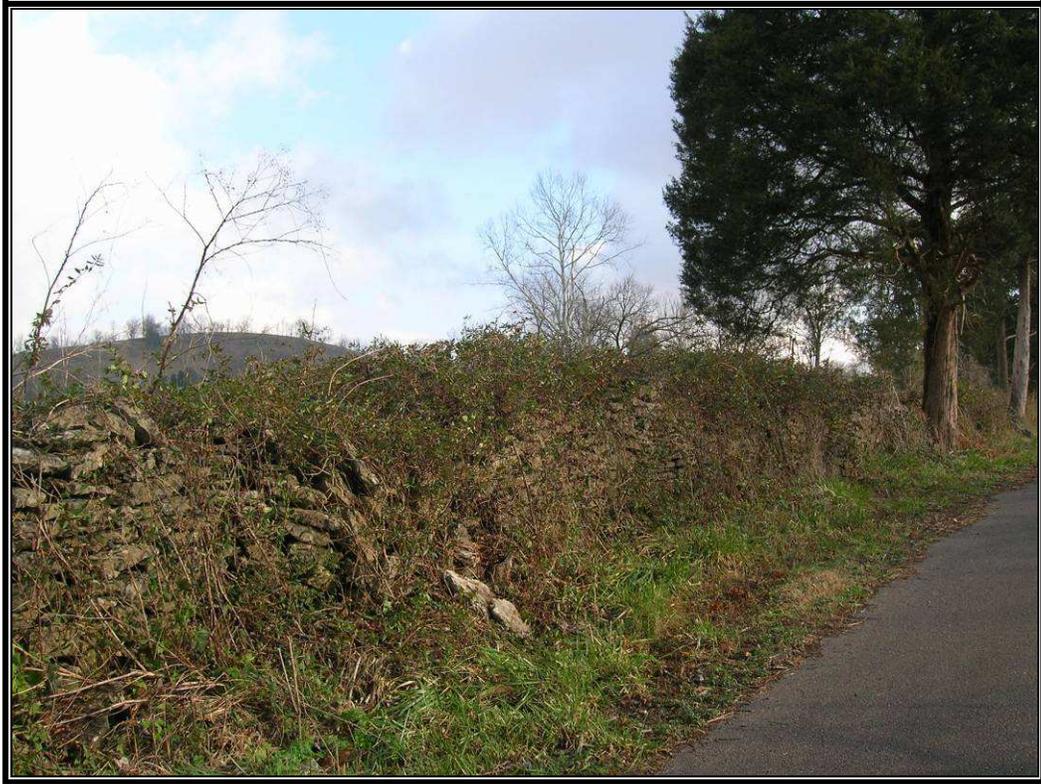
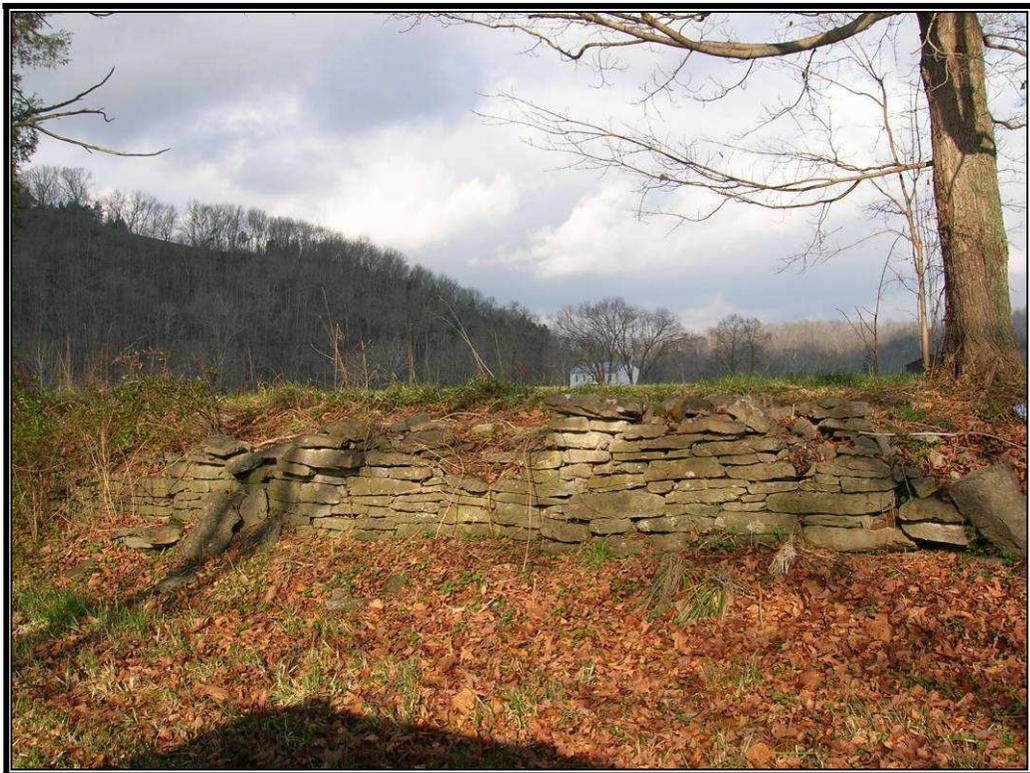
Figure 8.63. Looking east at portion of rock fence located on the east side of the driveway.

Figure 8.64. Looking north at portion of rock fence near its terminus, on the east side of the driveway.

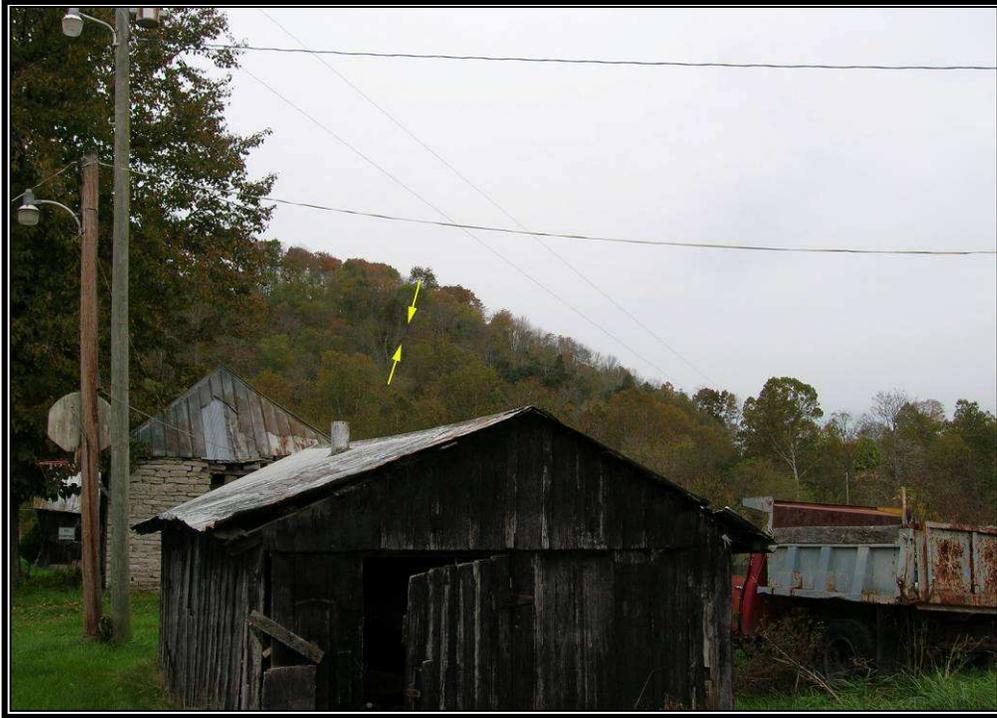
Section 10 of the proposed transmission line, which will parallel the existing line, is located approximately 450 ft to the northeast of the northeast boundary of Site 30. The line measures approximately 682 ft to the northwest of the house. Section 10 is a portion of Alternatives A, B, C, D, E, F, G, and H. The existing line is not readily visible from Site 30, as Figure 8.66 shows. This photo was taken from behind the house and the existing line is located in the heavily wooded hillside in the background of the photo. The house is oriented to the southwest, away from the existing line. Portions of the transmission line

do not appear to be visible from the front of the house. The existing line traverses through a wooded and hilly area as it continues to the southwest. Because of the distance between the site and the existing and proposed lines, and the topography, it does not appear the proposed transmission line will have an effect on the site. Therefore, a no effect for Site 30 is recommended.

Figure 8.66. Site 30, Looking west toward existing line from rear of house. Yellow arrows are pointing at existing line, located in wooded hill in background.

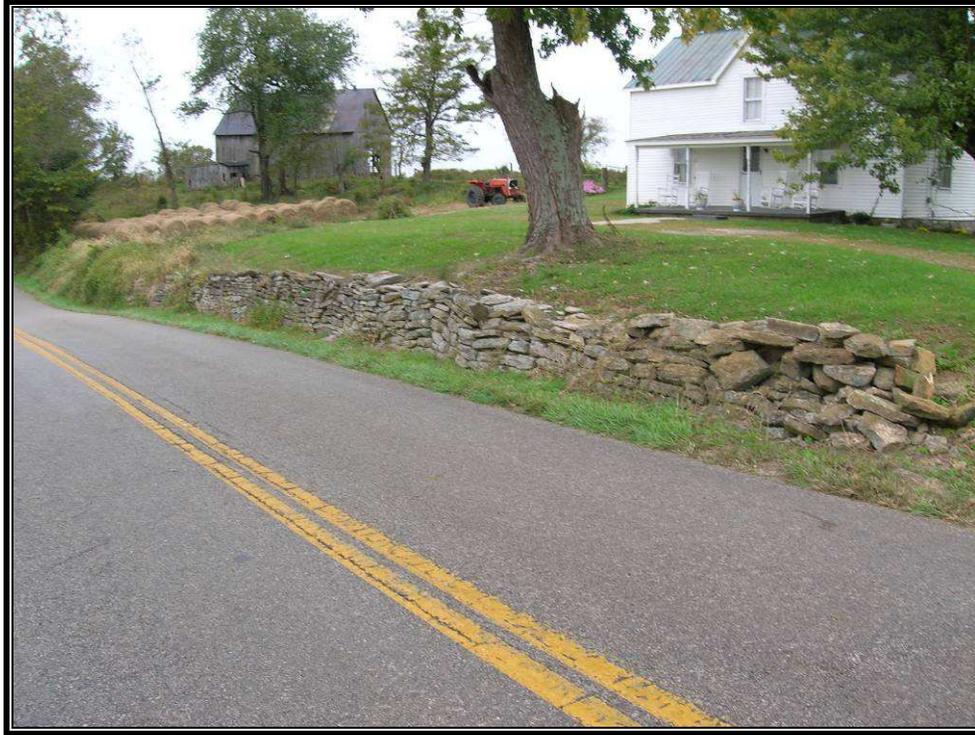
double-hung wood sashes. The upper level of the façade is comprised of a central cross gable containing a window with two-over-two-light double-hung wood sashes. An interior brick chimney pierces the ridgeline of the roof behind the cross gable. Windows on the side elevations also contain two-over-two-light double-hung wood sashes (Figure 8.68). A single-story, gable-roof addition is located on the rear elevation. A shed-roof porch has been partially enclosed on the southeast side of the addition. The addition has a corrugated metal roof. The house and addition are clad in vinyl siding. The window and door surrounds and the eaves and soffit are also clad in vinyl. The main block of the house rests on a parged stone foundation and its roof is covered with V-groove metal panels. A dry-laid stone retaining wall is located in front of the house, between KY 595 and the front yard (Figure 8.69). The wall is approximately six courses high and a portion on the west side is partially collapsed.

Figure 8.69. Site 31, Stone retaining wall.

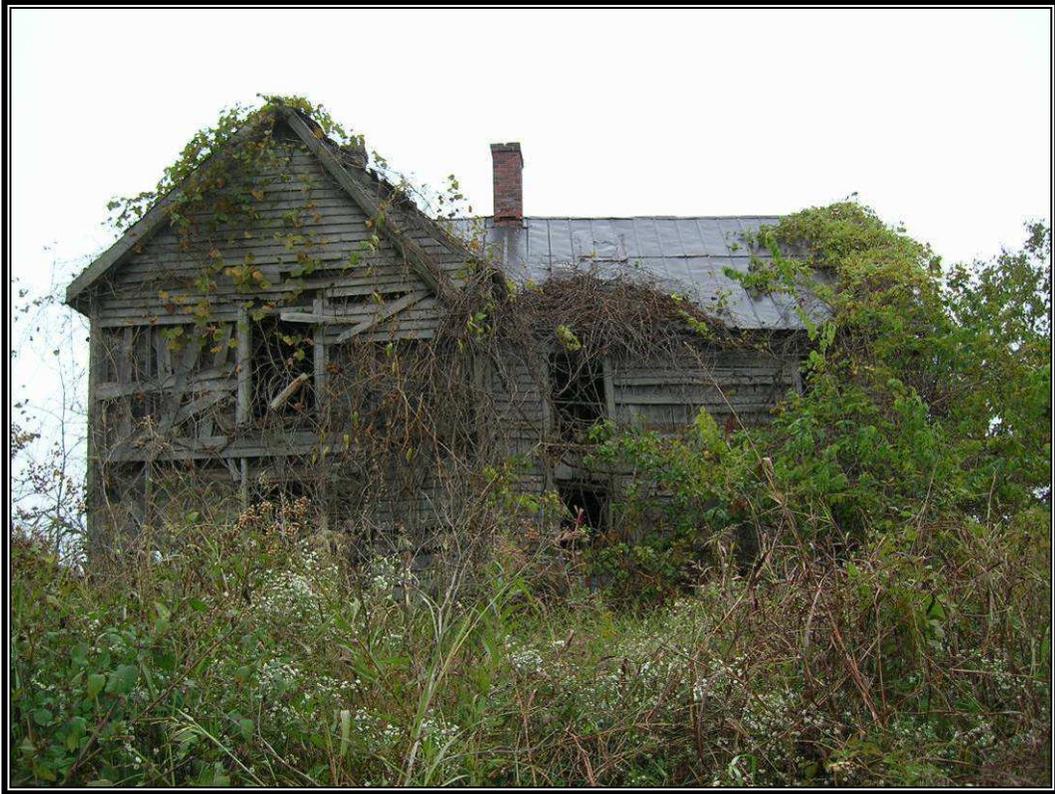
Description: This house is located off of KY 595, south of Cottonburg. It is a two-story, frame T-plan house in dilapidated condition (Figure 8.75). The house is comprised of a side-gable portion with a projecting front-gable portion forming the T-plan. The single-leaf entry on the façade is located on the side of the front-gable portion. Three window openings with missing sashes are located on both the lower and upper levels of the façade. An interior brick chimney pierces the ridgeline of the roof on the side-gable portion. Windows on the north elevation also have missing sashes, while a single-leaf door is located on the lower level (Figure 8.76). An interior brick chimney pierces the ridgeline of the front-gable portion of the house. The south elevation also contains windows with missing sashes, although a bottom sash with two divided lights is still in place in one of the

NRHP Evaluation: Not Eligible. Because of the under maintained nature of the house, its integrity of design, materials, workmanship, feeling, and association have been compromised. Windows and doors are missing, portions of the weatherboard siding have been removed, and there are no longer any distinctive features such as window and door trim, cornice line and return, or porches with turned wood posts or other ornamental features. This house no longer retains the integrity necessary to convey significance and does not appear to be a good example of a frame T-plan house. Additionally, this site does not appear to be associated with a significant person or event in history. As a result, this house does not appear to be eligible for inclusion in the NRHP under Criterion A, B, C, or D.

Figure 8.75. Site 33, Two-story, three-bay (w/w/w), frame T-plan house (MA-879).

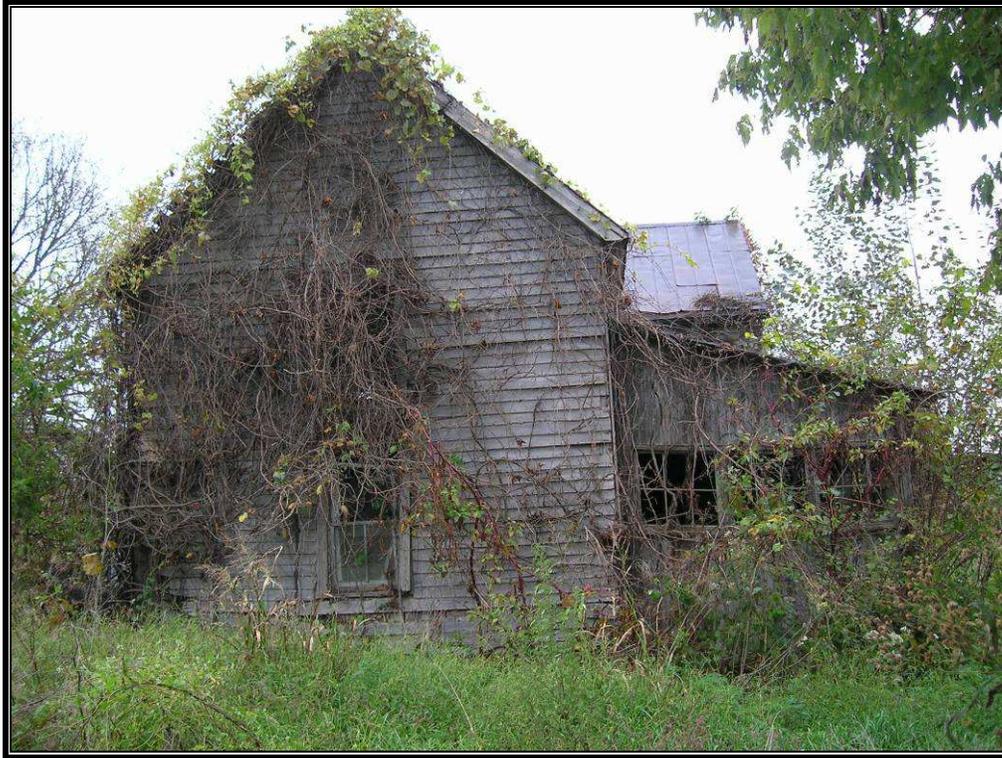
windows (Figure 8.77). A shed-roof addition is located on the rear of the house. It appears the front-gable portion of the house is of balloon frame construction with diagonal braces further bolstering the framing. The side-gable portion appears to be of box frame construction. Weatherboards clad the exterior of the house, with many portions of the siding missing. The foundation appears to be stone, but it is unclear whether it is a continuous stone foundation or a stone pier foundation. The roof is covered with metal panels. A nonhistoric tobacco barn is located near the house, as well as a smaller, collapsed gable-roof outbuilding.

Figure 8.77. Site 33, South elevation.

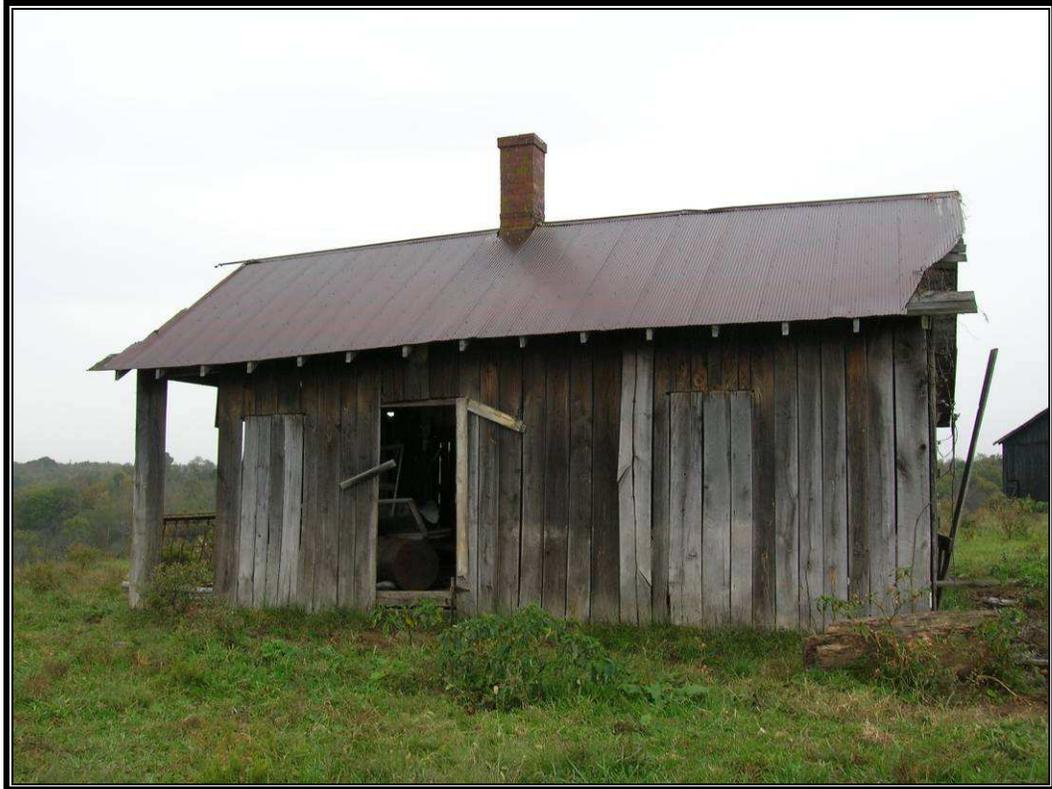
Description: This possible tenant house is located in a field off of KY 595, south of Cottonburg. It is a one-story, three-bay (d/d/d), side-gable box-frame house (Figure 8.78). The gable-roof extends over the façade, forming a porch area. There are three single-leaf batten doors on the façade. An interior brick chimney pierces the ridgeline of the roof towards the center of the house. The south wall is deteriorating and many of the boards are missing (Figure 8.79). The house extends into a shed-roof appendage on the rear elevation. The roof is covered with corrugated metal

NRHP Evaluation: Not Eligible. With its deteriorating condition and lack of architectural elements, this is not a particularly good example of a one-story, side-gable house. The possibility that the house may have been a tenant house or farm office does not outweigh its lack of integrity. Additionally, this site does not appear to be associated with a significant person or event in history. As a result, this house does not appear to be eligible for inclusion in the NRHP under Criterion A, B, C, or D.

Figure 8.78. Site 34, One-story, three-bay, side-gable box-frame house (MA-880).

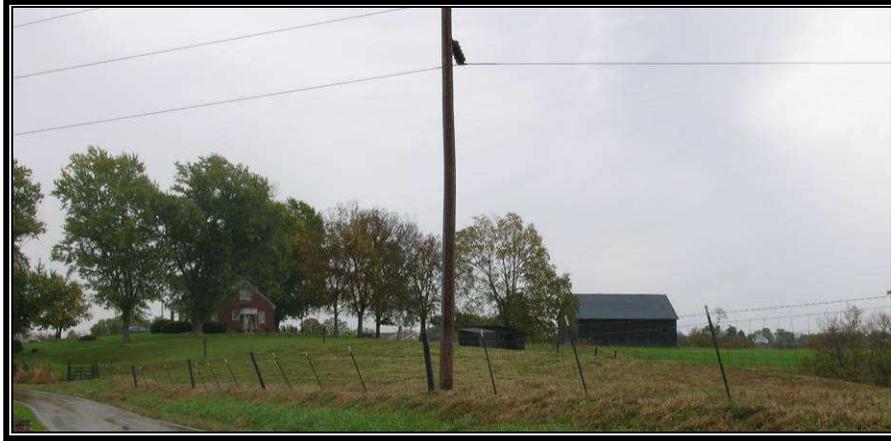
Section 10 of the proposed transmission line, which will parallel the existing line, is located approximately 227 ft to the northwest of Site 36 (Figure 8.91). Section 10 is a portion of Alternatives A, B, C, D, E, F, G, and H. Because there is already an existing transmission line near the house, it does not appear the proposed line will have an adverse effect on the site, nor does it appear that the proposed line will adversely effect the qualities for which the house is considered eligible, for its architectural significance. As a result, a no adverse effect determination is recommended for Site 36.

Figure 8.91. Site 36, Looking east toward Site 36, with existing transmission line in foreground.

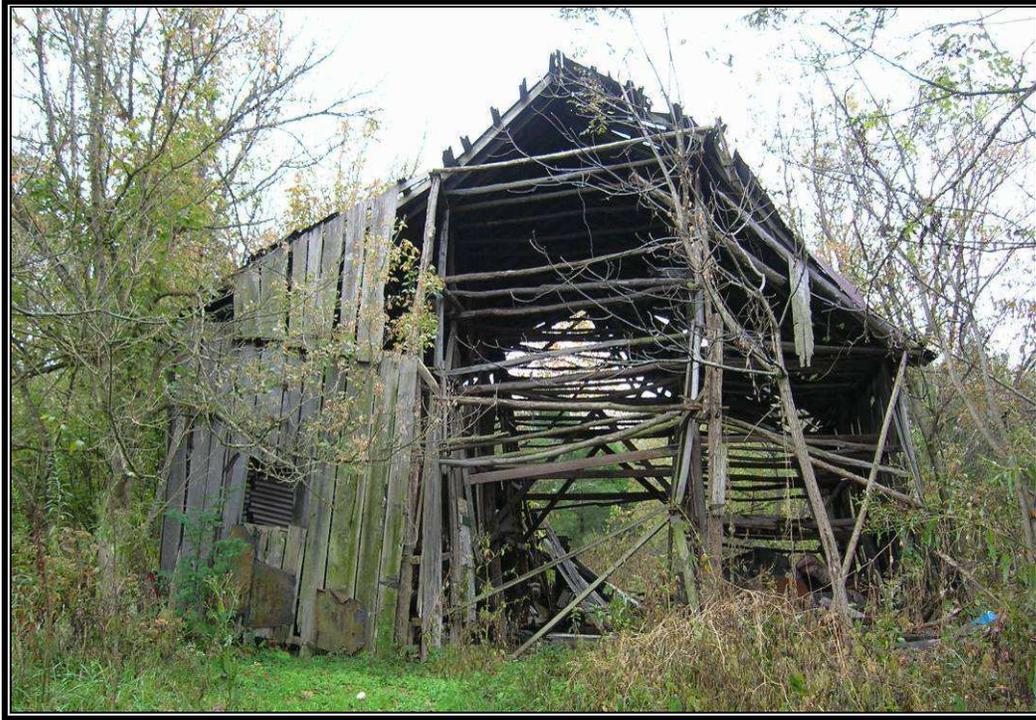
clad in vinyl siding and the roof is covered with V-groove metal panels. The house rests on a fieldstone foundation. A dilapidated gable-roof barn is located behind the house (Figure 8.104). The barn is missing several portions of the exterior walls. A gable-roof, vertical board outbuilding is also located in the house's yard (Figure 8.105). It has a single-leaf batten door and a metal roof. A shed-roof, vertical board outbuilding is also associated with the house (Figure 8.106). The outbuilding is in a deteriorating condition.

Figure 8.104. Site 38, Gable-roof barn.

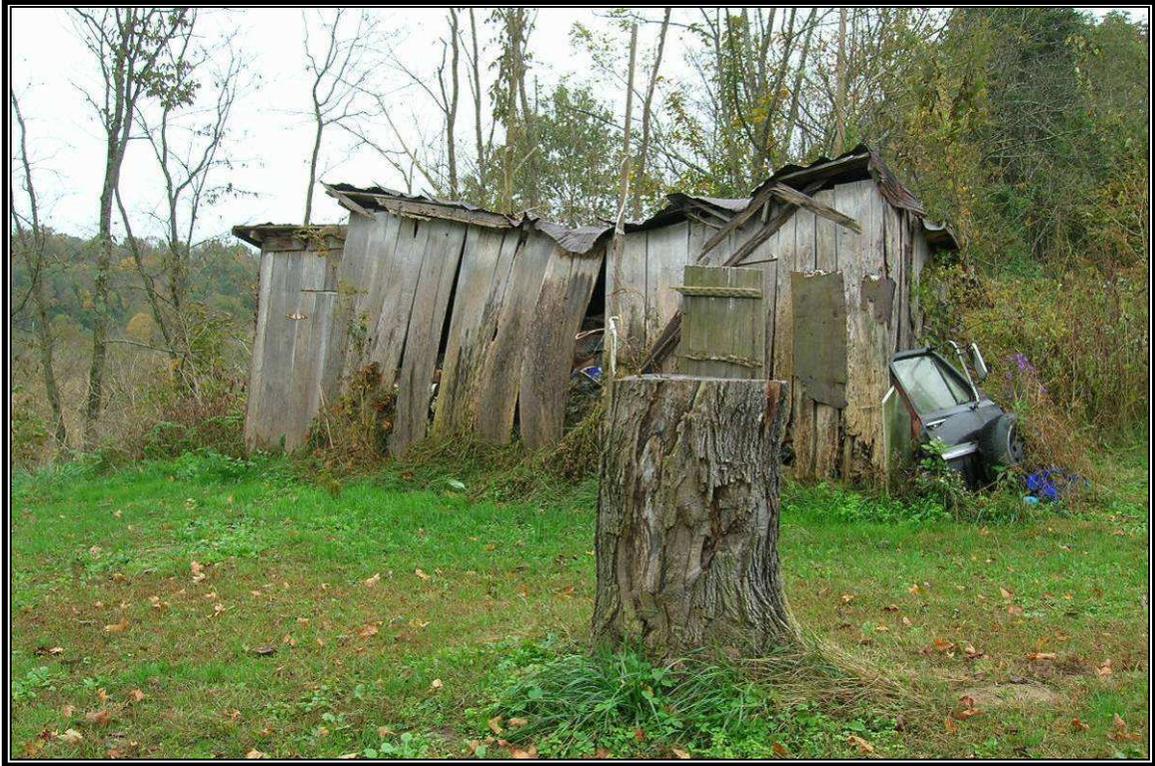
Figure 8.106. Site 38, Shed-roof outbuilding.

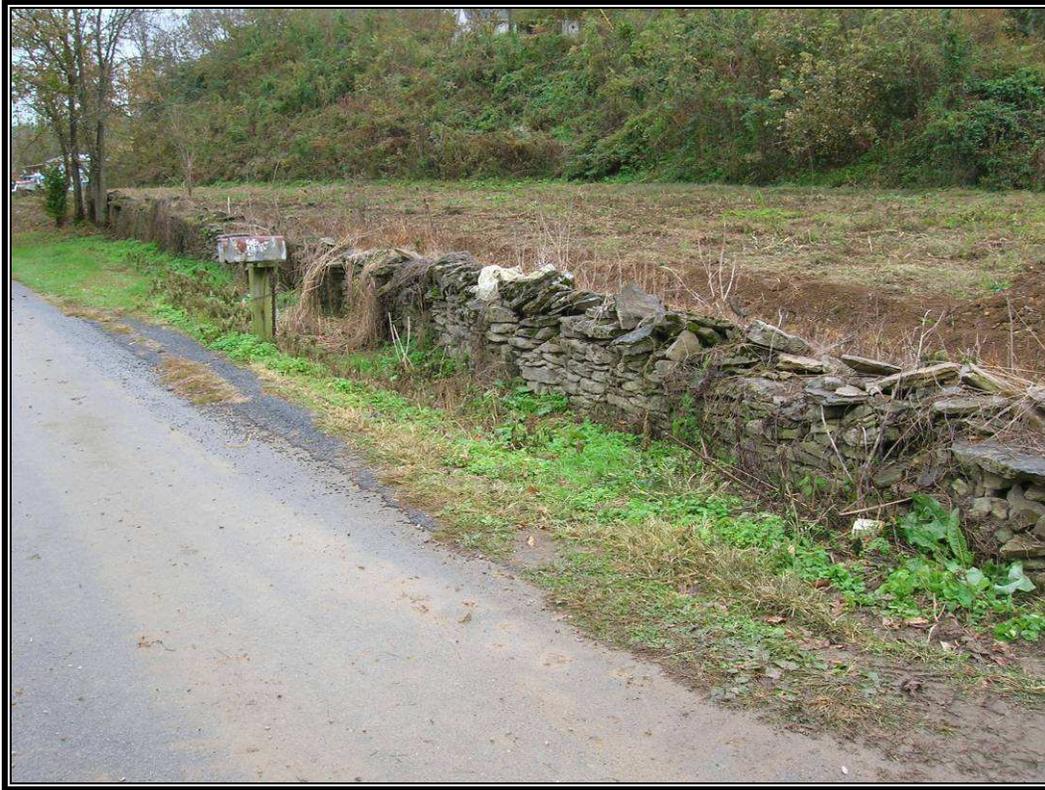
Description: This is a dry-laid rock fence, located along the southwest side of Bradshaw Mill Road (Figure 8.107). The rock fence does not appear to be related to a house or other property type in the immediate vicinity. Measuring approximately 30 meters in length, the rock fence is approximately nine to ten courses in height. The fence has coping along most portions, although several areas have fallen into disrepair (Figure 8.108-8.109). A mortared stone-lined culvert is adjacent to the fence (Figure 8.110).

Figure 8.107. Site 39, Dry-laid rock fence along Barnes Mill Road (GD-460).

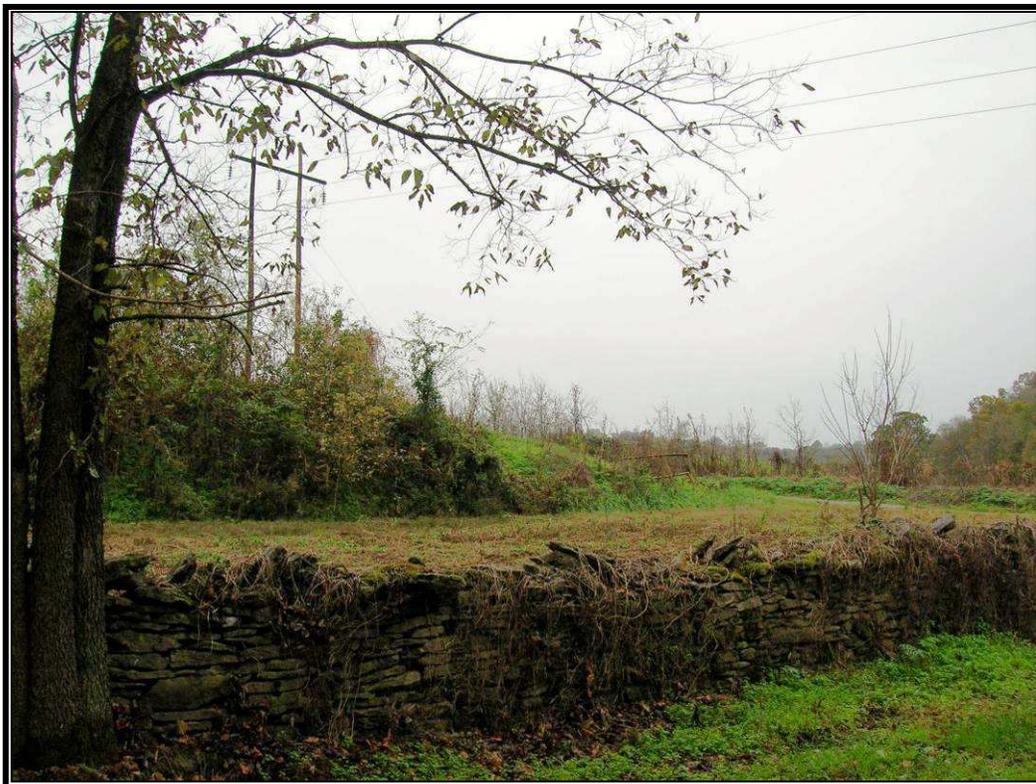
NRHP Evaluation: Not Eligible. With its deteriorating coping and general disrepair, this does not appear to be a particularly outstanding example of a dry-laid rock fence in rural Garrard County. A better example in Garrard County includes Site 93. Nor does the culvert appear to be of historic significance. As a result, this site does not appear to be eligible for inclusion in the NRHP under Criterion A, B, C, or D.

Figure 8.108. Site 39, View of dry-laid rock fence, looking north.

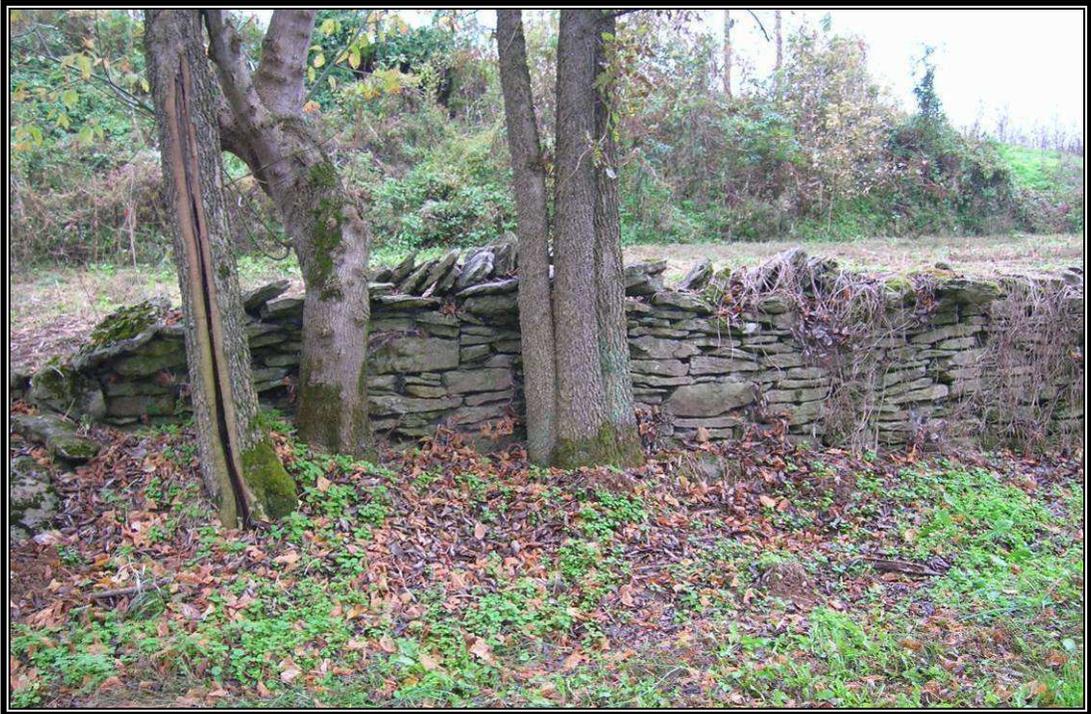
Figure 8.109. Site 39, View of north end of rock fence.

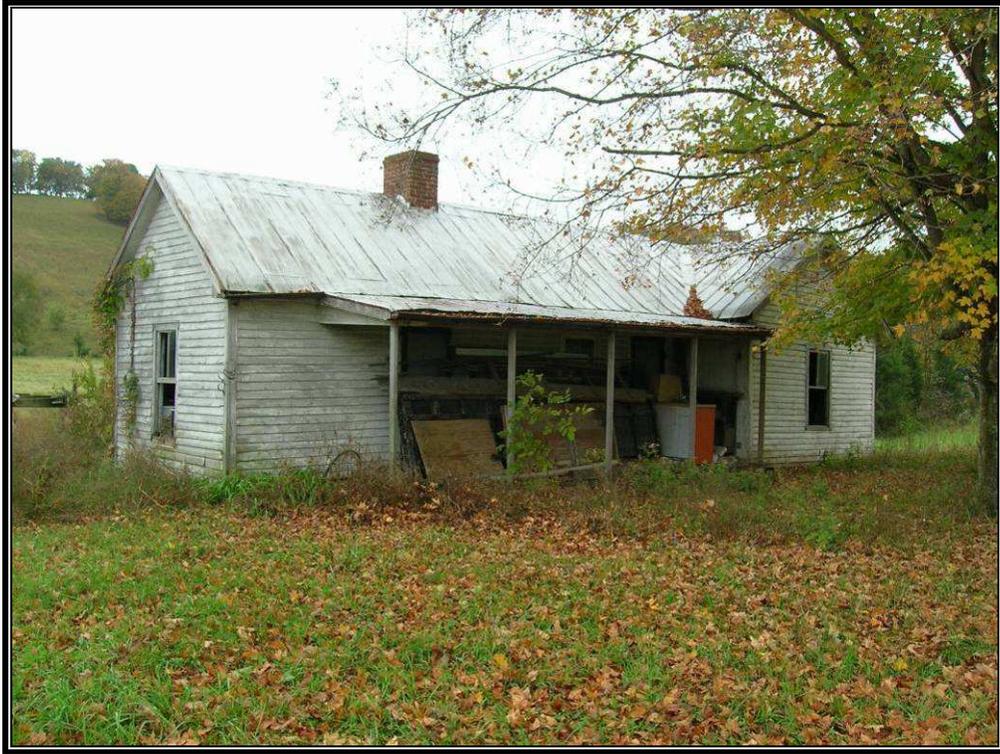
Description: This house, which appears to be abandoned, is located on Long Branch Road, south of Paint Lick Creek. It is a one-story, four-bay (d/w/d/w), frame T-plan house (Figure 8.111). The shed-roof porch, which has square wood posts, extends across the side-gable portion of the façade. Two single-leaf entries are located on the side-gable portion of the façade. The entries appear to contain wood plank doors. Windows on the side-gable and front-gable portions have two-over-two-light double-hung wood sashes, although one window is missing the bottom sash. An interior brick chimney pierces the ridgeline of the roof of the side-gable portion. Windows along the side and rear elevations also have two-over-two-light double-hung wood sashes, although portions of the sashes and lights are missing. While the front and side elevations are clad in weatherboards, the rear elevation is clad in board and batten siding (Figure 8.112). A single-leaf nonhistoric panel door is located on the rear elevation. A shortened interior brick chimney pierces the ridgeline of the front-gable portion of the roof, towards the rear elevation. The roof is covered with V-groove metal panels. The house rests on a dry-laid fieldstone foundation.

NRHP Evaluation: Not Eligible. With its replacement siding on the rear elevation, replacement doors, and missing window sashes, this house no longer retains the integrity necessary to convey significance. In addition, the house lacks any distinctive or character defining features that may have once appeared on the porch or in other architectural details throughout the house. The outbuildings do not appear to date to the construction of the house, nor do they impart significance on the site as a whole. This site does not appear eligible for inclusion in the NRHP under Criterion A, B, C, or D.

Figure 8.111. Site 40, One-story, four-bay, frame T-plan house (GD-461).

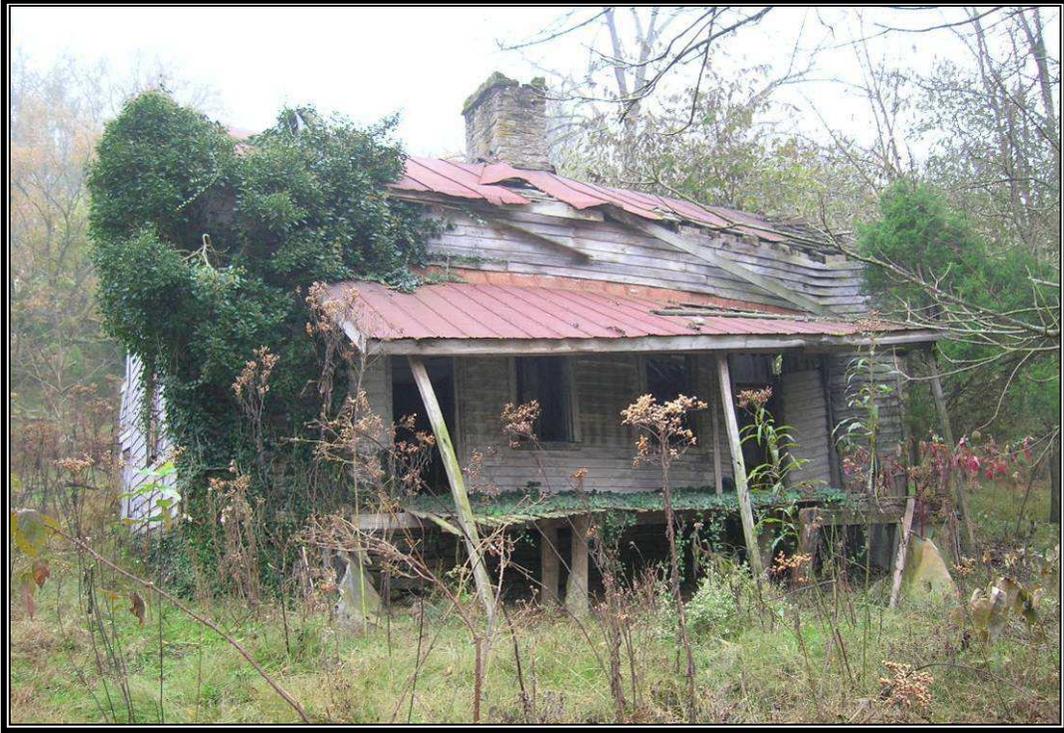
Description: This house, which is abandoned and in deteriorated condition, is located on the west side of Back Creek. It is a one-story, four-bay (d/w/w/d), side-gable box-frame house with a central mortared stone chimney (Figure 9.13). A shed-roof porch shelters the façade bays. The porch has missing posts and is currently supported by square wood posts that extend to the ground. The porch deck is covered with wood slats and rests on a wood pier foundation. Window bays with missing sashes are located at the center of the façade while single-leaf entries are located in the outer façade bays. The entries have missing doors. A large interior stone chimney pierces the center of the roof. A single-leaf entry with a missing door is located on the rear elevation (Figure 9.14). While a majority of the house is

Figure 9.13. Site 44, One-story, four-bay, side-gable, box-frame house (GD-465).

NRHP Evaluation: Not Eligible. Because of its deteriorating condition, this house has missing windows and doors, missing porch components, and replacement siding on the rear elevation. As a result, this house no longer retains the integrity necessary for significance. Nor do the outbuildings, several of which are also in a state of neglect and disrepair, impart significance to the site as a whole. This site does not appear to be associated with a significant person or event in history. As a result, this house does not appear to be eligible under Criterion A, B, C, or D.
