Section 8. Inventory of Historic Resources: Sites 21–40

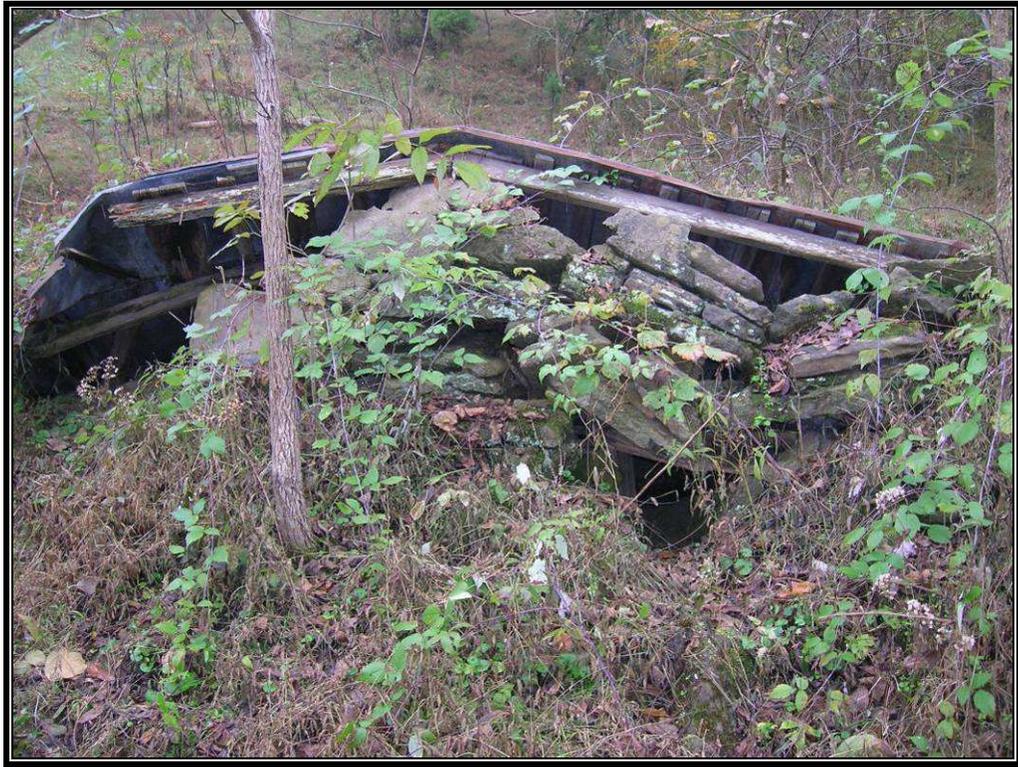
clad with weatherboards, the rear is partially clad in board and batten siding and particle board. The house rests on a dry-laid stone foundation and the roof is covered with standing seam metal. A collapsed stone cellar is located behind the house (Figure 9.15). The cellar appears to have had a gable roof. A gable-roof outbuilding clad in board and batten siding is also located near the house (Figure 9.16). The outbuilding has several portions of its walls missing and also has a corrugated metal roof. A gable-roof, vertical board barn with shed-roof wings is located south of the house (Figure 9.17). Both the shed-roof wings and the central portion of the barn have bays. The roof is covered with corrugated metal. The west side of the barn has four vertical side vents. A shed-roof, vertical board outbuilding is located next to the barn (Figure 9.18).

Figure 9.15. Site 44, Collapsed stone cellar.
